Safety Recall

Code: 44M9

Subject	TPMS Coding & Safety Certification Label Information
Release Date	May 03, 2016
Affected Vehicles	U.S.A.: Certain 2016 Model Year Volkswagen Touareg with 21-inch Wheels/Tires <i>Check Campaigns/Actions screen in Elsa on the day of repair to verify that a VIN qualifies for repair under this action. Elsa is the <u>only</u> valid campaign inquiry & verification source.</i> <ul style="list-style-type: none">✓ Campaign status must show "open."✓ If Elsa shows other open action(s), inform your customer so that the work can also be completed at the same time the vehicle is in the workshop for this campaign.
Problem Description	<p>In certain vehicles, the tire pressure monitoring system (TPMS) has been incorrectly programmed to a lower pressure than required. Because of this, the warning for tire pressure loss will be delayed, and could result in the driver not being aware that one or more tires are low.</p> <p>Additionally, the tire pressures printed on the Safety Certification label in certain vehicles are incorrect. This makes the label non-compliant with Federal Motor Vehicle Safety Standards.</p> <p>Driving with too low tire pressure may cause tire fai

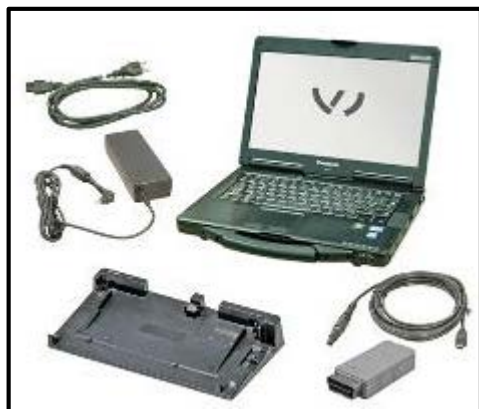
- VAS6150C – Diagnostic Tester (or equivalent)

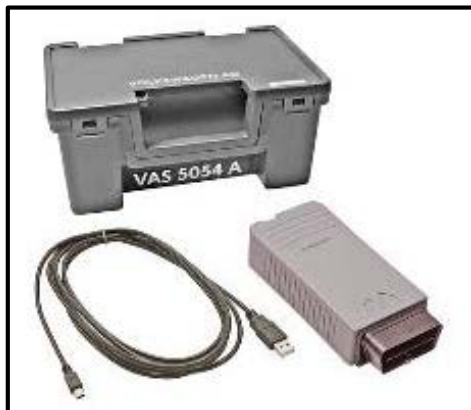
- VAS5054A – Remote Diagnosis Head (or equivalent)

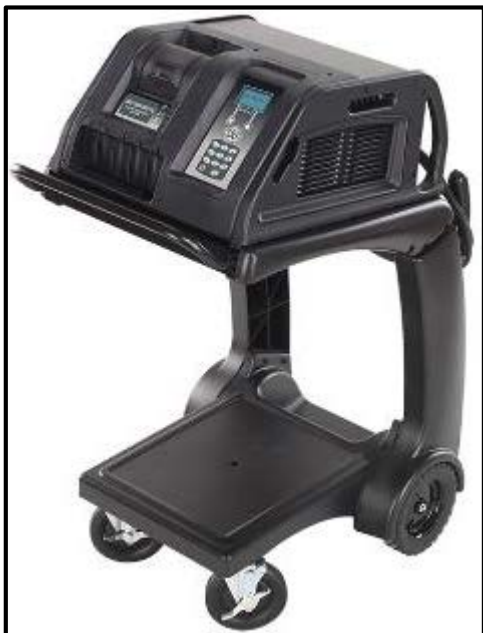
- GRX3000VAS – Battery Tester/Charger (or equivalent)

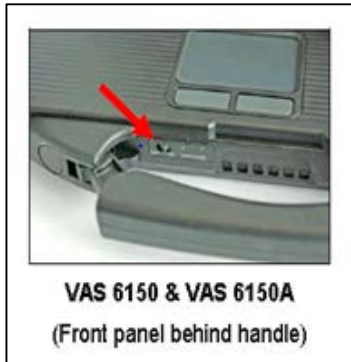
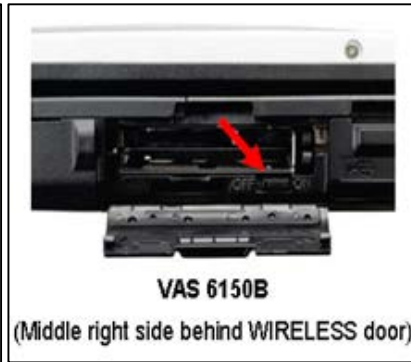
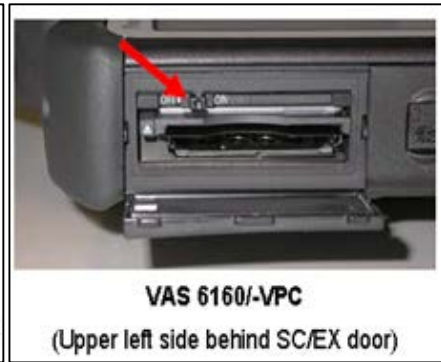
If the Bluetooth wireless VAS 5054A transmitter head is used in conjunction with a VAS tester, the transmitter head **MUST BE** connected with a USB cable to the tester.

The Bluetooth function of the scan tool **MUST BE PHYSICALLY SWITCHED OFF** prior to performing this update. <See pictures>

Performing the software update using a Bluetooth connection greatly increases the required time to perform the update. It also increases the risk of losing connection to the vehicle and damaging the control module being updated.

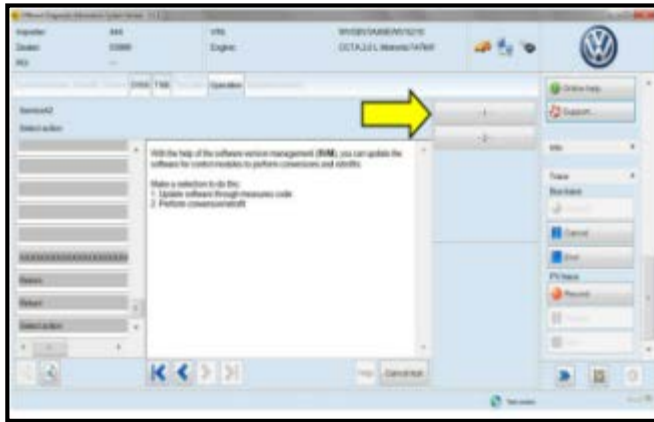
- Select the appropriate option to update “through measures code” <arrow>.

NOTE
 Read this screen carefully. The option to update software through measures code is **NOT** always selection #1 on this screen.

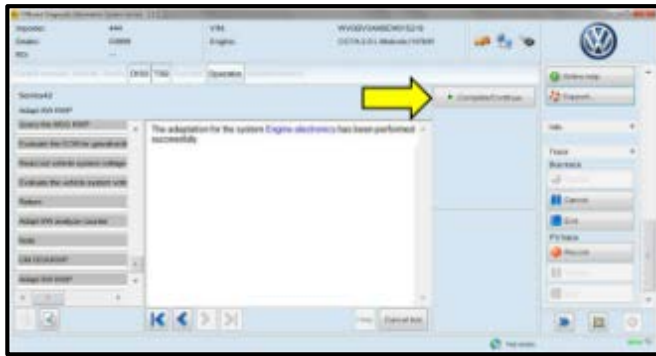
- When the SVM update is complete a confirmation message is displayed <as shown>.
- Select “Complete/Continue” <arrow>.

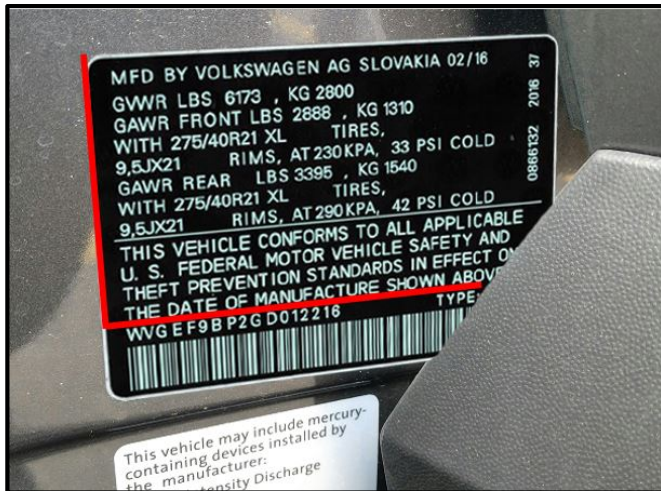
- Clean the Vehicle Safety Certification Label and surrounding area as necessary to remove any dirt or debris.

- The surface of the existing label must be clean, dry, and free from oil residue prior to applying the overlay label.
 - Handle the overlay label carefully. Do not touch the adhesive backing.
-
- Remove the paper backing from the label overlay (7D000US44M9_02), align the left and bottom edges of the label overlay where shown <lines>, and apply the label overlay to the vehicle.
