Safety Recall S28 / NHTSA 16V-249

Shift Interlock Solenoid Electrical Connector

2016 (WK) Jeep® Grand Cherokee

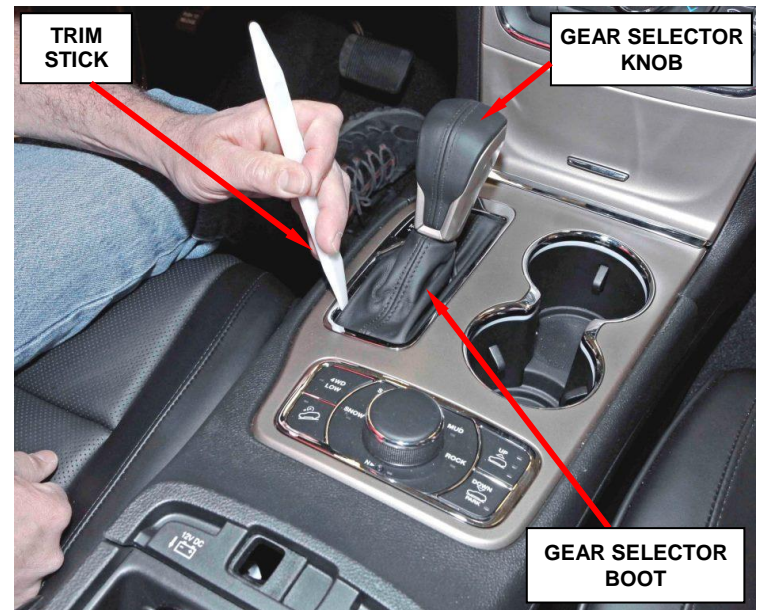
**Figure 1 – Gear Selector Boot**

2. Using Trim Stick C-4755 or equivalent, detach the gear selector boot from the gear selector bezel (Figure 1).
3. Remove and save the gear selector knob retaining screw (Figure 2).
4. Remove and save the gear selector knob and boot from the gear selector stalk (Figure 2).
5. Open the storage bin door and storage door on the center console.

18. Snap the gear selector boot to the gear selector bezel.
19. Close the storage bin door and center console storage door.
20. Connect the negative battery cable.

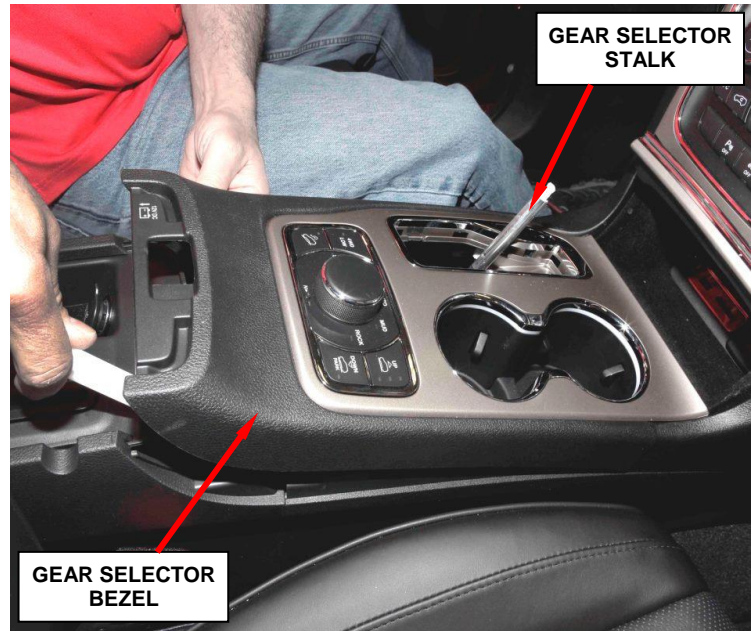
Figure 3 – Gear Selector Bezel

- Using Trim Stick C-4755 or equivalent, detach the gear selector bezel from the center console (Figure 3).

CAUTION: There are wire connectors attached to the Terrain Select switch, cup holders and “PRNDM”. Take care not to pull out wires while detaching the selector bezel

15. Install the gear selector bezel onto the console.
16. Install the gear selector knob and boot to the gear shift stalk as an assembly (Figure 2).
17. Install the gear selector knob retaining screw (Figure 2). Tighten the screw to 18 in. lbs. (2 N·m).
