**SAFETY RECALL BULLETIN**  
**NHTSA SAFETY RECALL: 16V-088**  
**TRANSPORT CANADA RECALL: 2016067**  
**Iowa Mold Tooling Co., Inc. Safety Recall TB2016002**

<b>Classification:</b>	<b>SAFETY RECALL BULLETIN – MANDATORY MECHANICAL</b>
<b>Subject:</b>	IMT Series III Telescopic Crane Valve Bank Cover
<b>Attn:</b>	IMT Customer/Owner
<b>Date:</b>	March 2016
<b>Safety Recall Information:</b>	This document provides work instructions to replace the valve bank cover on IMT Series III cranes manufactured between 04/04/13 through 01/22/16.
<b>Affected models:</b>	2013-2016 IMT Dominator-Propane, Dominator 1, Dominator 2, Dominator 3 and Dominator 4 vehicles fitted with Series 3 crane models 6000, 7500, 8600, 9500, 10000, 12000 and 14000 that were built with a certain valve bank cover

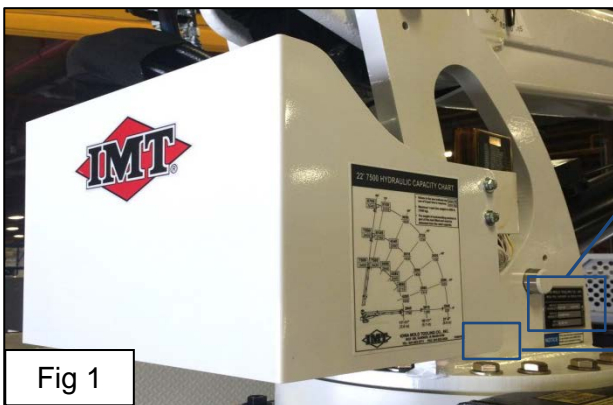
Fig 1

**Why are you receiving this bulletin?** IMT has identified cranes built with a certain valve bank cover on the back side of the crane mast that can crack. Under certain road conditions the cracks can propagate and eventually cause the cover to break. If not repaired, a broken valve bank cover can detach from the vehicle and create a possibility of a road hazard which could result in a vehicle crash or injury.

**What will we do?** IMT has developed a new valve bank cover, made from thicker, high strength steel. We will provide a new cover, with the appropriate decals installed, to you at no charge. IMT will reimburse you for one-half hour of labor to remove the old cover and install the new cover. Cranes manufactured on and after 01/25/16 have the new valve bank cover. The new valve bank cover has an identifying feature (see Fig 2) on the forward, bottom edge.

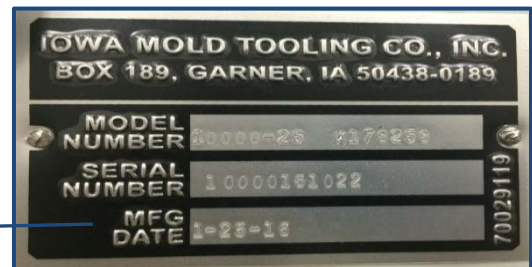
Fig 3

**What should you do?** If your crane was manufactured between 04/04/2013 and 01/22/2016 (the manufacture date is on the serial plate on your crane – see Fig 3) you will need to fill out the attached order form and send it to IMT. Once you have the new cover, remove the old cover and discard it. Installation instructions will be supplied with the new cover.  
**Please be reminded that it is a violation of Federal law for you to sell or lease any IMT crane covered by this notification until this recall has been performed on these vehicles. Substantial civil penalties apply to violations of this law.**

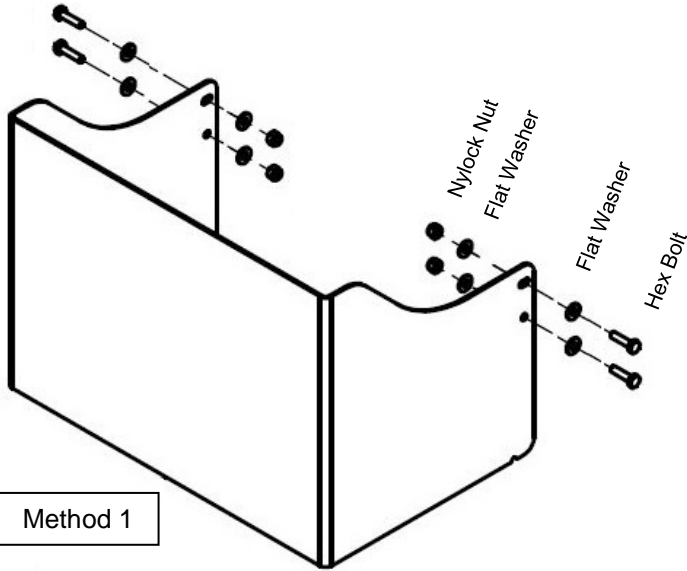
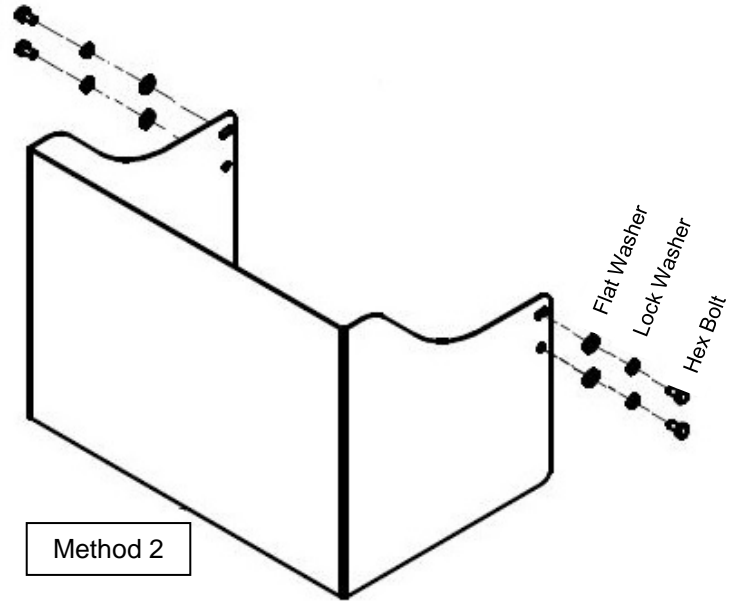
- Method 1 uses (4) bolts with flat washers and nylock nuts, bolting the cover to the valve bank mounting bar.
  - Method 2 uses (4) bolts with locking and flat washers bolting into threaded holes in the valve bank mounting bar.

1. Remove the valve bank cover by removing and retaining (4) ¼" hex bolts and hardware that hold the cover to the valve bank. NOTE: there are two methods used to retain the cover to the valve bank (see next page).

2. Install the new cover using the hardware removed in step one. Insure that all of the hardware is installed as shown above. Tighten the bolts just enough so that the back side of the cover can be adjusted up/down.
