Keystone RV Company

SAFETY ADVISORY # 16-251

Outback 326RL TV Bracket Screws

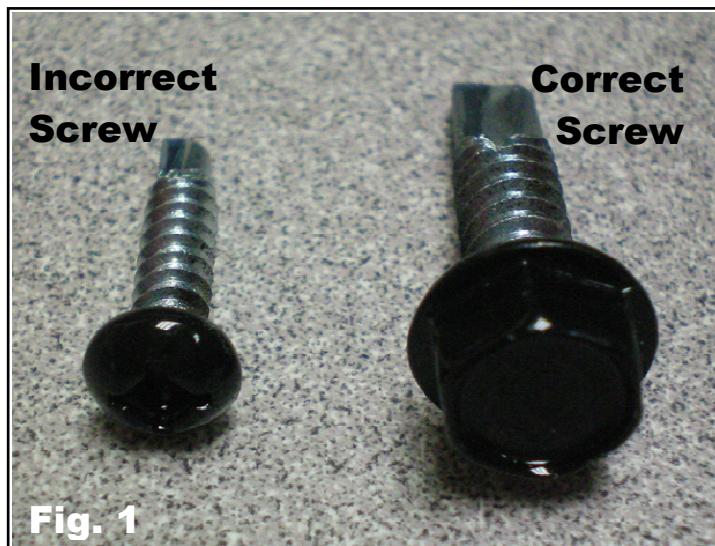
Keystone is conducting a voluntary **RECALL** notification campaign in accordance with the National Highway Transportation and Safety Act. It has been decided the vehicles in this recall population may have been manufactured with an interior TV bracket not properly secured to the wall. If the TV bracket breaks loose from the wall while a person is nearby, it will lead to an increased risk of personal injury.

Loosen the existing screws (#8 x 3/4" self-drilling) on the TV wall bracket. Keeping the parts together, remove the TV wall bracket and TV.

Remove TV wall bracket screws (#8 x 3/4" self-drilling). Using existing holes, re-install TV wall bracket and TV with 1/4" - #14 - 1" self-drilling screws, Fig. 1.
