Dealer Service Instructions for:

Safety Recall S34 / NHTSA 16V-302

Manual Transaxle Clutch Pedal

2012 - 2016 (FF) FIAT 500 vehicles

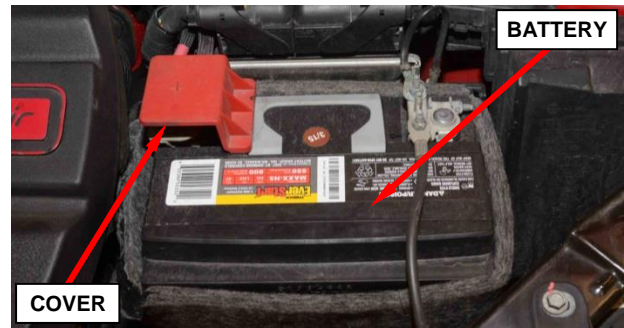
**Figure 2 – Battery Terminal Cover**

1. Open the vehicle hood.
2. Remove and save the cover from the battery positive terminal (Figure 2).

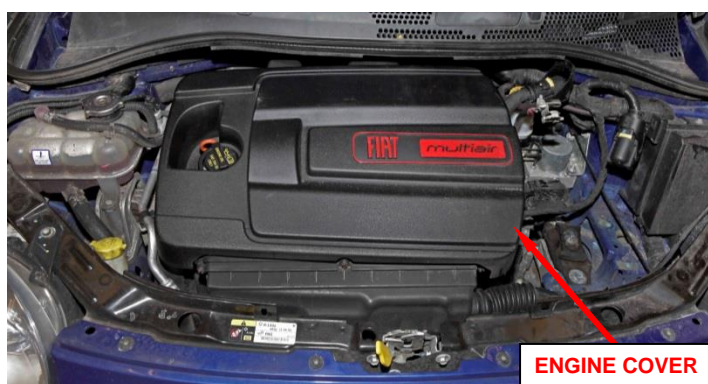
Figure 21 – Engine Cover

1. Remove and save the engine cover (Figure 21).

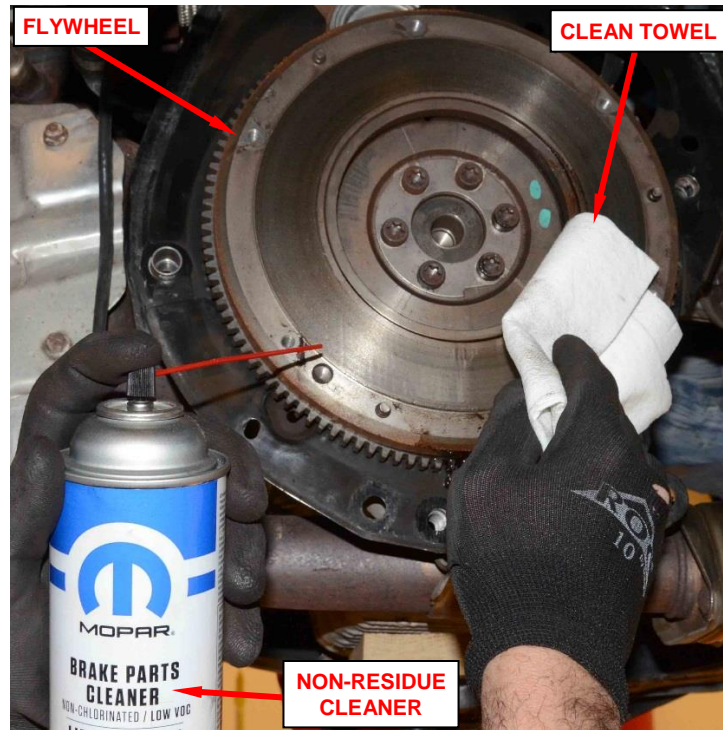
Figure 61 – Clean Flywheel Surface

71. Clean the surface of the flywheel with Mopar® brake parts cleaner or equivalent non-residue cleaner to make certain that all oil, grease and rust has been removed (Figure 61).

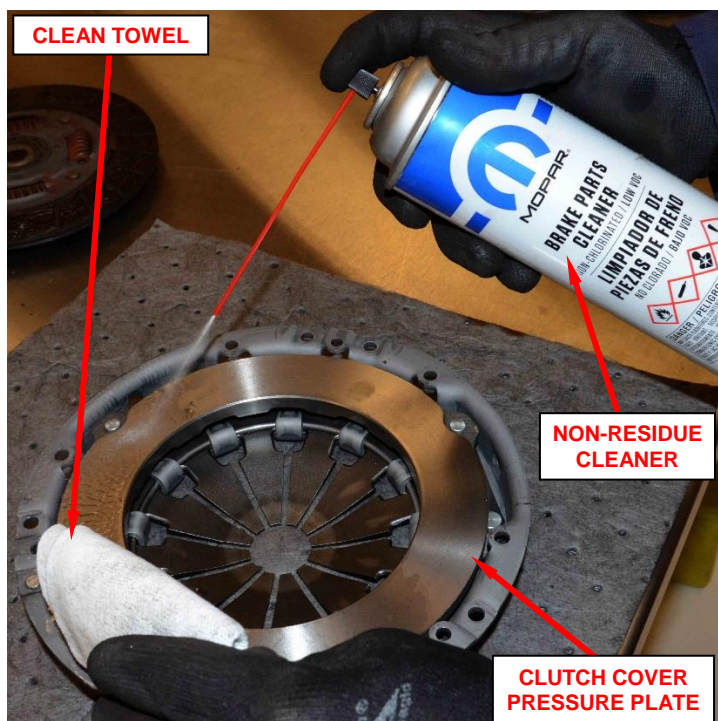
Figure 62 – Clean Clutch Cover

72. Clean the **NEW** clutch cover pressure plate surface with Mopar® brake parts cleaner or equivalent non-residue cleaner to make certain that all oil, grease and rust has been removed (Figure 62).
