<b>GROUP</b> <b>Safety Recall Campaign</b>	<b>MODEL</b> <b>2013MY Forte (TD)</b>
	<b>NUMBER</b> <b>SC 132 (REV 3 8/17/2016)</b>	<b>DATE</b> <b>June 2016</b>
<b>VOLUNTARY SAFETY RECALL CAMPAIGN</b>		
<b>SUBJECT: FRONT SEAT BELT ASSEMBLY (SC 132)</b>

This bulletin provides the procedure to inspect, and replace if necessary, the front seat belt assemblies on certain 2013MY Forte vehicles produced from 9/10/2012 through 10/31/2012. The screws holding the seat belt retractor's retaining plate in a small number of vehicles may not have been properly tightened due to a machining error in the screw threads by the supplier. As a result, the plate can break during certain frontal impact collisions. The broken piece of the plate may come in contact with an occupant thereby increasing the risk of injury.

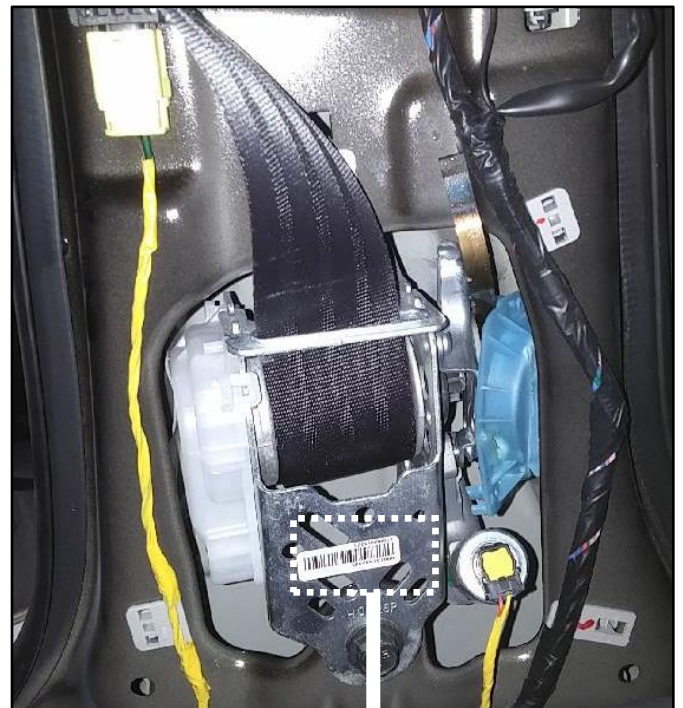
1. Remove the center pillar lower trim by referring to “Body (Interior and Exterior) → Seat Belt → Front Seat Belt → Repair Procedures” in the applicable Workshop Manual.
2. Check the manufacturing date in the LOT number on the front seat belt assembly as shown.

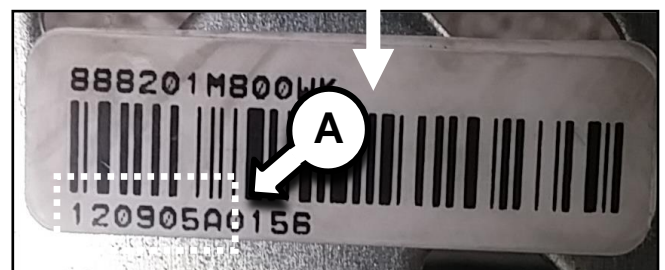
3. If the LOT number indicates a manufacturing date (A) of “120905,” replace the seat belt assembly.  
(Refer to the “Replacement Procedure” on Page 3.)

4. If the date (A) on the label is **not** “120905,” no further action on this assembly is required. Reassemble the trim pieces.
5. Repeat Steps 1-4 for the opposite side belt assembly.

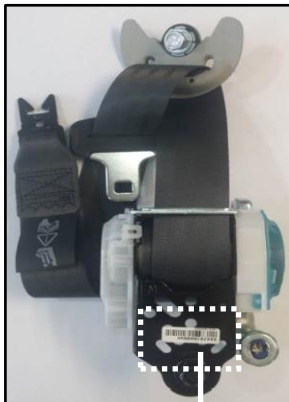
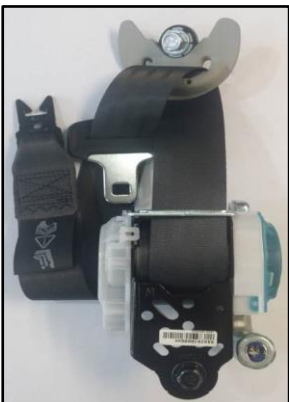
Replace <b>only</b> those parts manufactured on September 5, 2012 (shown as “120905” on the label).

1. Remove the front seat belt assembly by referring to the “Body (Interior and Exterior) → Seat Belt → Front Seat Belt → Repair Procedures” in the applicable Workshop Manual.
2. Install the new front seat belt assembly in the reverse order of removal.
