SAFETY RECALL BULLETIN

SUBJECT:			No: SR-16-002REV
LANCER PASSENGER SIDE FRONTAL AIR BAG INFLATOR - SAFETY RECALL CAMPAIGN - REVISION			DATE: November, 2018
			MODEL: 2006-07 Lancer
CIRCULATE TO:	<input checked="" type="checkbox"/> GENERAL MANAGER	<input checked="" type="checkbox"/> PARTS MANAGER	<input checked="" type="checkbox"/> TECHNICIAN
<input checked="" type="checkbox"/> SERVICE ADVISOR	<input checked="" type="checkbox"/> SERVICE MANAGER	<input checked="" type="checkbox"/> WARRANTY PROCESSOR	<input checked="" type="checkbox"/> SALES MANAGER

This campaign bulletin instructs dealers to replace the passenger side frontal air bag inflator with a desiccated one, and return the subject air bag inflator per the instructions at the end of this bulletin.

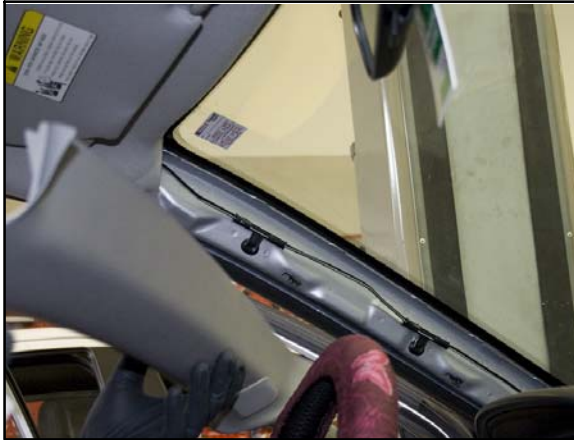
2. Remove the front left and right A-pillar trims.

3. Remove the instrument panel.

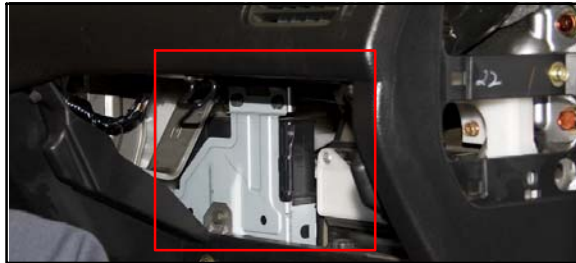
NOTE: Unbolt the ECM/PCM prior to dash removal.

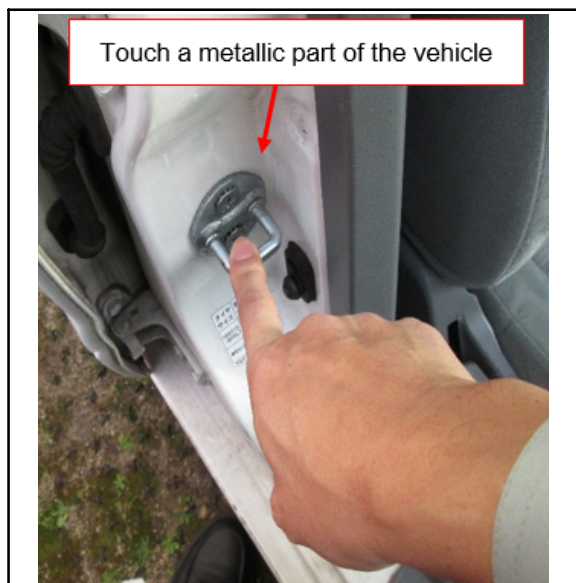
INFLATOR REMOVAL

CAUTION: ELIMINATE STATIC ELECTRICITY
Before starting work, and periodically while working on the vehicle, touch a metallic part of the vehicle to discharge static electricity.

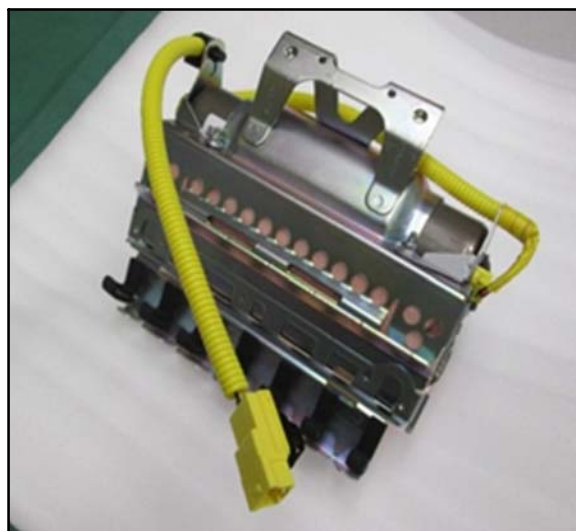
2. Place the air bag module on a clean work bench covered with a new, clean, static-free cloth/sheet with the air bag facing down.

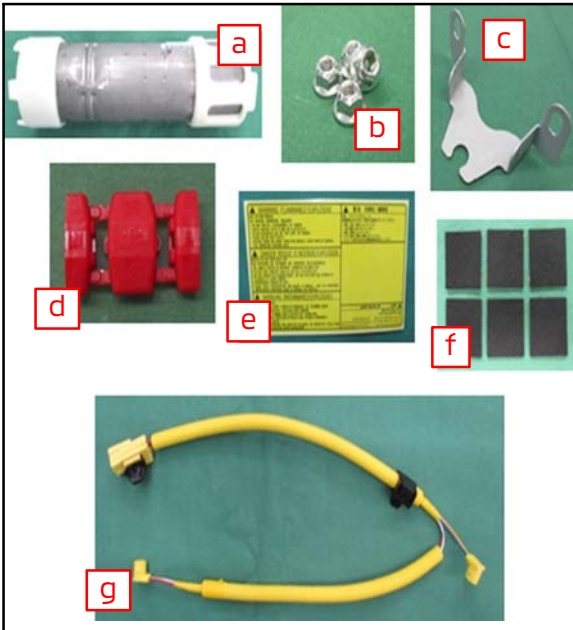
Prepare Air bag Inflator Kit Part No.: 7030A977 ◀

3. Confirm that the following contents are included in the Air bag Inflator Kit:
- a. (1) Replacement dessicated inflator ◀
 - b. (4) Replacement Nuts M5
 - c. (1) Replacement Stopper Plate ◀
 - d. (1) Electro tap
 - e. (1) Caution Label
 - f. (6) Felt tapes ◀
 - g. (1) Replacement Wiring Harness

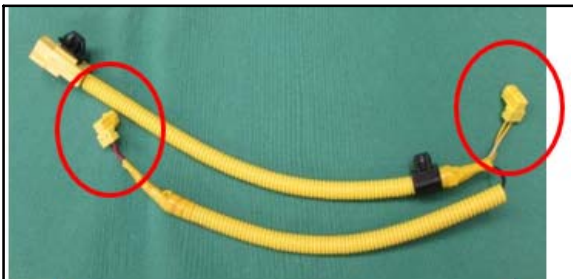
Replacement Wiring Harness x 1

NOTE: The replacement wiring harness' connector is different from the original connector. However, the two are compatible. The replacement wiring harness has the same function and performance as the original.

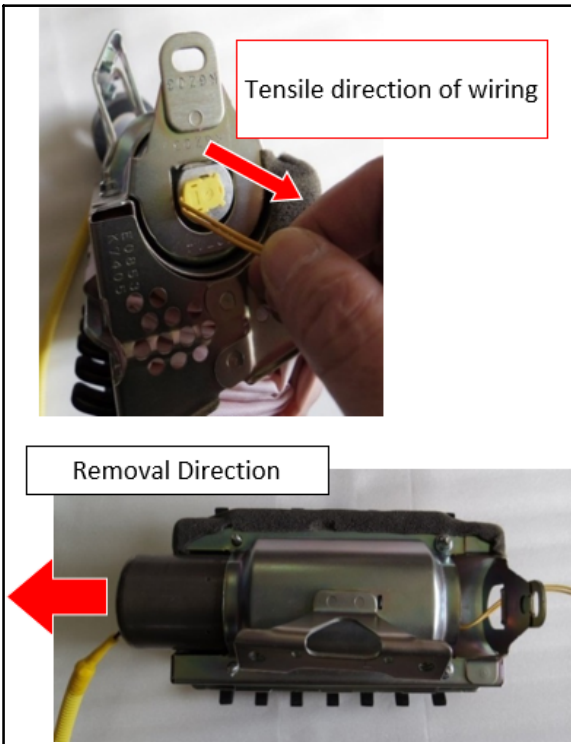
22. **Gently** pull on and straighten the yellow wires so that it is in line with the inflator. This will prevent the wire from contacting the edges of the inflator housing during removal.
23. Continue pulling on the harness while gently pushing the inflator with your finger in the illustrated direction until the inflator is completely separated from the housing.

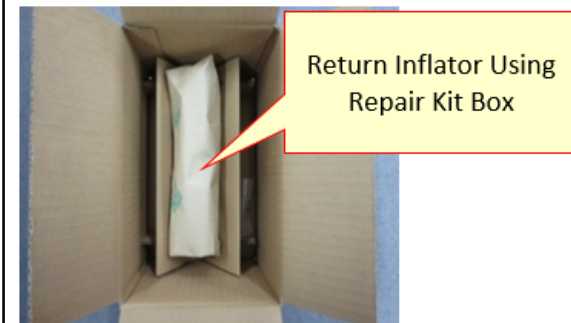
24. Place the removed inflator into the empty box that the new inflator kit contents were previously held in.
25. Package the removed inflator in the Repair Kit box, for returning to Takata.

CAUTION:
Do NOT replace box with another inflator box for tracking purposes.

CAUTION:
Do NOT disconnect any wires from the removed inflator.

NOTE: Stopper Plate will be reused.
Dispose the nuts that have been removed.

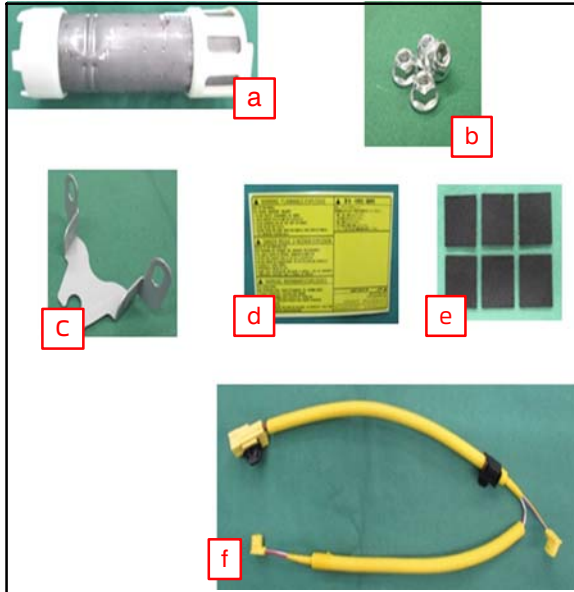
INFLATOR INSTALLATION

1. Verify that you have all of the following parts ready for installation:
 - a. (1) Replacement desiccated inflator ◀
 - b. (4) Replacement Nuts M5 ◀
 - c. (1) Replacement Stopper Plate ◀
 - d. (1) Caution Label ◀
 - e. (6) Felt Tapes ◀
 - f. (1) Replacement Wiring Harness ◀

NOTE: The Connector of the replacement wiring harness looks different from original connector installation in the vehicle, however they are compatible. The wiring harness in the repair kit box had the same function and performance as the one in the vehicle.

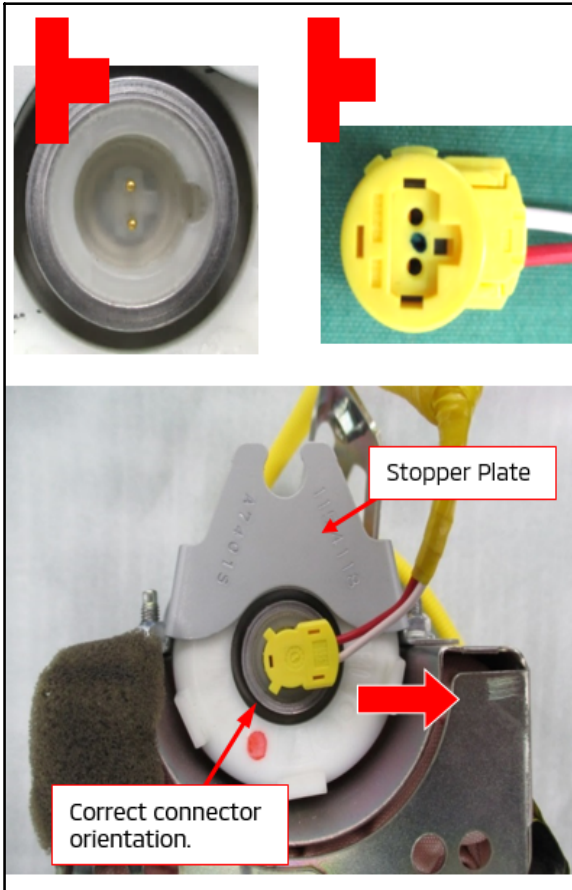
19. Connect the red and white wire to the inflator's Stopper Plate side. ◀
- a. Align the "T" shape on the connector and inflator. ◀
 - b. Confirm connector and harness position is as illustrated. ◀

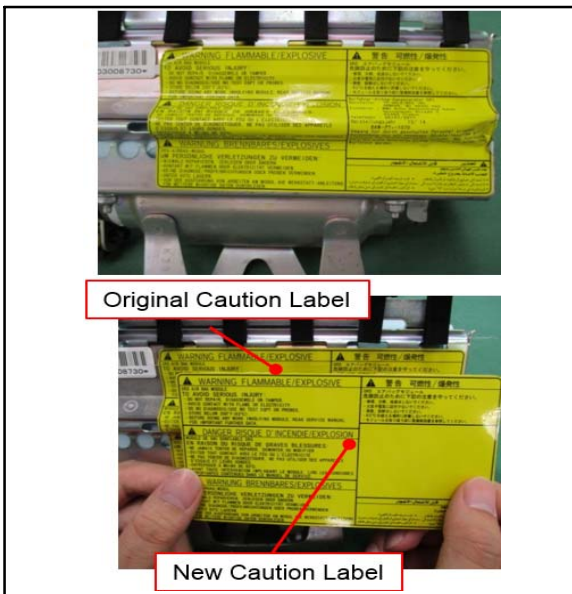
23. Wipe original Caution Label with dry, clean rag or cloth.

24. Paste the new Caution Label directly on top of the original Caution Label

25. Wipe and press with a dry, clean rag or cloth.

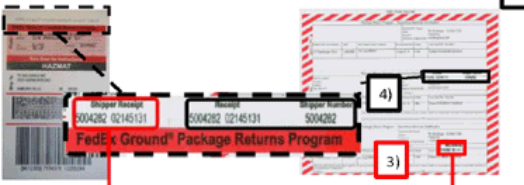
a) Peel off the SHIPPER RECEIPT from the top of the FedEx Ground PRP Shipping label, place it in the Tracking ID box on the Customer Copy of the OP 900PRP form.

b) Peel off the RECEIPT & SHIPPER NUMBER from the top of the FedEx Ground PRP Shipping label, and place it in the Tracking ID box on the FedEx copy.
