**TECHNICAL INSTRUCTIONS**  
**FOR**  
**SAFETY RECALL GLG**  
**FRONT PASSENGER AIRBAG MODULE**  
**CERTAIN 2007 – 2009 MY ES 350**

## I. OPERATION FLOW CHART

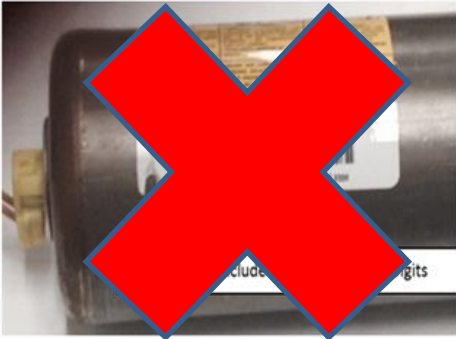
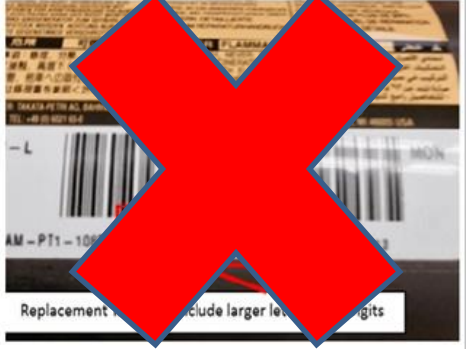
**How to Identify the Inflator serial code on the Original and Replacement Inflator can?**

The Inflator serial code is an **11 digit code** on the Inflator can. It can be found with a bar code on removing the Inflator can from the Airbag Assembly unit.

The first two characters of the **Original Inflator Serial code** will be from [AA, AB, AJ, FD or JD].

The first two characters of the **Replacement Inflator Serial code** will be either 'LT' or 'LR'.
