**TECHNICAL INSTRUCTIONS**  
**FOR**  
**SAFETY RECALL GLG**  
**FRONT PASSENGER AIRBAG MODULE**  
**CERTAIN 2010 MY GX 460**

## II. BACKGROUND

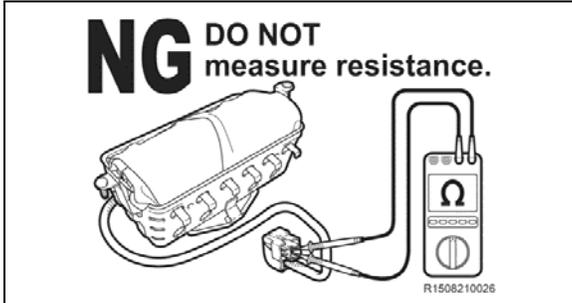
#### 2. DO NOT MEASURE RESISTANCE

- a) **NEVER** measure the resistance of an airbag, this may cause accidental activation.

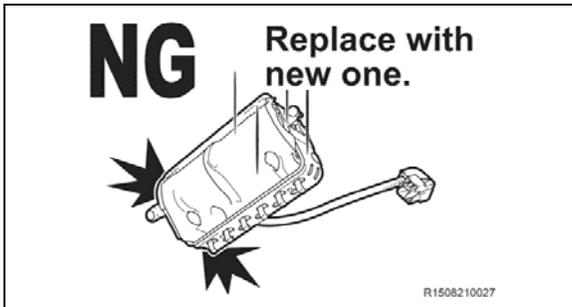
#### 3. HANDLE THE AIRBAG CAREFULLY

- a) If the airbag is dropped, replace it with a **NEW** one.

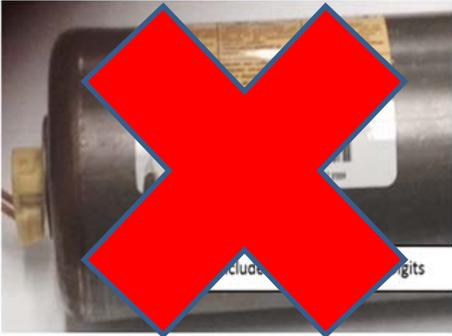
**Original Inflator**

How to identify the inflator serial code on the Original and Replacement Inflator can?  
The Inflator serial code is an 11 digit code on the Inflator can. It can be found with a bar code on removing the Inflator can from the Airbag Assembly unit.  
The first two characters of the Original Inflator Serial code will be from [AA, AB, AJ, FD or JD].  
The first two characters of the Replacement Inflator Serial code will be either 'LT' or 'LR'.
