TECHNICAL INSTRUCTIONS
FOR
SAFETY RECALL G0P
FRONT PASSENGER AIRBAG INFLATOR MODULE
CERTAIN 2010 MY 4Runner

VII. PASSENGER AIRBAG MODULE REPLACEMENT

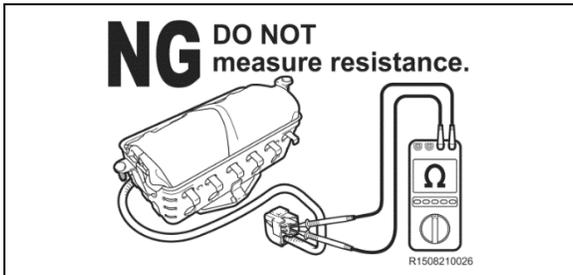
1. ELIMINATE STATIC ELECTRICITY

- a) Before starting work and periodically while working on the vehicle, touch a metallic part of the vehicle to discharge static electricity in the body.

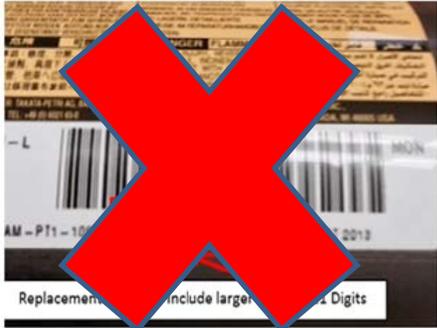
Replacement Inflator

The first two characters of the **Replacement Inflator Serial code** will be either 'LT' or 'LR'.

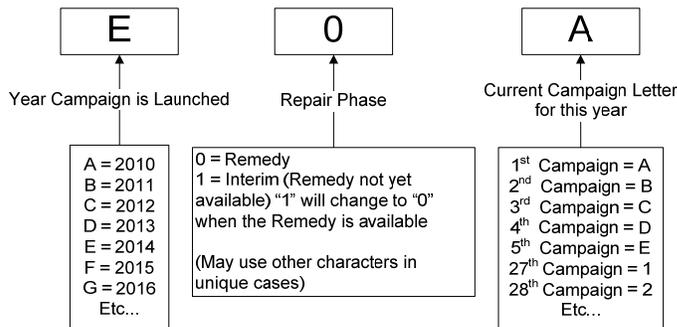
A. CAMPAIGN DESIGNATION DECODER

Examples:

A0D = Launched in 2010, Remedy Phase, 4th Campaign Launched in 2010

B1E = Launched in 2011, Interim Phase, 5th Campaign Launched in 2011

C1C = Launched in 2012, Interim Phase, 3rd Campaign Launched in 2012
