# IMPORTANT UPDATE

## TECHNICAL INSTRUCTIONS FOR SAFETY RECALL G0R FRONT PASSENGER AIRBAG INFLATOR MODULE CERTAIN 2009-2010 MODEL YEAR MATRIX

**Updated 7-17-18**

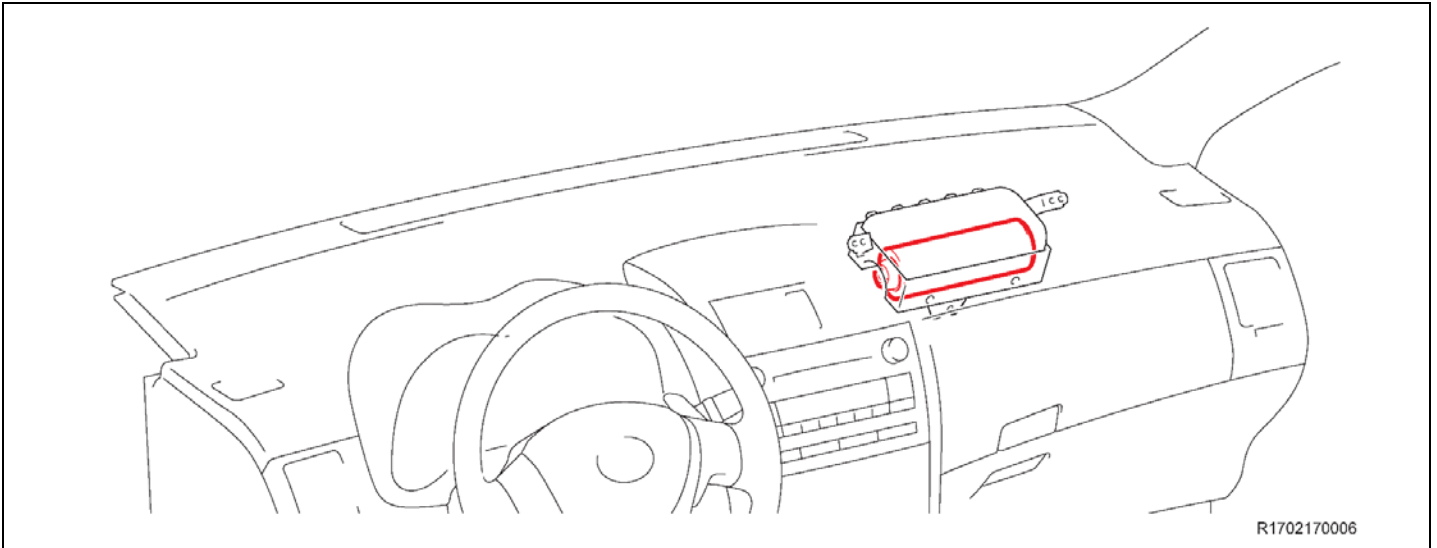
The subject vehicles are equipped with front passenger airbag inflators produced by Takata. The propellant in these inflators may degrade after prolonged exposure to high absolute humidity and fluctuating high temperatures. Degraded propellant can cause inflator rupture during airbag deployment. In the event of an inflator rupture, metal fragments could pass through the airbag cushion material, striking the vehicle occupants, and result in serious injury or death.

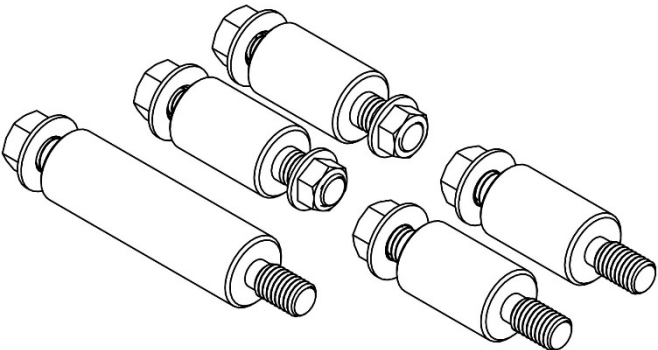
| Image | Name | Quantity |
|---|---|---|
| | Adaptor set* | 1 |

\*The adaptor set was sent to dealers at the start of this campaign.

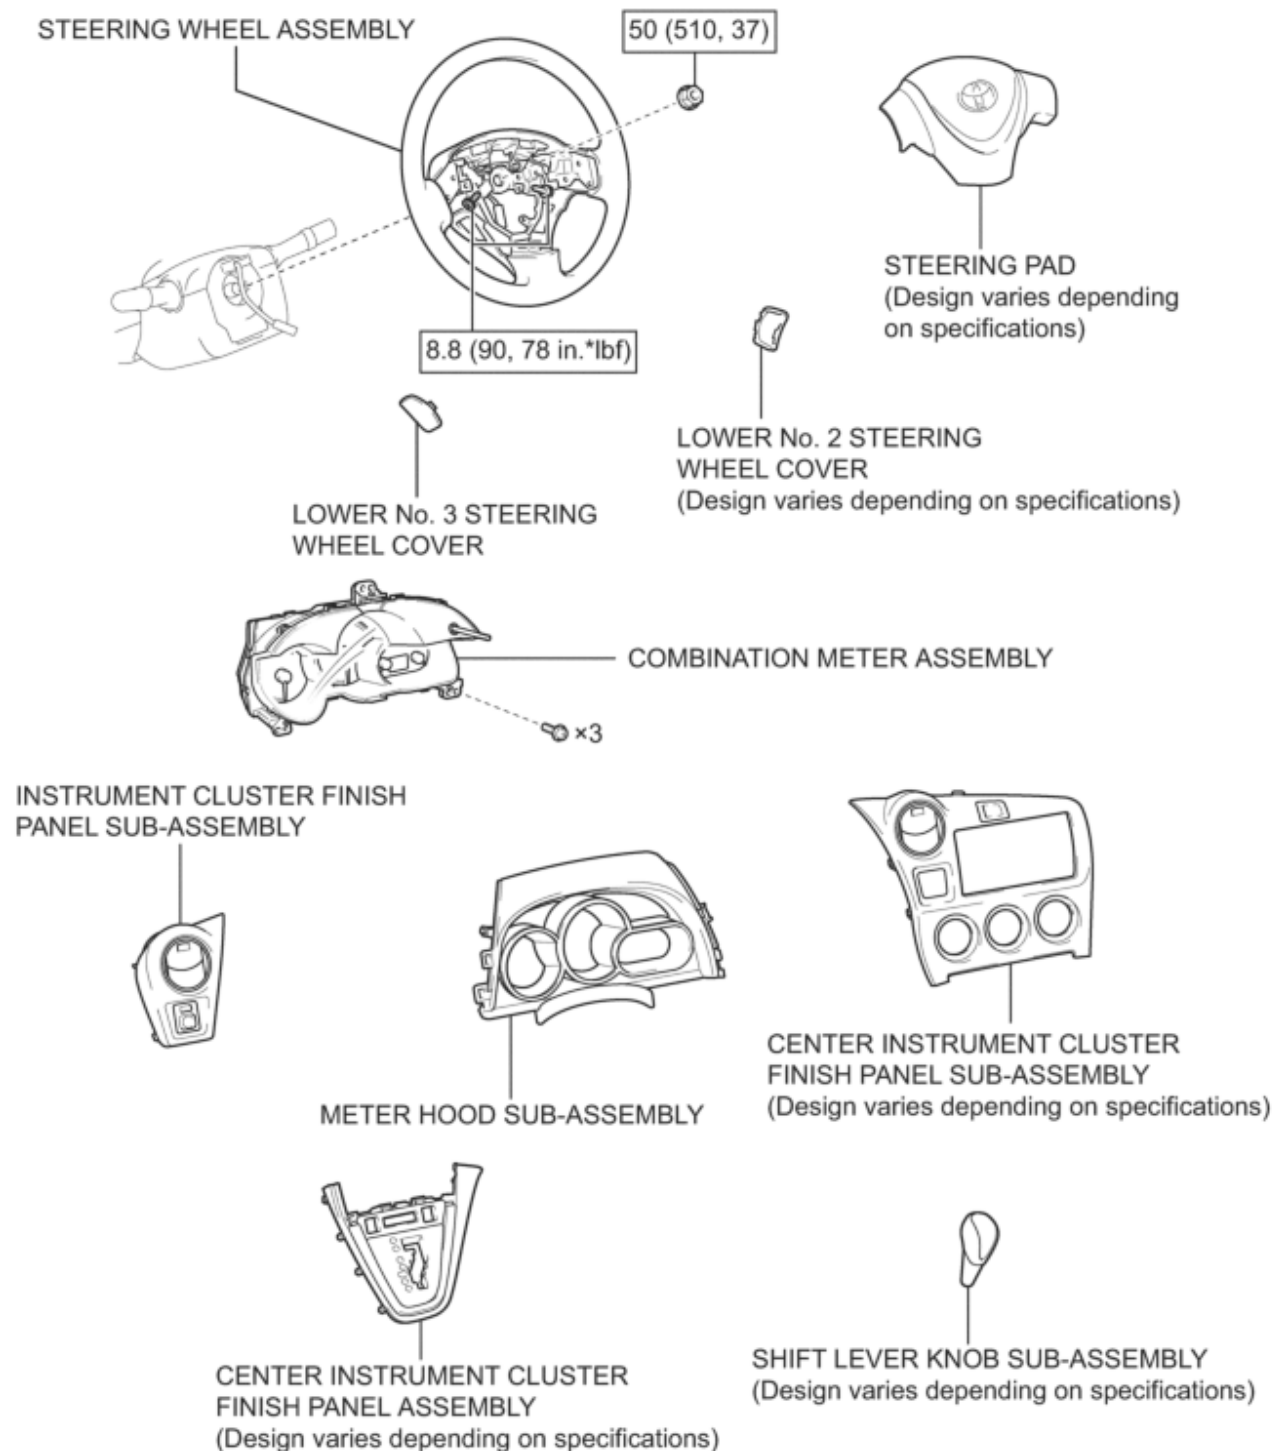
R1703010002

N\*m (kgf\*cm, ft\*lbf) : Specified torque

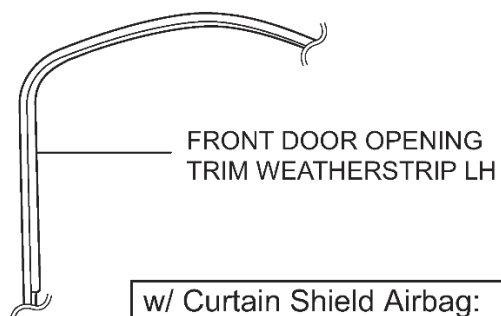
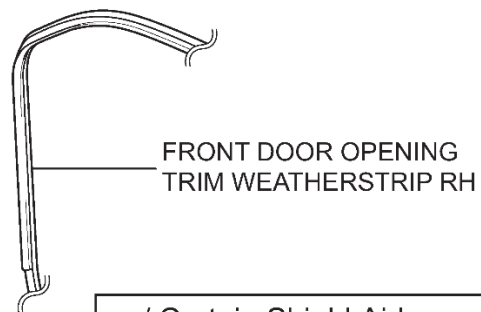
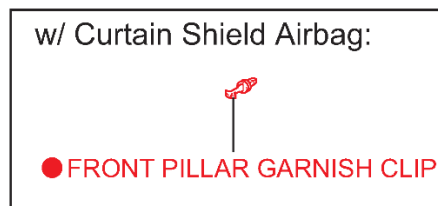
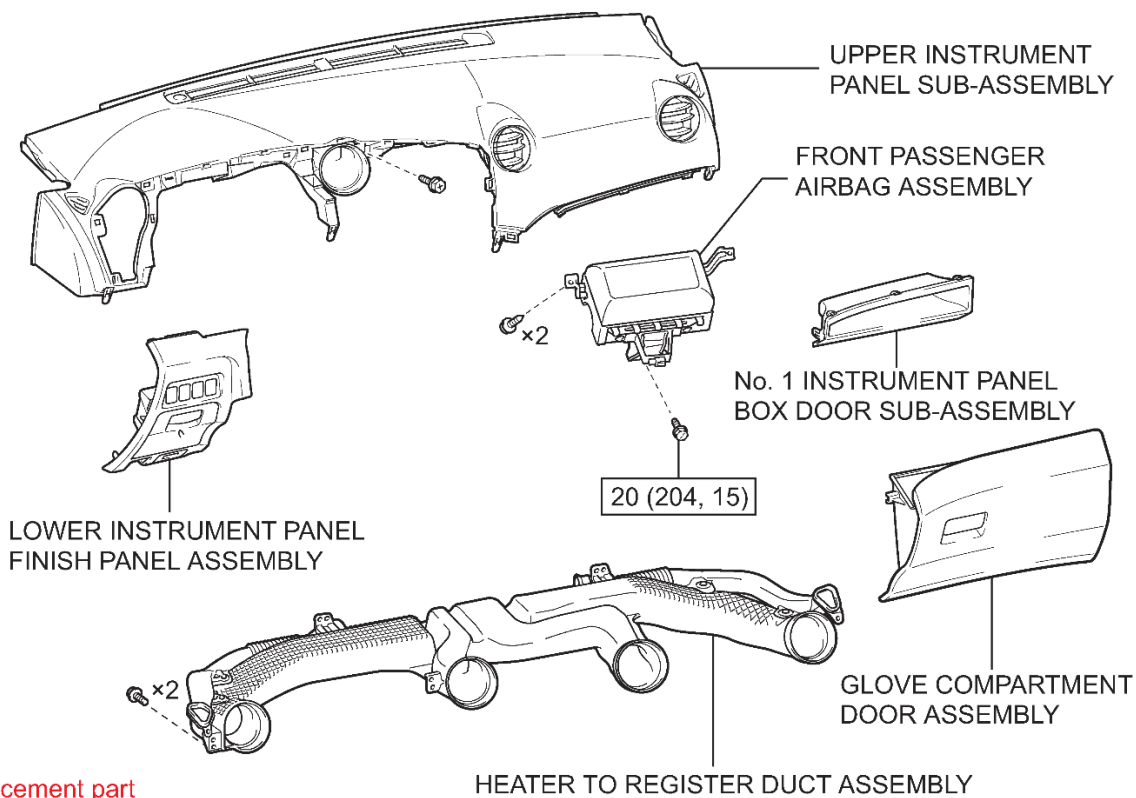
R1703010003

● : Replacement part

N\*m (kgf\*cm, ft.\*lbf) : Specified torque

**3.9 N·m (40, 35 in.\*lbf)**  
**Be careful not to**  
**overtighten.**

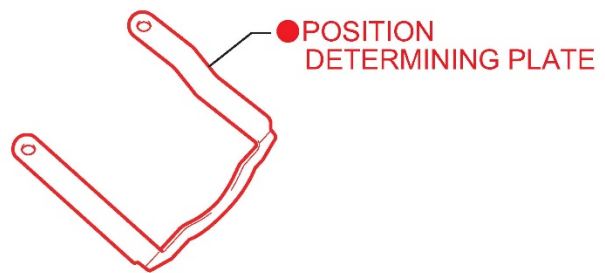
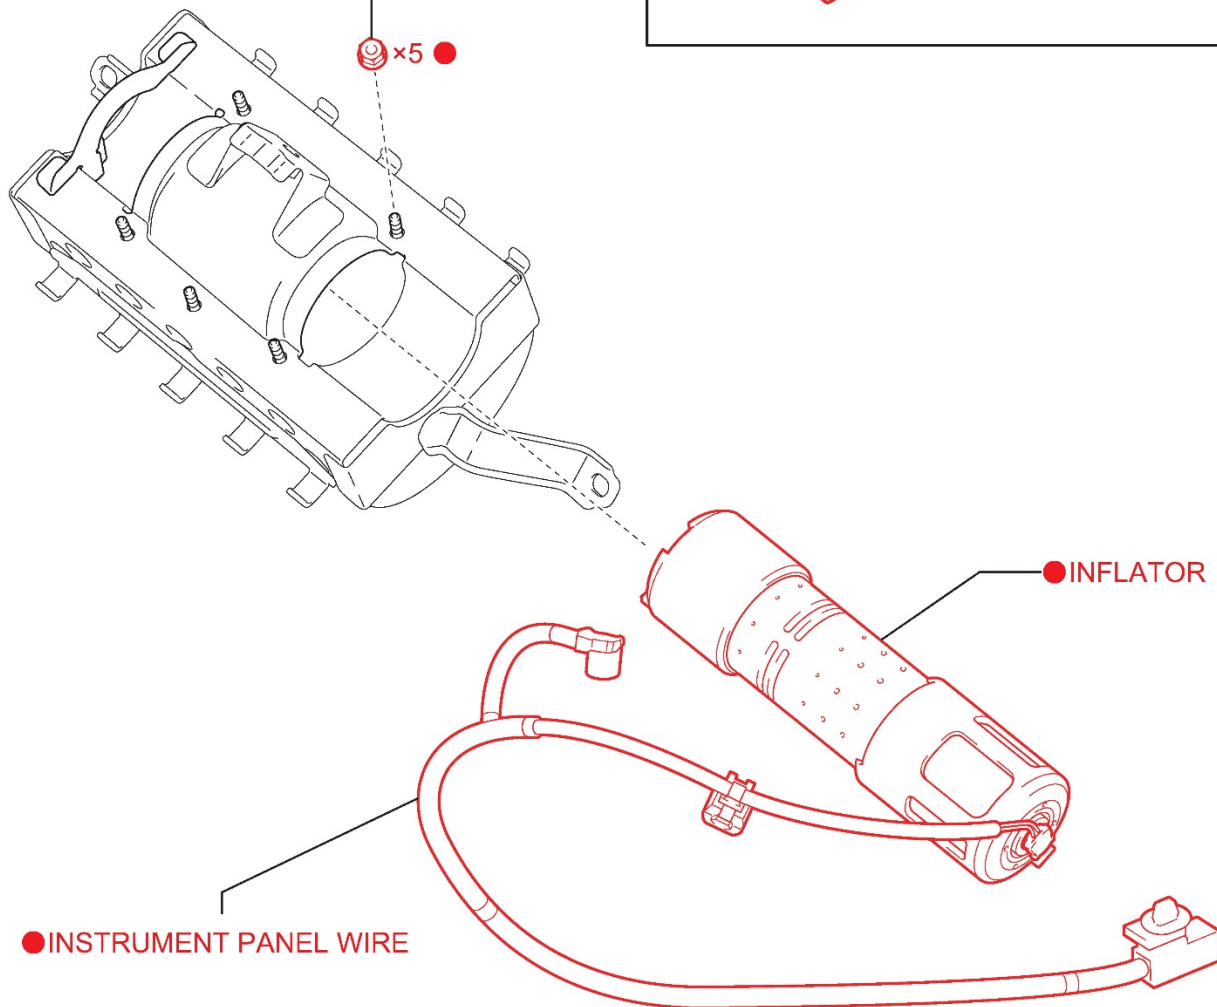
R1702270035

for MATRIX:

● : Replacement part

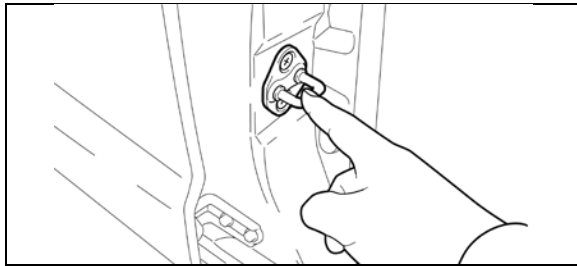
#### 1. ELIMINATE STATIC ELECTRICITY

- Before starting work and periodically while working on the vehicle, touch a metallic part of the vehicle to discharge static electricity in the body.

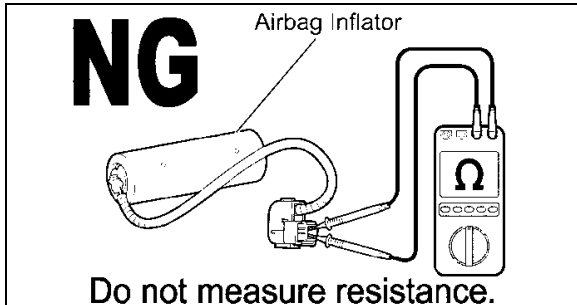
#### 2. DO NOT MEASURE RESISTANCE

- DO NOT** measure resistance of airbag components, this may cause accidental activation.

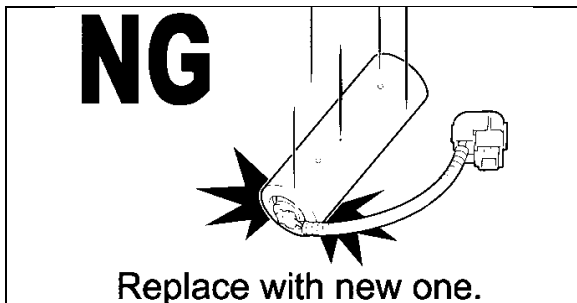
#### 3. HANDLE THE AIRBAG CAREFULLY

- If an inflator is dropped, replace it with a **NEW** inflator.

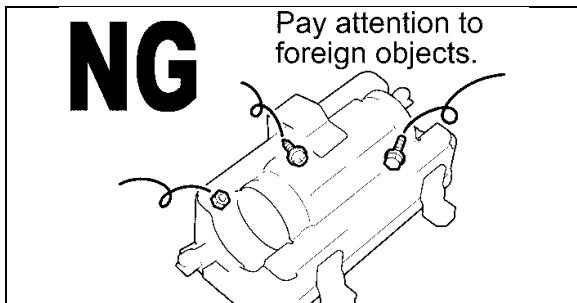
#### 4. DO NOT ALLOW FOREIGN OBJECTS NEAR AIRBAG

- Be sure to collect and account for all removed nuts/bolts to prevent them from landing in the airbag assembly.
- Any foreign objects in the airbag assembly may cause damage or injury if the airbag is activated.

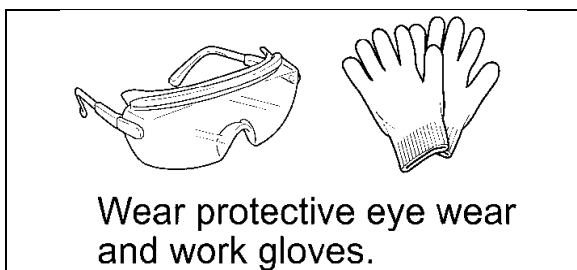
#### 5. WEAR PROTECTIVE EQUIPMENT

- Always wear appropriate protective equipment when working on the SRS.

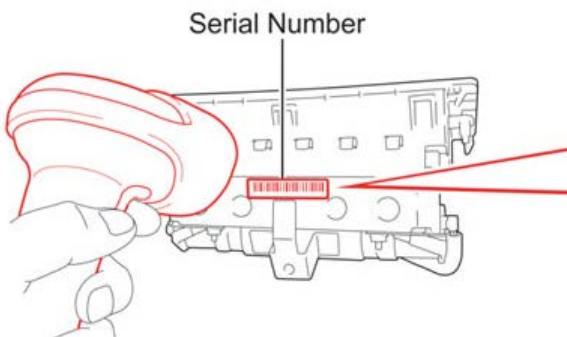
**Airbag Serial Number Label Example**

- The airbag serial number is **ALWAYS** the **12 DIGITS** located between the asterisks.
- The 3 digits before the asterisk **ARE NOT** part of the serial number, and **SHOULD NOT** be entered or an inaccurate response may be returned.

The **AIRBAG ASSEMBLY** serial number and the **INFLATOR** serial number are **DIFFERENT**. The **AIRBAG ASSEMBLY** serial number **MUST** be recorded prior to replacement.

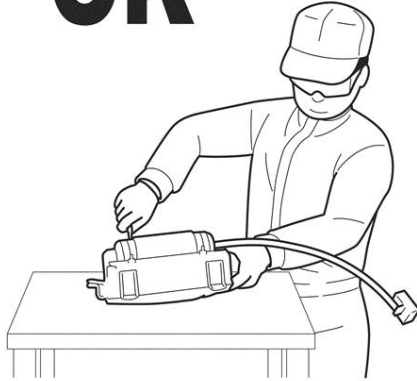
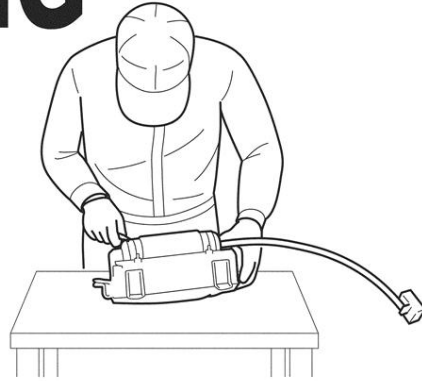
R1301230008E

- Carefully place the airbag on the bench inflator side up.

- Avoid standing directly over the inflator.

# OK

# NG

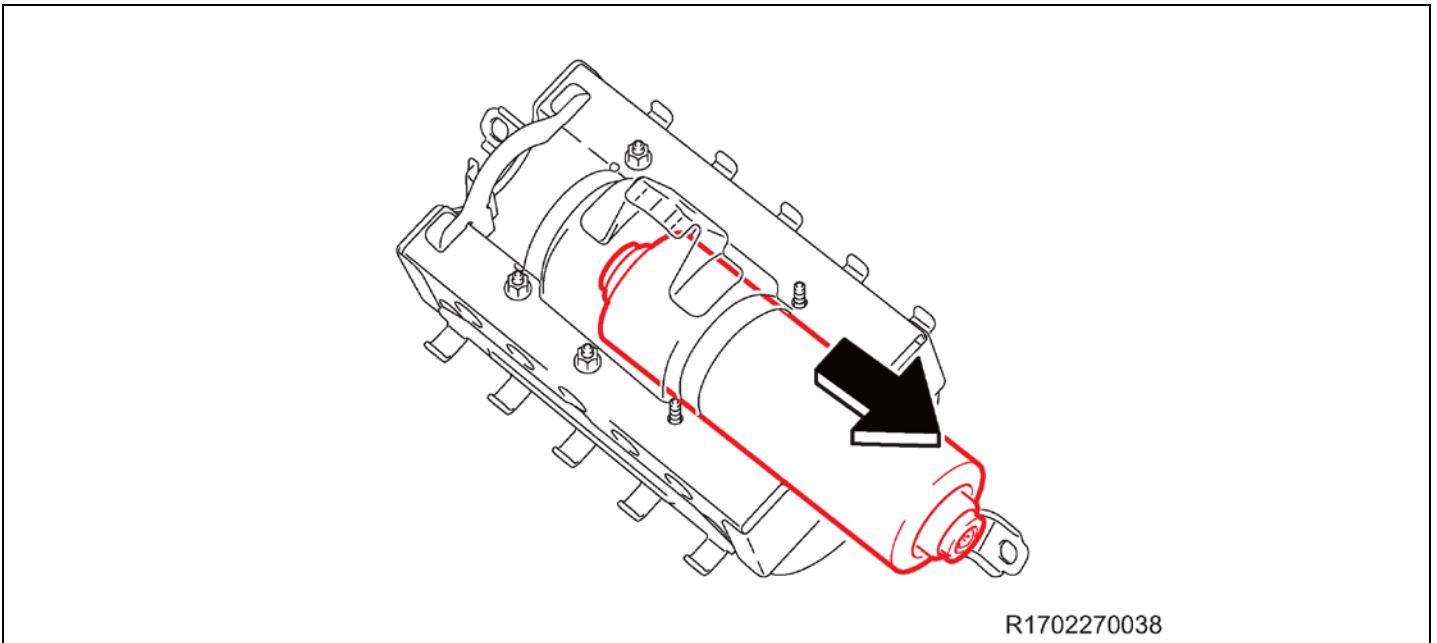
- a) Gently push in the studs until the nuts make contact with the housing to loosen the inflator for removal.

- b) Remove the inflator from the airbag assembly and place it on a safe work surface.
- c) Mark the old inflator so it is not reused.

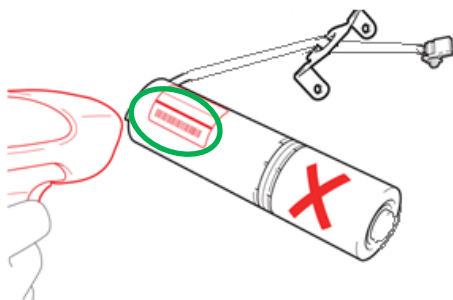
### Step a) Old Inflator (bar code)

- Scan the **OLD** inflator bar code.
- Scan the **NEW** inflator QR code.

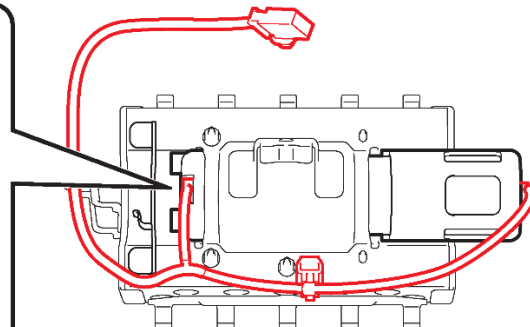
R1702270041

- b) Connect the connector to the inflator and ensure that the connector lock is fully engaged as shown.  
c) Route and secure the wire harness as shown.

**ALIGN CONNECTORS**

Wire Harness Side:

Inflator Side:

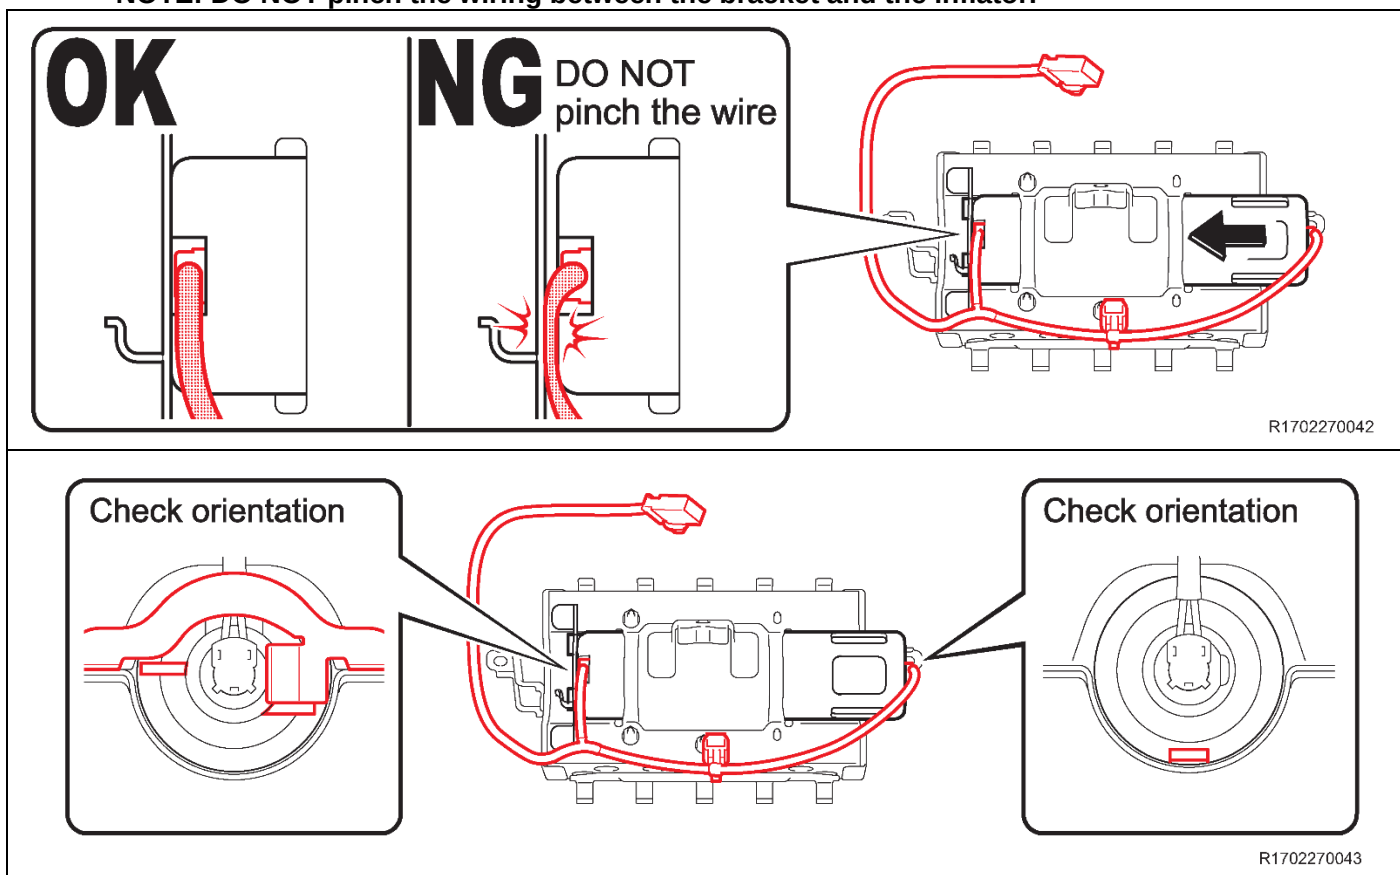
d) Fully insert the inflator and ensure that the inflator is correctly oriented as shown.

**NOTE: DO NOT pinch the wiring between the bracket and the inflator.**

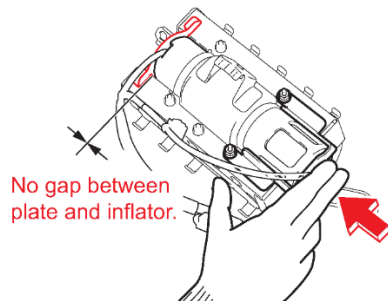
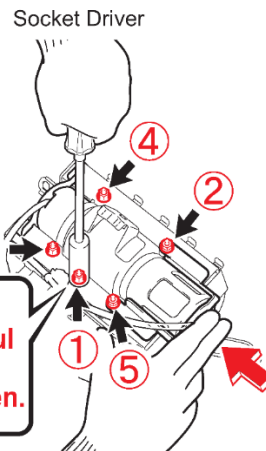
- a) Tighten the 5 nuts evenly in several increments in the sequence shown. Use a socket driver or torque wrench to tighten the nuts.

Torque: 35in. lbf (3.9N·m)

- There will be some resistance when tightening the nuts because they are self-locking, confirm the nuts are tightened correctly.
- **DO NOT** use a power tool, T-handle, or ratchet when tightening the nuts to avoid overtorqueing and deforming the studs.
- You may need to turn the airbag to the left or right with in the mounting bracket to access the center nut.

**OK**

3.9 N·m  
Be careful  
not to  
overtighten.

**Too Tight!**

**These tools cause overtightening !**
