**TECHNICAL INSTRUCTIONS**  
**FOR**  
**SAFETY RECALL GLG**  
**FRONT PASSENGER AIRBAG INFLATOR REPLACEMENT**  
**CERTAIN 2007 – 2012 MY ES 350**

## II. BACKGROUND

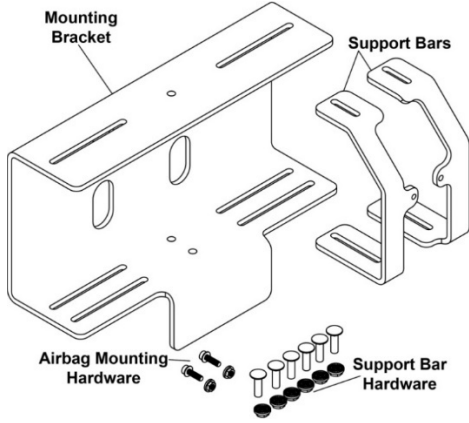
Airbag Mounting Bracket & hardware (Provided to the dealership at the launch of SSC DLC)	1

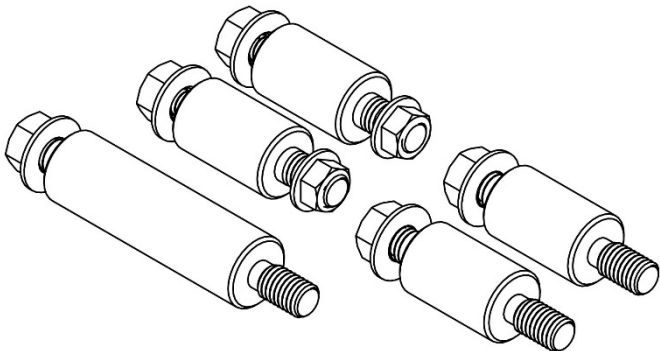
579943 Adaptor set*	1

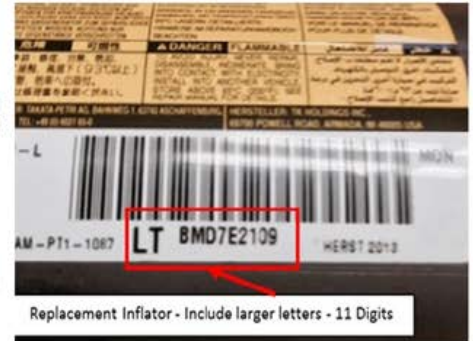
The Inflator serial code is an 11 digit code on the Inflator can. It can be found with a bar code on removing the Inflator can from the Airbag Assembly unit.

The first two characters of the Original Inflator Serial code will be from [AA, AB, AJ, FD or JD].

The first two characters of the Replacement Inflator Serial code will be either 'LT' or 'LR'.

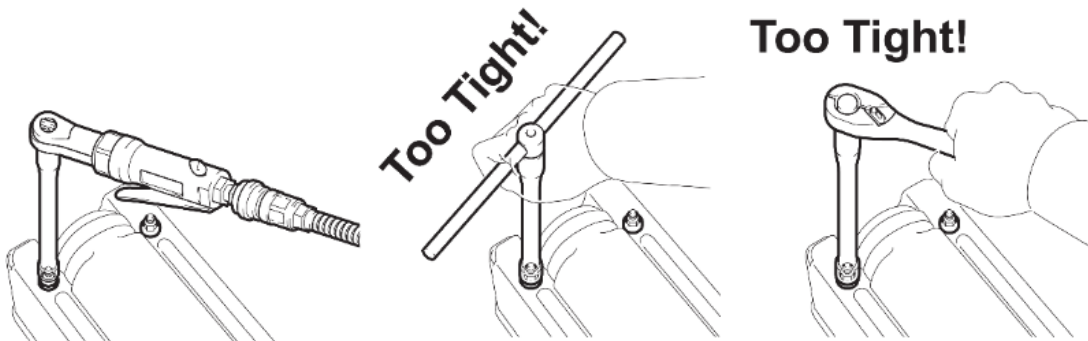
R1701260011Z01

- There will be some resistance when tightening the nuts because they are self-locking, confirm the nuts are tightened correctly.
- **DO NOT** use a power tool, T-handle, or ratchet when tightening the nuts to avoid over torqueing and deforming the studs.
- You may need to slide the airbag to the left or right with in the mounting bracket to access the center nut.

**These tools cause overtightening !**
