# IMPORTANT UPDATE

## TECHNICAL INSTRUCTIONS FOR SAFETY RECALL GLH FRONT PASSENGER AIRBAG MODULE CERTAIN 2007 – 2010 MY ES 350 **UPDATED 4-18-2018**

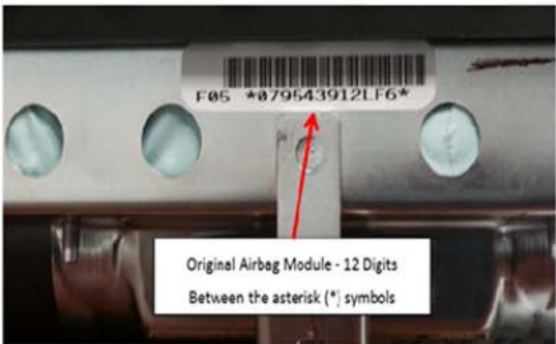
Original Airbag Module - 12 Digits  
Between the asterisk (\*) symbols

Check this box if the label is damaged or missing
