## IMPORTANT UPDATE

# TECHNICAL INSTRUCTIONS FOR SAFETY RECALL G0R FRONT PASSENGER AIRBAG INFLATOR MODULE CERTAIN 2008 - 2010 MY SCION xB

**UPDATED 7-17-2018**

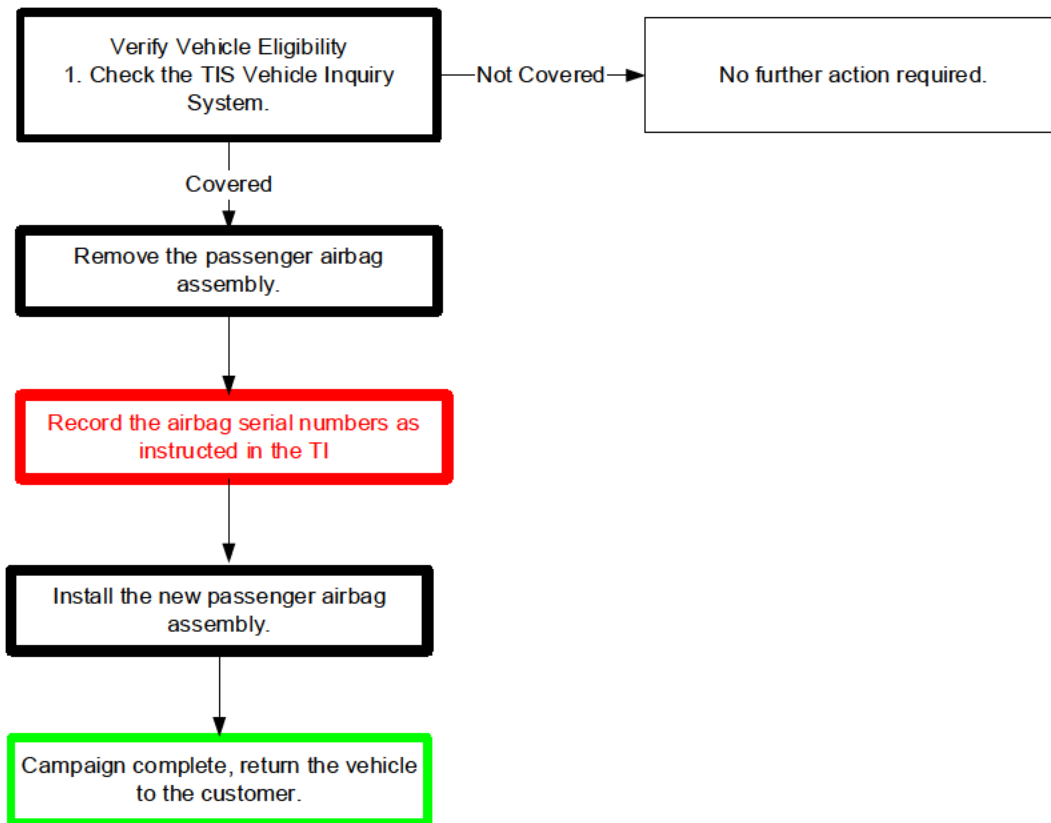
## I. OPERATION FLOW CHART

The flow chart is for reference only. **DO NOT** use it in place of the full technical instructions. Follow **ALL** steps as outlined in the full technical instructions to confirm the campaign is completed correctly.

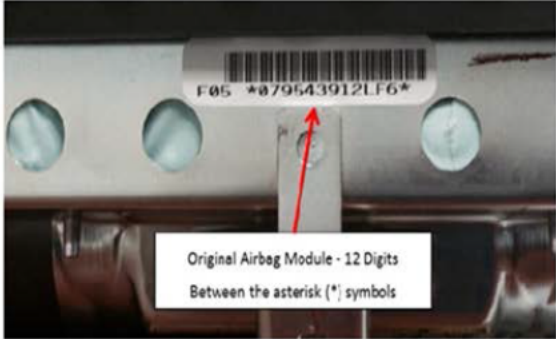
a) If the airbag serial number cannot be scanned or is not present check the box as shown below.

Check this box if the label is damaged or missing

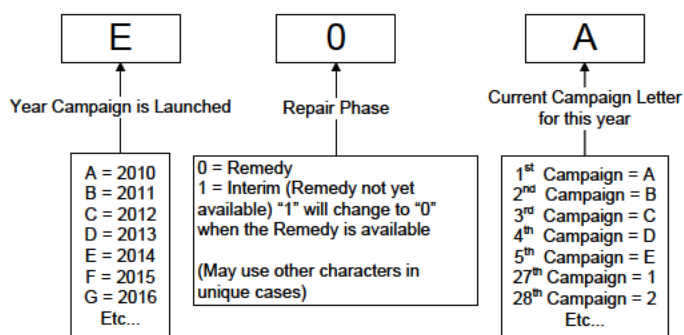
### A. CAMPAIGN DESIGNATION DECODER

Examples:

A0D = Launched in 2010, Remedy Phase, 4<sup>th</sup> Campaign Launched in 2010

B1E = Launched in 2011, Interim Phase, 5<sup>th</sup> Campaign Launched in 2011

C1C = Launched in 2012, Interim Phase, 3<sup>rd</sup> Campaign Launched in 2012
