# IMPORTANT UPDATE

## TECHNICAL INSTRUCTIONS FOR SAFETY RECALL G0P FRONT PASSENGER AIRBAG INFLATOR MODULE CERTAIN 2009 – 2013 MODEL YEAR COROLLA

**Updated 4-18-18**

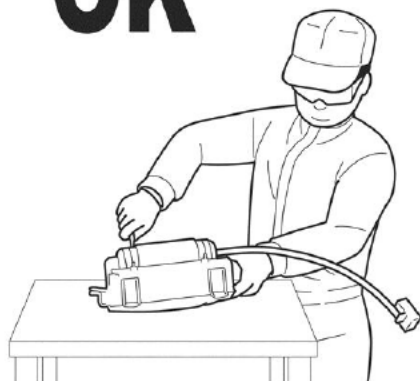
- Carefully place the airbag on the bench inflator side up.

**NOTE:** Place clean sheet(s) of paper on the bench to protect the airbag.

- Avoid standing directly over the inflator.

# OK

# NG

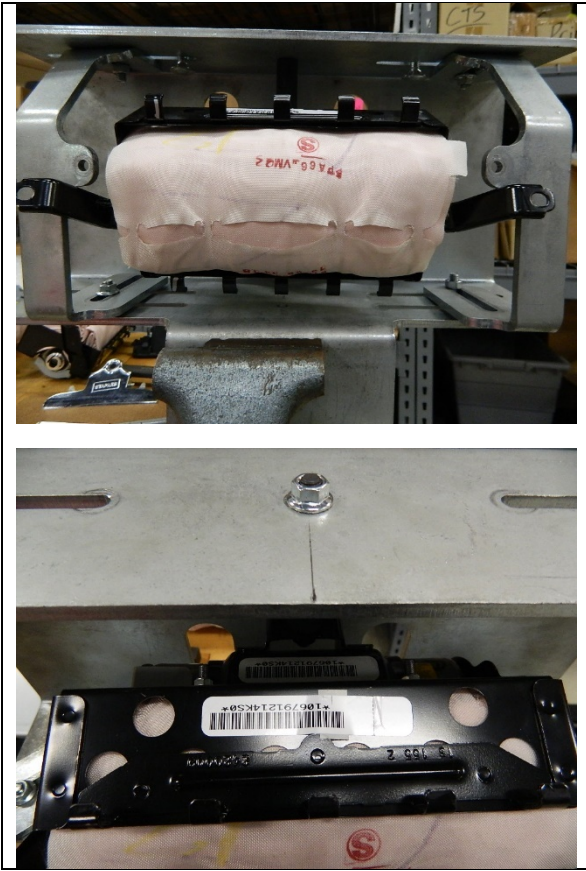
e) Use the long adaptor shown.

f) Thread the adaptor into the airbag as shown.  
**Note: Use the same mounting nut on the airbag that attaches the airbag to the vehicles cross tube.**
