# IMPORTANT UPDATE

## TECHNICAL INSTRUCTIONS FOR SAFETY RECALL GLG FRONT PASSENGER AIRBAG MODULE CERTAIN 2010-2013 MY GX 460 **UPDATED 1-9-2018**

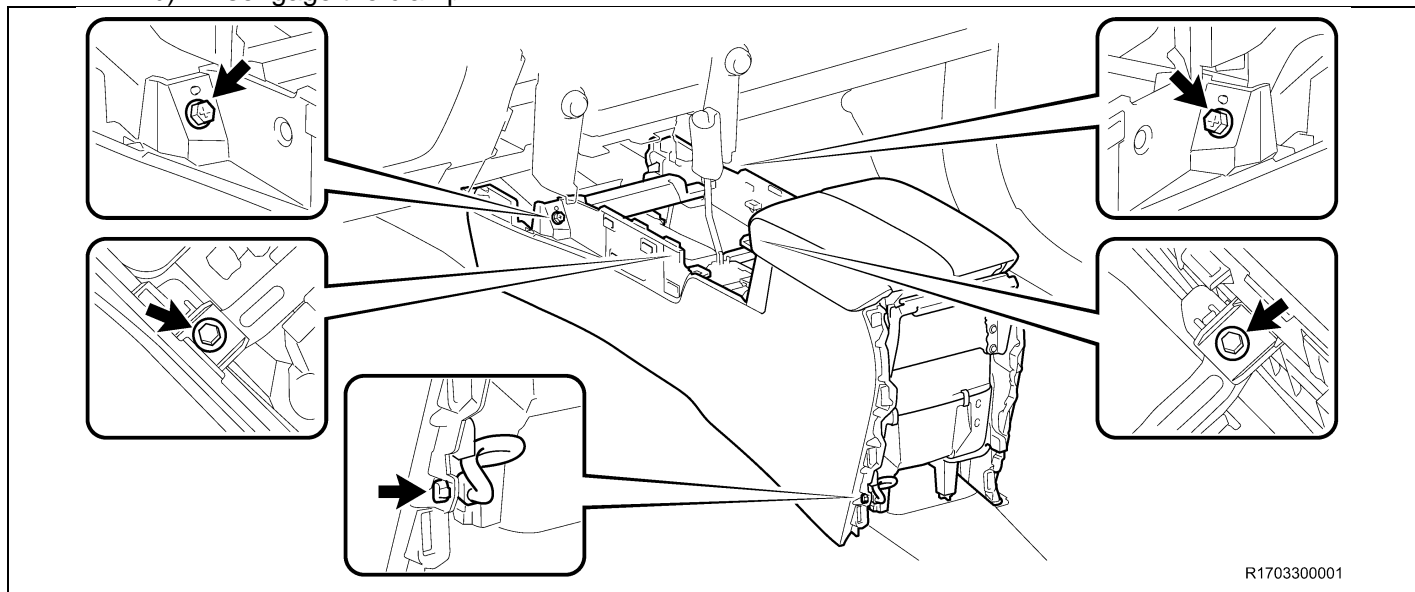
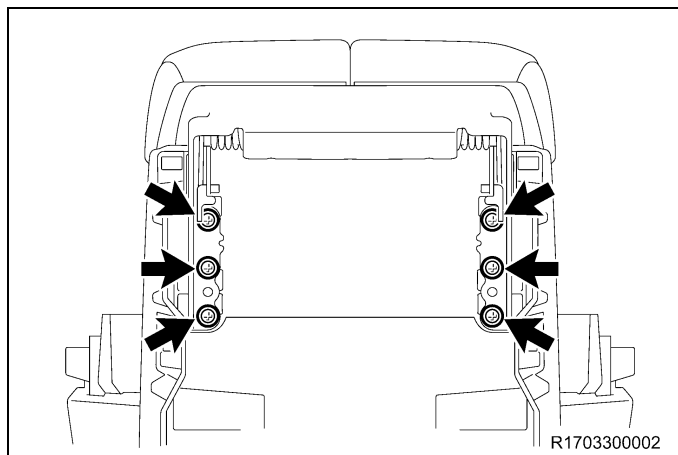
- a) Remove the 2 bolts and 2 screws.
- b) Disengage the clamp.

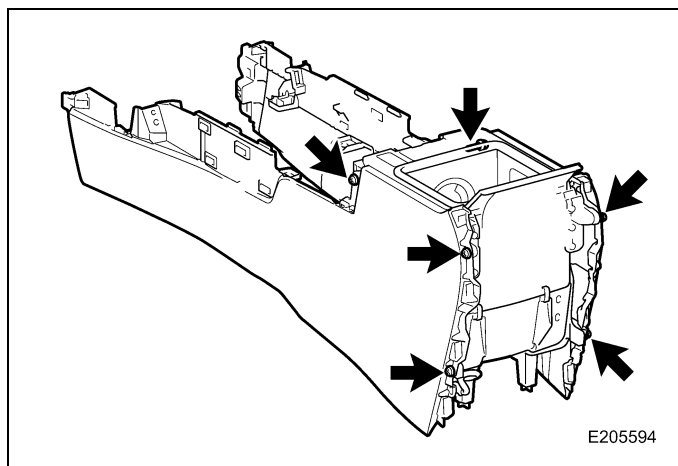
- c) Remove the 6 screws.
- d) Remove the console door.

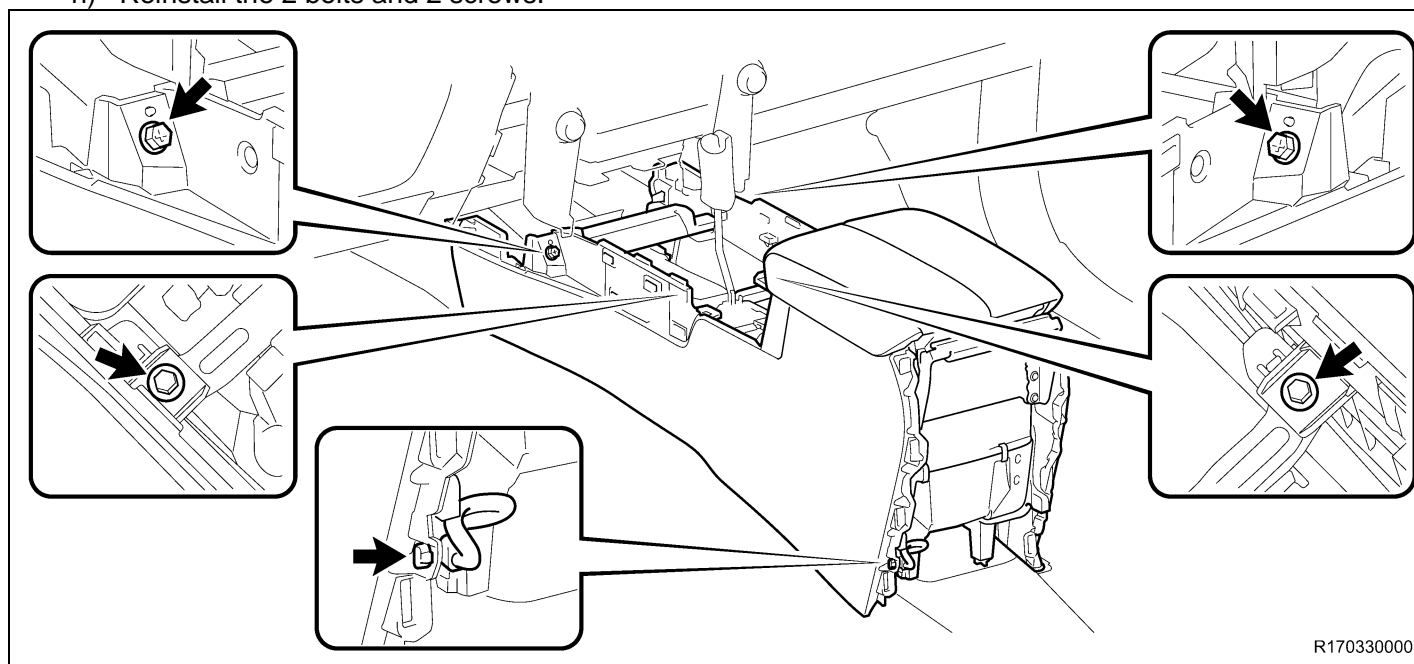
R1703300001

- e) Reinstall the console door.  
f) Reinstall the 6 screws

- g) Reengage the clamp.
- h) Reinstall the 2 bolts and 2 screws.
