# **TECHNICAL INSTRUCTIONS**

# SAFETY RECALL G0P/G0R

## FRONT PASSENGER AIRBAG MODULE

## **CERTAIN 2006 – 2011 MY YARIS HATCHBACK**

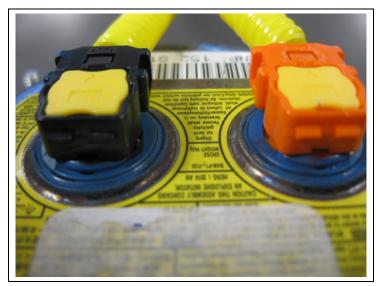
## 1. INSTALL THE NEW AIRBAG

a) Install the new harness onto the new airbag by plugging in the two connectors.

NOTE: Match the color of the harness connector to that of the airbag. Ensure that the connectors are fully seated.

b) Engage the secondary locks.

NOTE: Ensure the secondary locks are fully engaged.

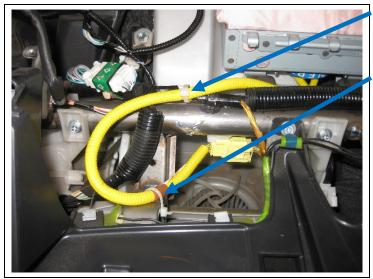
After the upper instrument panel has been installed secure the new airbag adaptor harness as shown.

Secure the adaptor harness to the dash harness.

Also secure the adaptor harness to the dash bracket.

NOTE: The upper instrument panel has been removed for clarity. Both areas can be accessed through the opening for the glove box door and/or the opening for the combination meter.

Check that the adaptor harness has the proper clearances and is not strained.
