**TECHNICAL INSTRUCTIONS**  
**FOR**  
**SAFETY RECALL GLG**  
**FRONT PASSENGER AIRBAG MODULE**  
**CERTAIN 2007 – 2011 MY ES 350**  
**UPDATED SEPTEMBER 21, 2017**

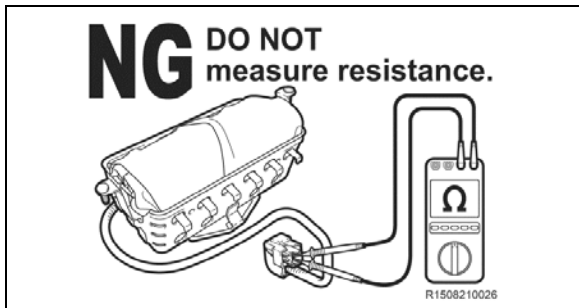
#### 2. DO NOT MEASURE RESISTANCE

- a) **NEVER** measure the resistance of an airbag, this may cause accidental activation.
