# TECHNICAL INSTRUCTIONS FOR SAFETY RECALL G0P FRONT PASSENGER AIRBAG INFLATOR MODULE CERTAIN 2011-2013 MODEL YEAR SIENNA

**Updated 7-17-18**

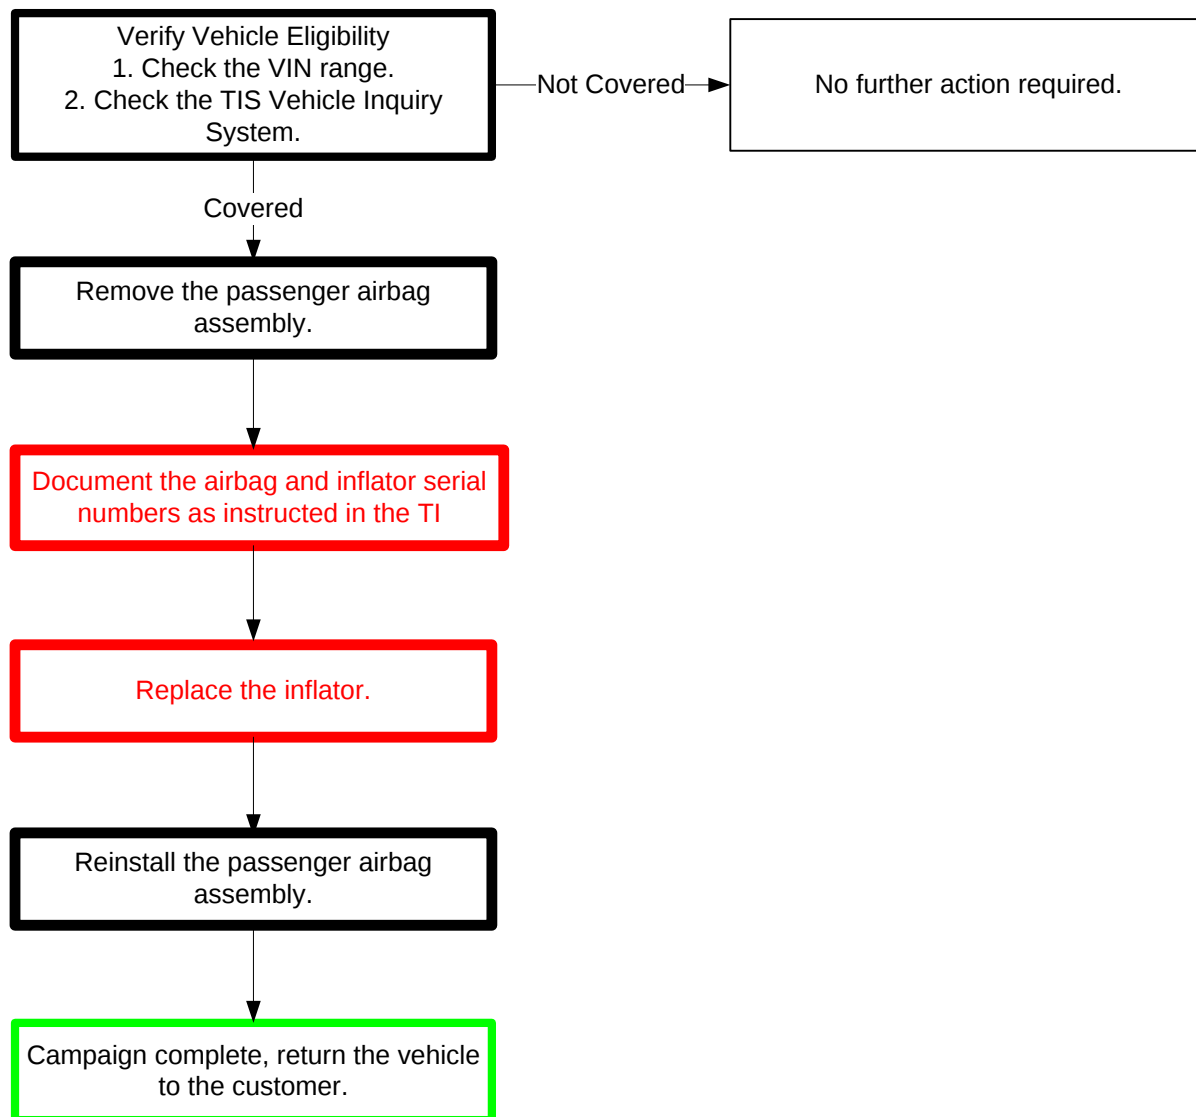
## I. OPERATION FLOW CHART

The flow chart is for reference only. **DO NOT** use it in place of the full technical instructions. Follow **ALL** steps as outlined in the full technical instructions to confirm the campaign is completed correctly.

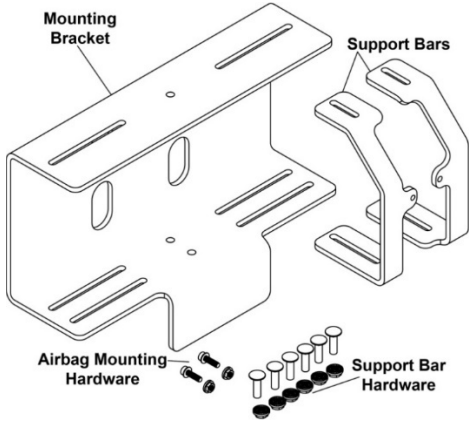
| Image | Name | Quantity |
|---|---|---|
| | Airbag Mounting Bracket & hardware | 1 |

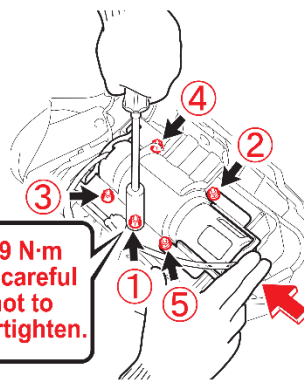
R1702010002H

- a) Tighten the 5 nuts evenly in several increments in the sequence shown. Use a socket driver or torque wrench to tighten the nuts.

**Torque: 35in. lbf (40 kgf.cm, 3.9N·m)**

- There will be some resistance when tightening the nuts because they are self-locking, confirm the nuts are tightened correctly.
- **DO NOT** use a power tool, T-handle, or ratchet when tightening the nuts to avoid overtorqueing and deforming the studs.
- You may need to turn the airbag to the left or right with in the mounting bracket to access the center nut.

**These tools cause overtightening !**

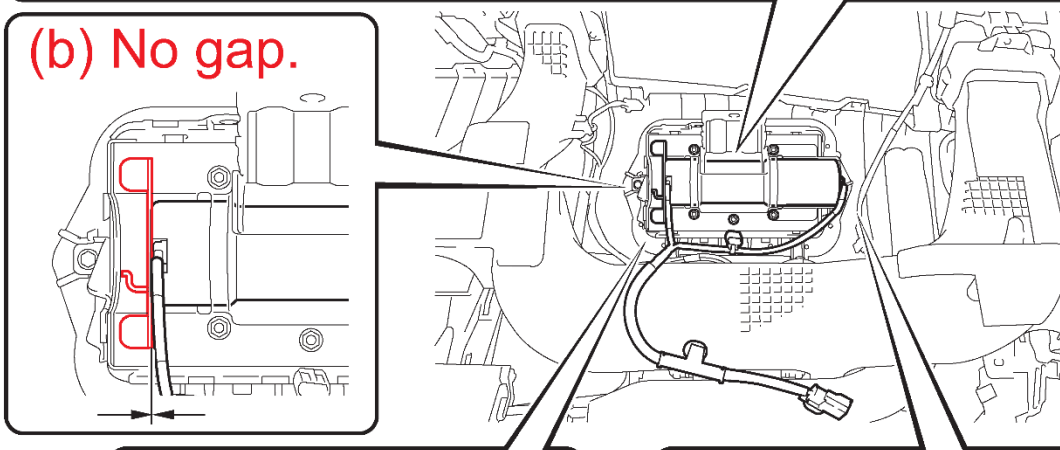
(b) No gap.

- If any gaps exist, the flats may move apart and could result in abnormal operation during airbag deployment.

- a) Confirm the **NEW** inflator and 5 **NEW** nuts have been installed.
- b) Confirm the position of the inflator and position determining plates are correct.
- c) Confirm the routing of the inflator wire harness.
