# TECHNICAL INSTRUCTIONS FOR SAFETY RECALL GLG/GLH/HLA FRONT PASSENGER AIRBAG INFLATOR REPLACEMENT CERTAIN 2010-2015 MY IS 250/350 CONVERTIBLE

### UPDATED 1-9-2019

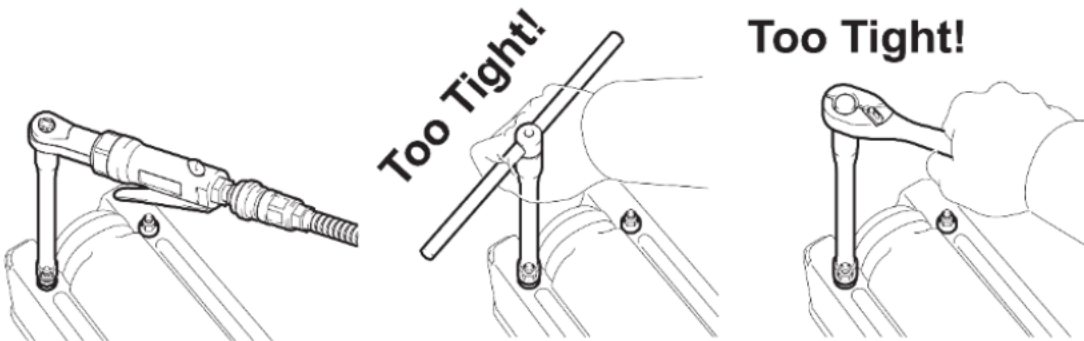
R1701260011Z01

k) Tighten the 5 nuts evenly in several increments in the sequence shown. Use a socket driver or torque wrench to tighten the nuts.

- There will be some resistance when tightening the nuts because they are self-locking, confirm the nuts are tightened correctly.
- **DO NOT** use a power tool, T-handle, or ratchet when tightening the nuts to avoid over torqueing and deforming the studs.
- You may need to slide the airbag to the left or right with in the mounting bracket to access the center nut.

**OK**

**These tools cause overtightening !**
