**TECHNICAL INSTRUCTIONS
FOR
SAFETY RECALL G0P
FRONT PASSENGER AIRBAG INFLATOR MODULE
CERTAIN 2009 MODEL YEAR COROLLA**

II. BACKGROUND

IX. PASSENGER AIRBAG INFLATOR REPLACEMENT

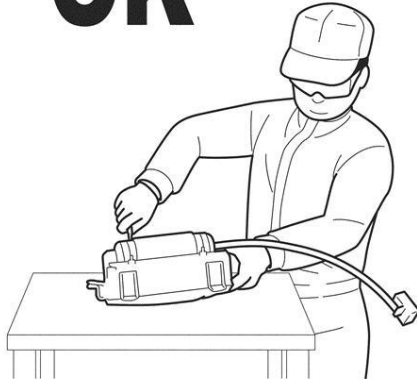
- Carefully place the airbag on the bench inflator side up.

NOTE: Place clean sheet(s) of paper on the bench to protect the airbag.

- Avoid standing directly over the inflator.

OK

NG

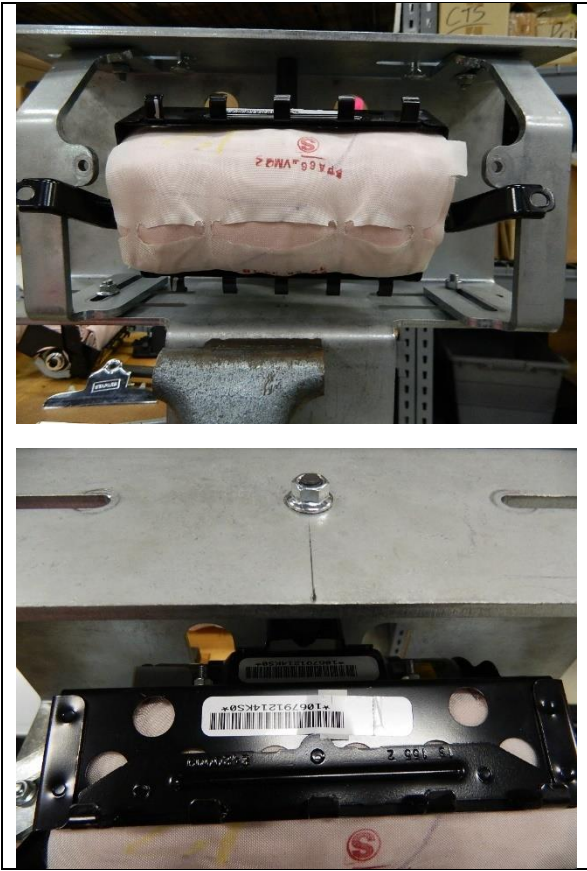
e) Use the long adaptor shown.

f) Thread the adaptor into the airbag as shown.
Note: Use the same mounting nut on the airbag that attaches the airbag to the vehicles cross tube.
