# TECHNICAL INSTRUCTIONS FOR SAFETY RECALL G0P FRONT PASSENGER AIRBAG INFLATOR CERTAIN 2008 – 2013 MY SCION xB

**Updated 1-9-18**

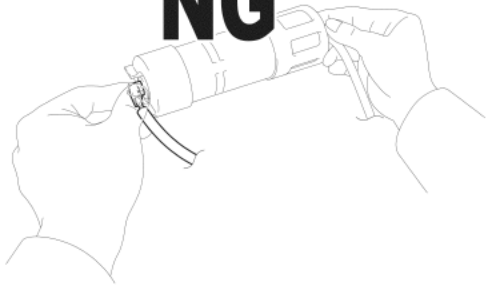
R170128000

DO NOT CONNECT PREMATURELY  
CANNOT DISCONNECTED

1. **IMPORTANT NOTICE WHEN CONNECTING INSTRUMENT PANEL WIRE CONNECTOR TO AIRBAG INFLATOR**
  - a) Once connected, the instrument panel wire connector cannot be disconnected from the airbag inflator. If the instrument panel wire connector is incorrectly connected to the inflator, replace the instrument panel wire and inflator with new ones.

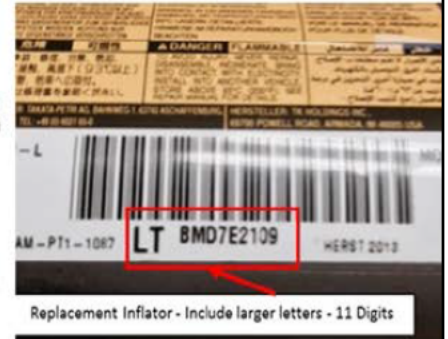
### Replacement Inflator

The first two characters of the **Replacement Inflator Serial code** will be either 'LT' or 'LR'.

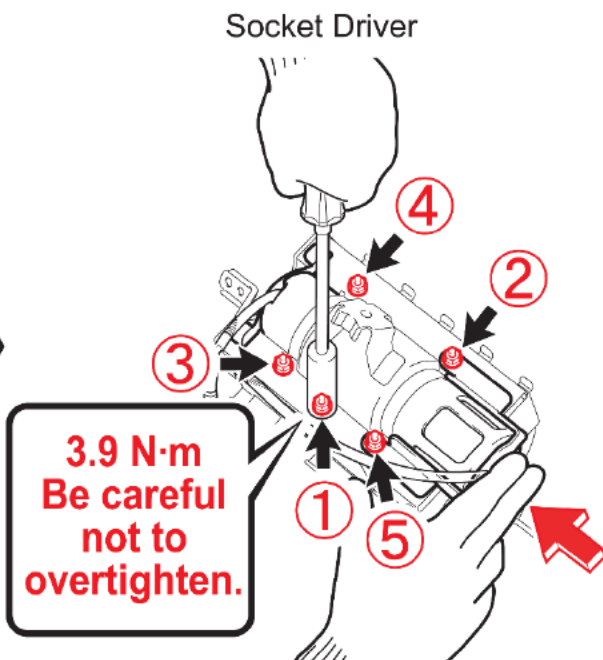
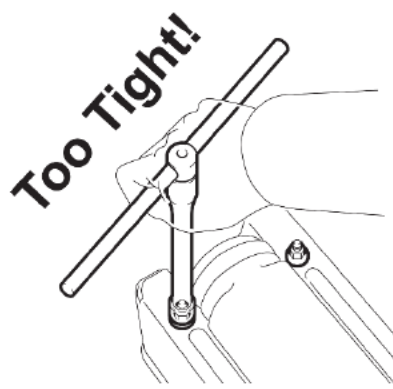
R1707250013

**The tightening torque is low (3.9 N·m). Use of an air ratchet wrench or tightening strongly with a T-handle wrench or a ratchet handle may cause deformation of the stud bolt.**

**OK**

**Too Tight!**

**These tools cause overtightening !**
