**TECHNICAL INSTRUCTIONS
FOR
SAFETY RECALL G0P
FRONT PASSENGER AIRBAG INFLATOR MODULE
CERTAIN 2009 – 2011 MODEL YEAR COROLLA**

Updated 08-31-17

II. BACKGROUND

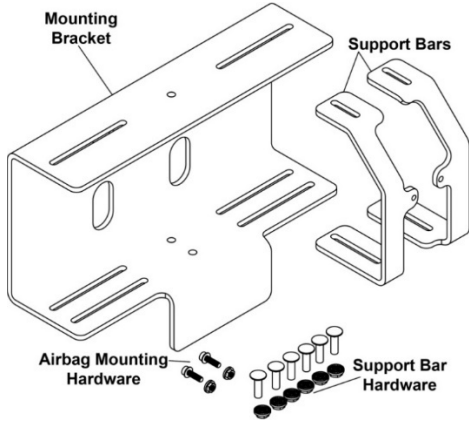
Airbag Mounting Bracket & hardware	1

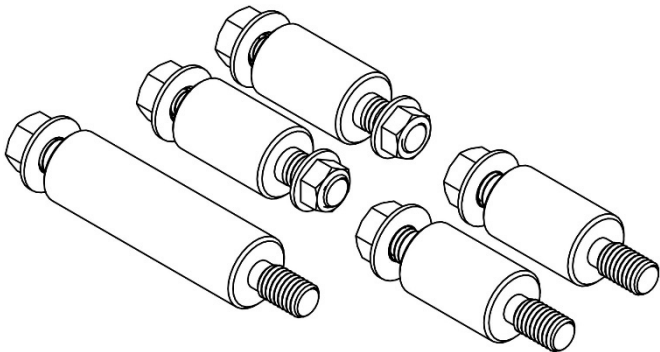
Adaptor set*	1

*The adapter set was sent to dealers at the start of this campaign.
