# TECHNICAL INSTRUCTIONS FOR SAFETY RECALL G0P/G0R/H0A FRONT PASSENGER AIRBAG INFLATOR MODULE CERTAIN 2010-2016 MY 4Runner

### UPDATE 1-11-2019

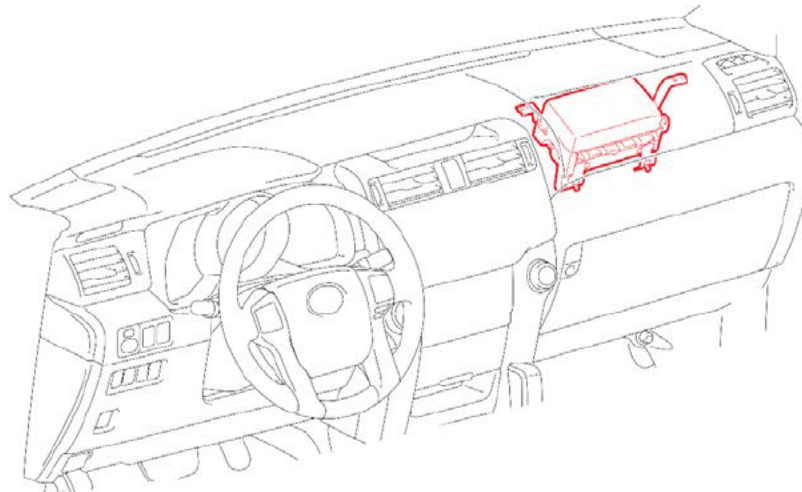
R1703160006A01

The subject vehicles are equipped with front passenger airbag inflators produced by Takata. According to Takata, the propellant in these inflators may degrade after prolonged exposure to high absolute humidity and fluctuating high temperatures. Degraded propellant can cause inflator rupture during airbag deployment. In the event of an inflator rupture, metal fragments could pass through the airbag cushion material, striking the vehicle occupants, and result in serious injury or death.

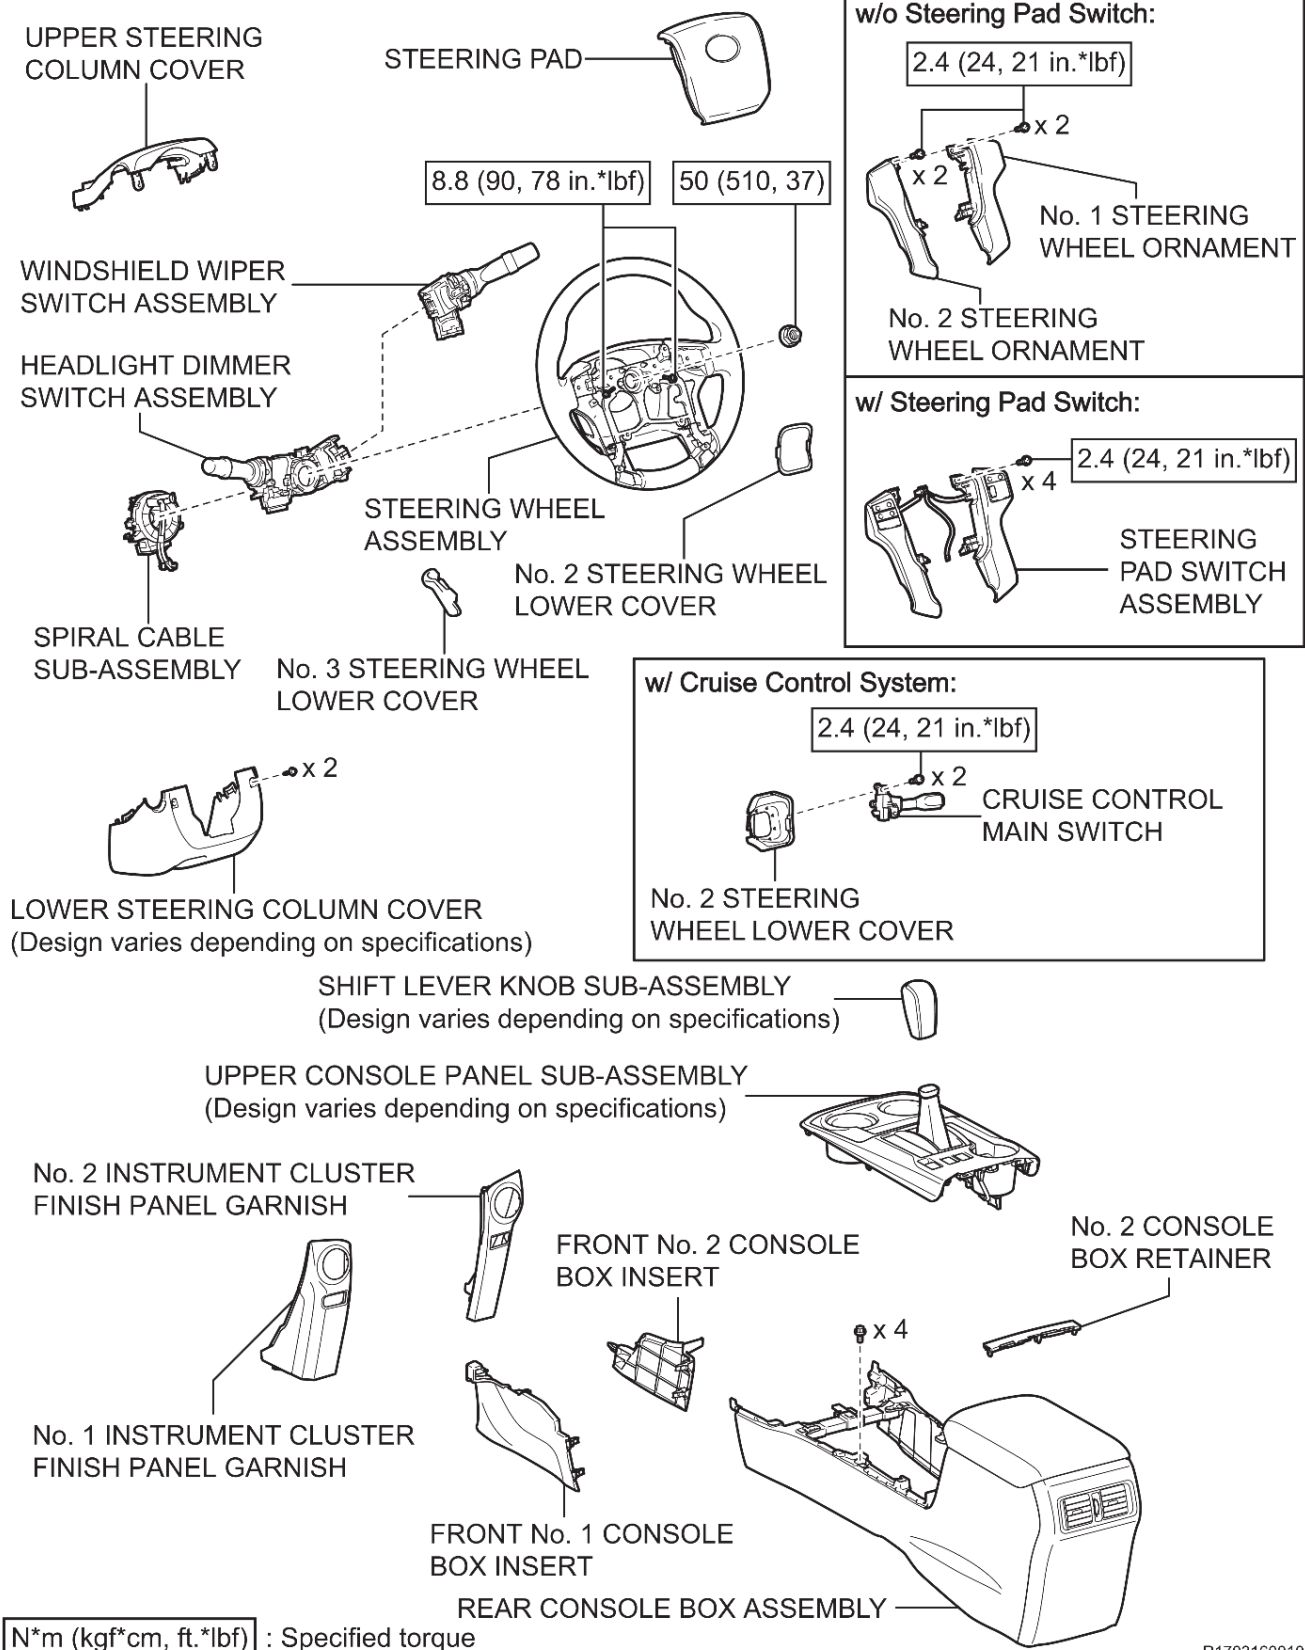
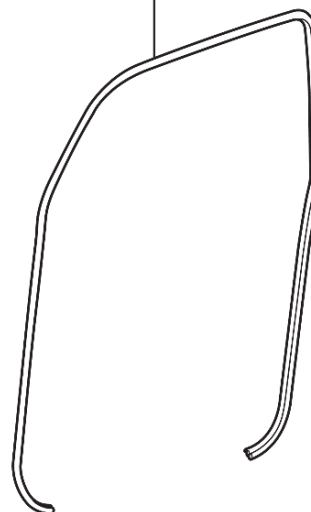
R1703160011

FRONT PILLAR  
GARNISH RH

FRONT DOOR OPENING TRIM  
WEATHERSTRIP RH

COWL SIDE TRIM BOARD RH

DOOR SCUFF PLATE ASSEMBLY RH

Part manufactured  
before August 2013:

Part manufactured  
after August 2013:

● FRONT PILLAR  
GARNISH LH

No. 1 FRONT PILLAR  
GARNISH COVER LH

FRONT PILLAR  
GARNISH LH

FRONT DOOR OPENING TRIM  
WEATHERSTRIP LH

COWL SIDE TRIM BOARD LH

DOOR SCUFF PLATE ASSEMBLY LH

● Replacement part

**NOTE:** The left front A-Pillar garnish needs to be replaced on vehicles manufactured prior to August 2013. Only one garnish is required per vehicle depending upon color code. The kit contains the garnish and the non-reusable clip. (see parts information)

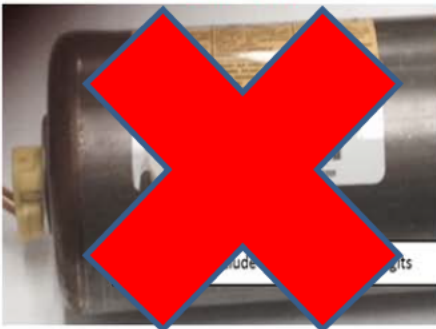
**Original Inflator**

The Inflator serial code is an 11 digit code on the Inflator can. It can be found with a bar code on removing the Inflator can from the Airbag Assembly unit.

The first two characters of the Original Inflator Serial code will be from [AA, AB, AJ, FD or JD].

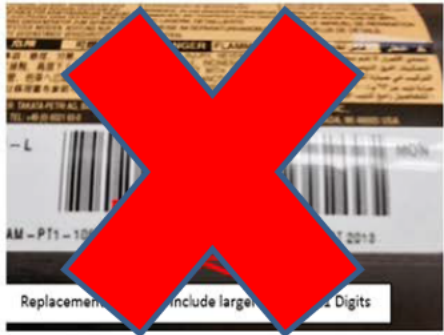
**Replacement Inflator**

The first two characters of the Replacement Inflator Serial code will be either 'LT' or 'LR'.

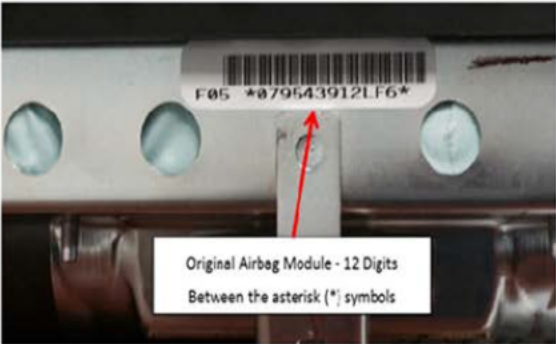
The Airbag module Assembly serial number is a 12 digit code. It can be found along with a bar code on opening the Airbag assembly unit. To manually enter these details into the application, the technician has to identify the 12 digit code between two Asterisks (\*) inside the Airbag assembly unit. The first seven characters of this 12 digit code are numbers and the 10<sup>th</sup> digit is either 'K' or 'L' always.

Check this box if the label is damaged or missing

If the airbag serial number and barcode are not legible or are not present, check the box in the application indicating the serial number is not legible.

a) If the airbag serial number cannot be scanned or is not present check the box as shown below.
