# IMPORTANT UPDATE

## TECHNICAL INSTRUCTIONS FOR SAFETY RECALL G0P/G0R/H0A FRONT PASSENGER AIRBAG INFLATOR MODULE CERTAIN 2009 – 2013 MODEL YEAR COROLLA

**Updated 1-9-2019**

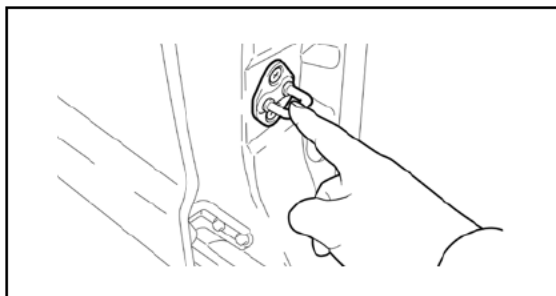
The anti-static mat set that is an essential SST may be available at your dealership and is optional to use during inflator replacement. If the anti-static kit is not available, before starting work and periodically while working on the vehicle, touch a metallic part of the vehicle to discharge static electricity in the body.

If the anti-static kit is not available, before starting work and periodically while working on the vehicle, touch a metallic part of the vehicle to discharge static electricity in the body.

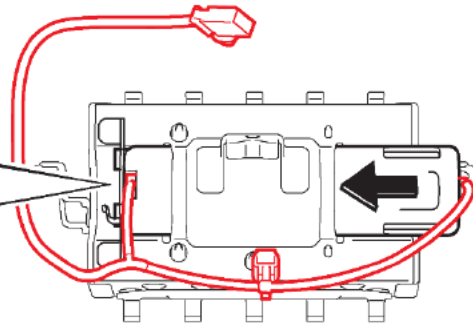
R1702270042

d) Fully insert the inflator and ensure that the inflator is correctly oriented as shown.

**NOTE: DO NOT** pinch the wiring between the bracket and the inflator.

**DO NOT**  
pinch the wire
