**TECHNICAL INSTRUCTIONS**  
**FOR**  
**SAFETY RECALL GOR**  
**FRONT PASSENGER AIRBAG INFLATOR MODULE**  
**CERTAIN 2009 MODEL YEAR Matrix**

## II. BACKGROUND

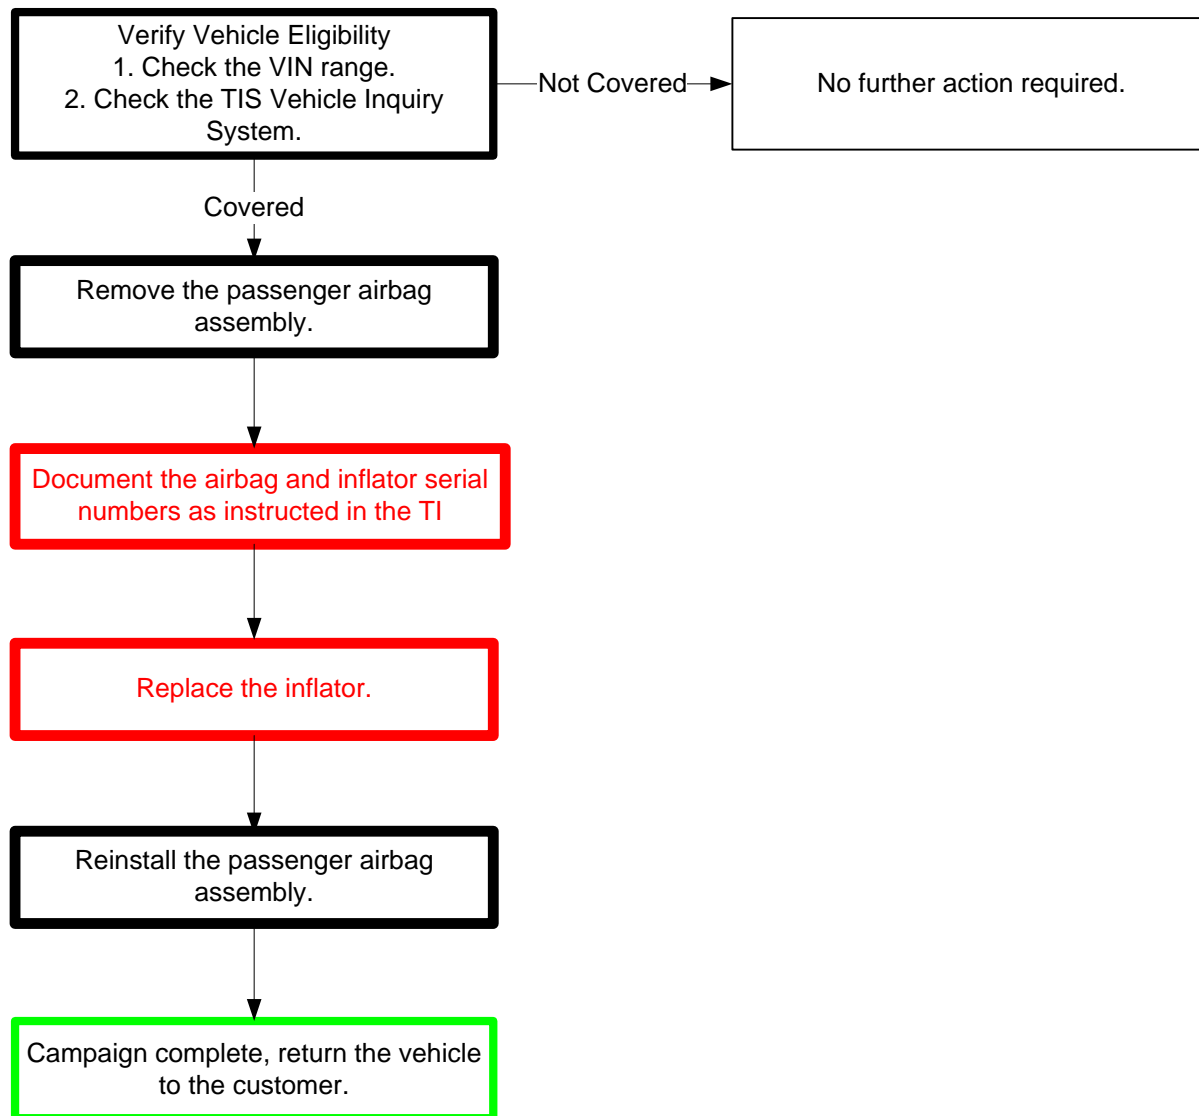
## I. OPERATION FLOW CHART

The flow chart is for reference only. **DO NOT** use it in place of the full technical instructions. Follow **ALL** steps as outlined in the full technical instructions to confirm the campaign is completed correctly.

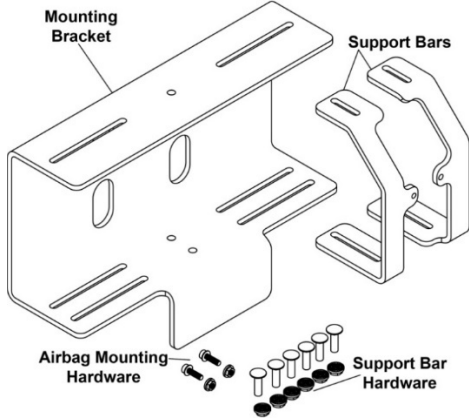
Airbag Mounting Bracket & hardware	1

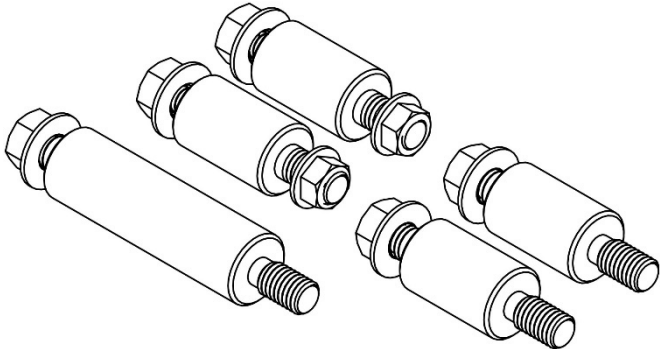
Adaptor set*	1

\*The adaptor set was sent to dealers at the start of this campaign.

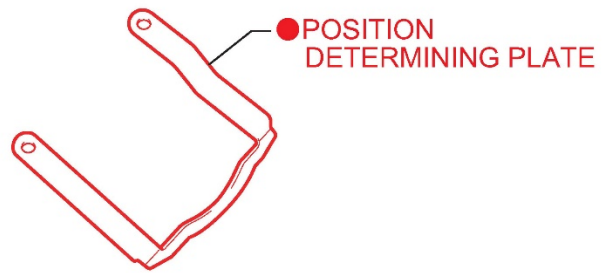
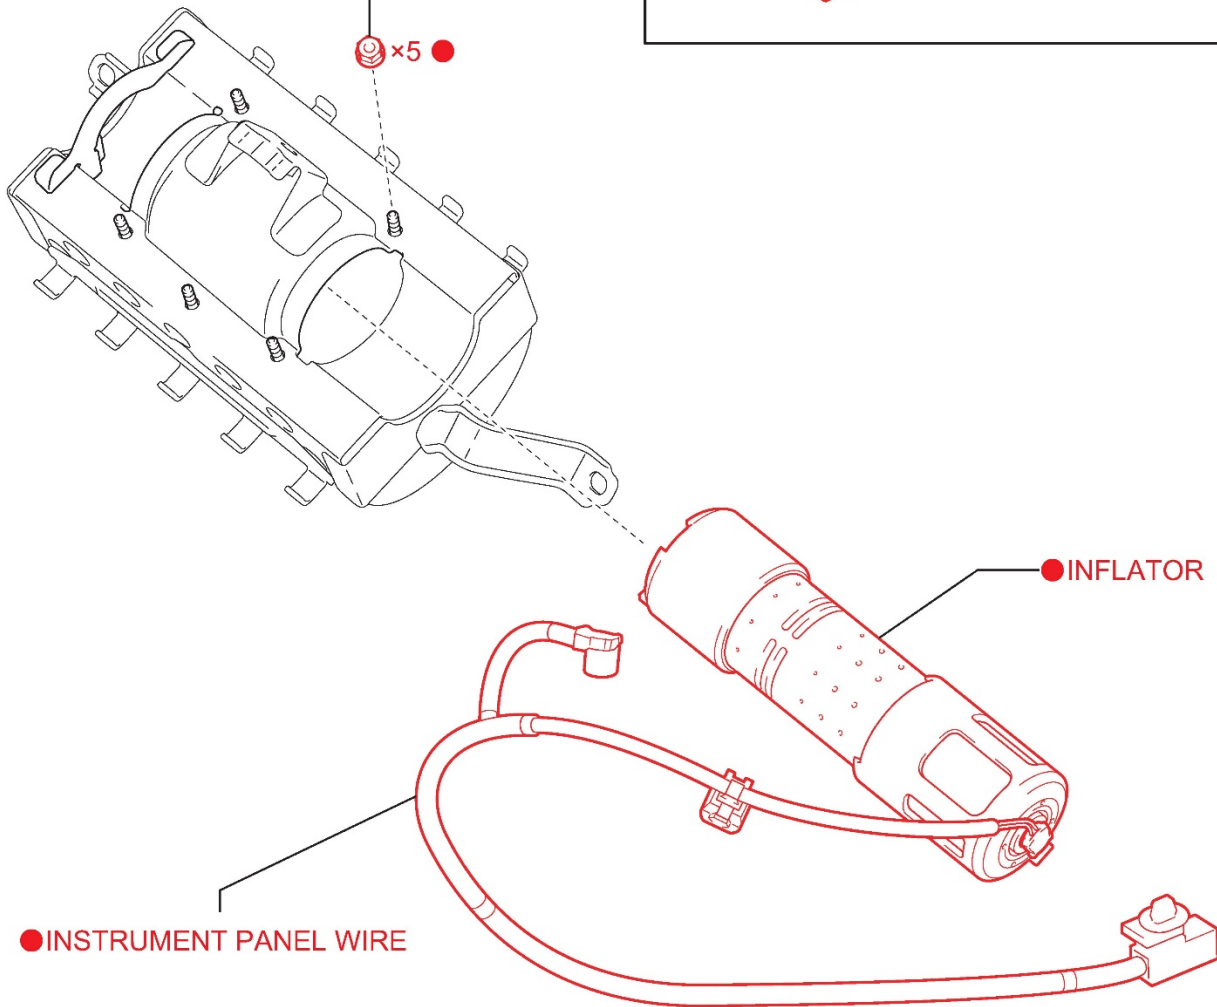
R1702270035

**3.9 N·m (40, 35 in.\*lbf)**  
**Be careful not to**  
**overtighten.**

for MATRIX:

● : Replacement part

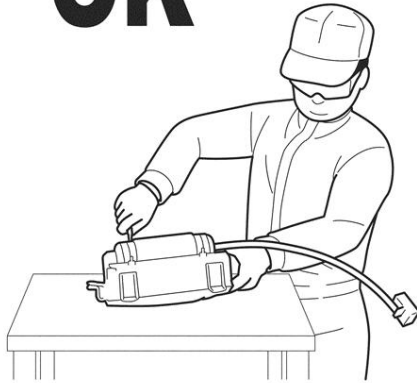
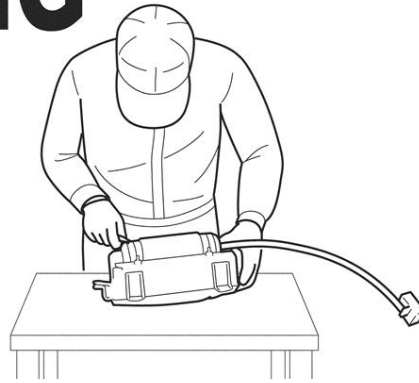
R1301230008E

- Carefully place the airbag on the bench inflator side up.

**NOTE: Place clean sheet(s) of paper on the bench to protect the airbag.**

- Avoid standing directly over the inflator.

# OK

# NG

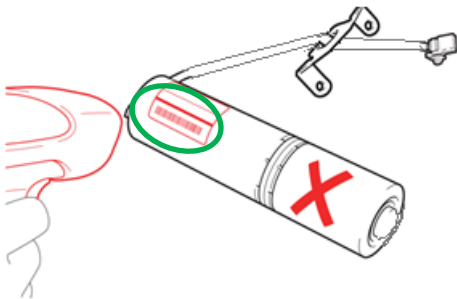
### Step a) Old Inflator (bar code)

- Scan the **OLD** inflator bar code.
- Scan the **NEW** inflator QR code.

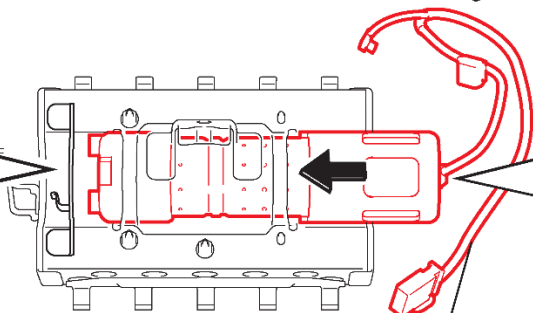
R1702270040

- a) Carefully slide the new inflator into the airbag assembly and align as shown.

- DO NOT** connect the inflator harness at this time. It is **CRITICAL** to first confirm that the inflator is installed in the correct position before connecting the harness.

**DO NOT** insert fully.

Check orientation

Upper side

Bottom

Instrument panel wire

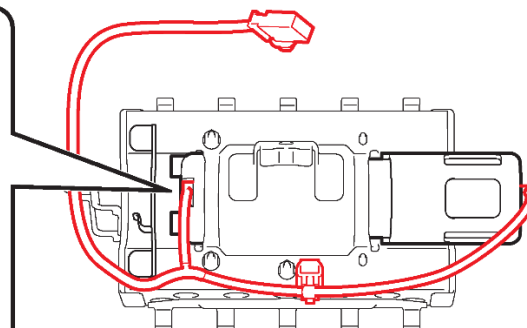
R1702270041

- b) Connect the connector to the inflator and ensure that the connector lock is fully engaged as shown.  
c) Route and secure the wire harness as shown.

**ALIGN CONNECTORS**

Wire Harness Side:

Inflator Side:

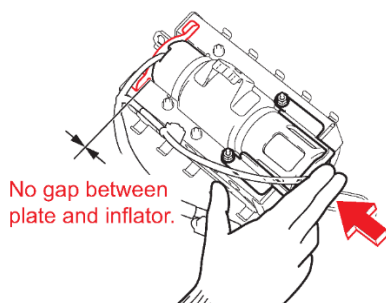
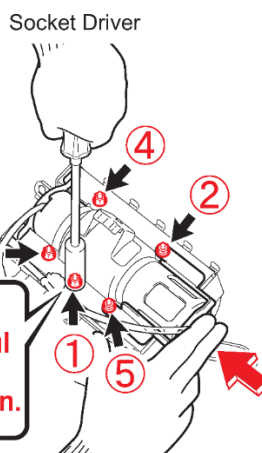
R1702270046

- a) Tighten the 5 nuts evenly in several increments in the sequence shown. Use a socket driver or torque wrench to tighten the nuts.

Torque: 35in. lbf (3.9N·m)

- There will be some resistance when tightening the nuts because they are self-locking, confirm the nuts are tightened correctly.
- **DO NOT** use a power tool, T-handle, or ratchet when tightening the nuts to avoid overtorqueing and deforming the studs.
- You may need to turn the airbag to the left or right with in the mounting bracket to access the center nut.

**OK**

3.9 N·m  
Be careful  
not to  
overtighten.

**Too Tight!**

**These tools cause overtightening !**
