# TECHNICAL INSTRUCTIONS FOR SAFETY RECALL G0P FRONT PASSENGER AIRBAG INFLATOR MODULE CERTAIN 2008 – 2013 MY SCION xB

**Updated 1-9-18**

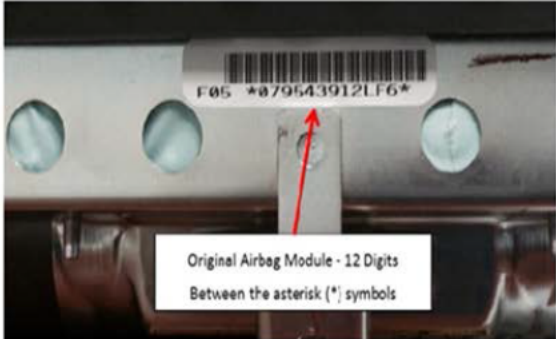
If the airbag serial number and barcode are not legible or are not present, check the box in the application indicating the serial number is not legible.

a) If the airbag serial number cannot be scanned or is not present check the box as shown below.

Original Airbag Module - 12 Digits  
Between the asterisk (\*) symbols

Check this box if the label is damaged or missing
