## TECHNICAL INSTRUCTIONS FOR SAFETY RECALL G0P FRONT PASSENGER AIRBAG INFLATOR MODULE CERTAIN 2010-2013 MY 4Runner

### UPDATE 7-17-18

## II. BACKGROUND

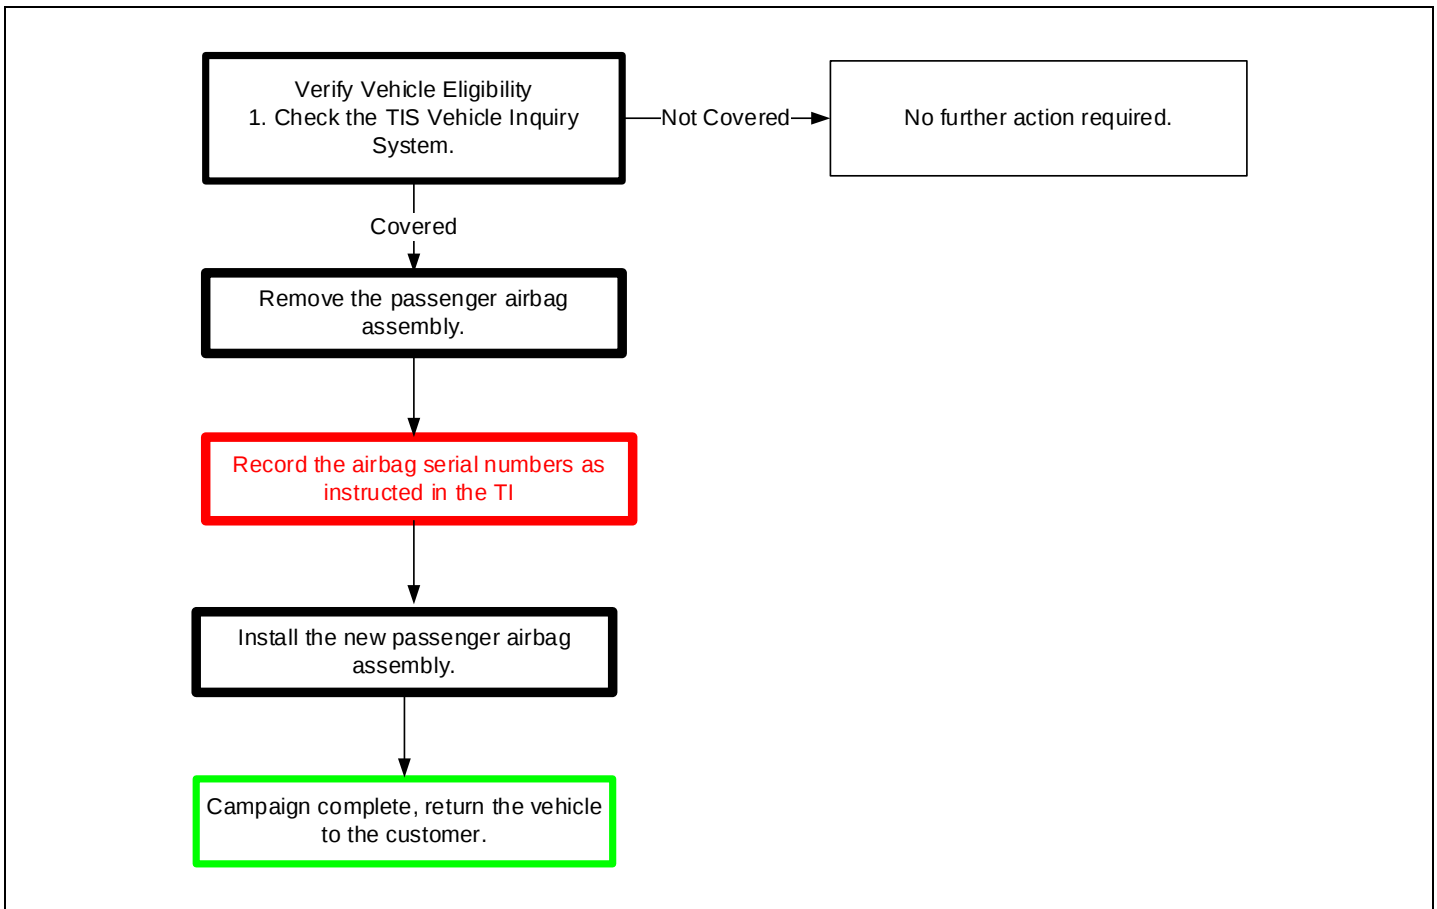
## I. OPERATION FLOW CHART

The flow chart is for reference only. **DO NOT** use it in place of the full technical instructions. Follow **ALL** steps as outlined in the full technical instructions to confirm the campaign is completed correctly.

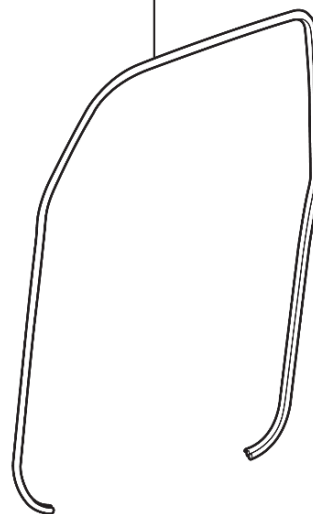
R1703160011

● FRONT PILLAR  
GARNISH LH

No. 1 FRONT PILLAR  
GARNISH COVER LH

FRONT PILLAR  
GARNISH LH

FRONT DOOR OPENING TRIM  
WEATHERSTRIP LH

COWL SIDE TRIM BOARD LH

DOOR SCUFF PLATE ASSEMBLY LH

● Replacement part

**NOTE:** The left front A-Pillar garnish needs to be replaced on vehicles manufactured prior to August 2013. Only one garnish is required per vehicle depending upon color code. The kit contains the garnish and the non-reusable clip. (see parts information)

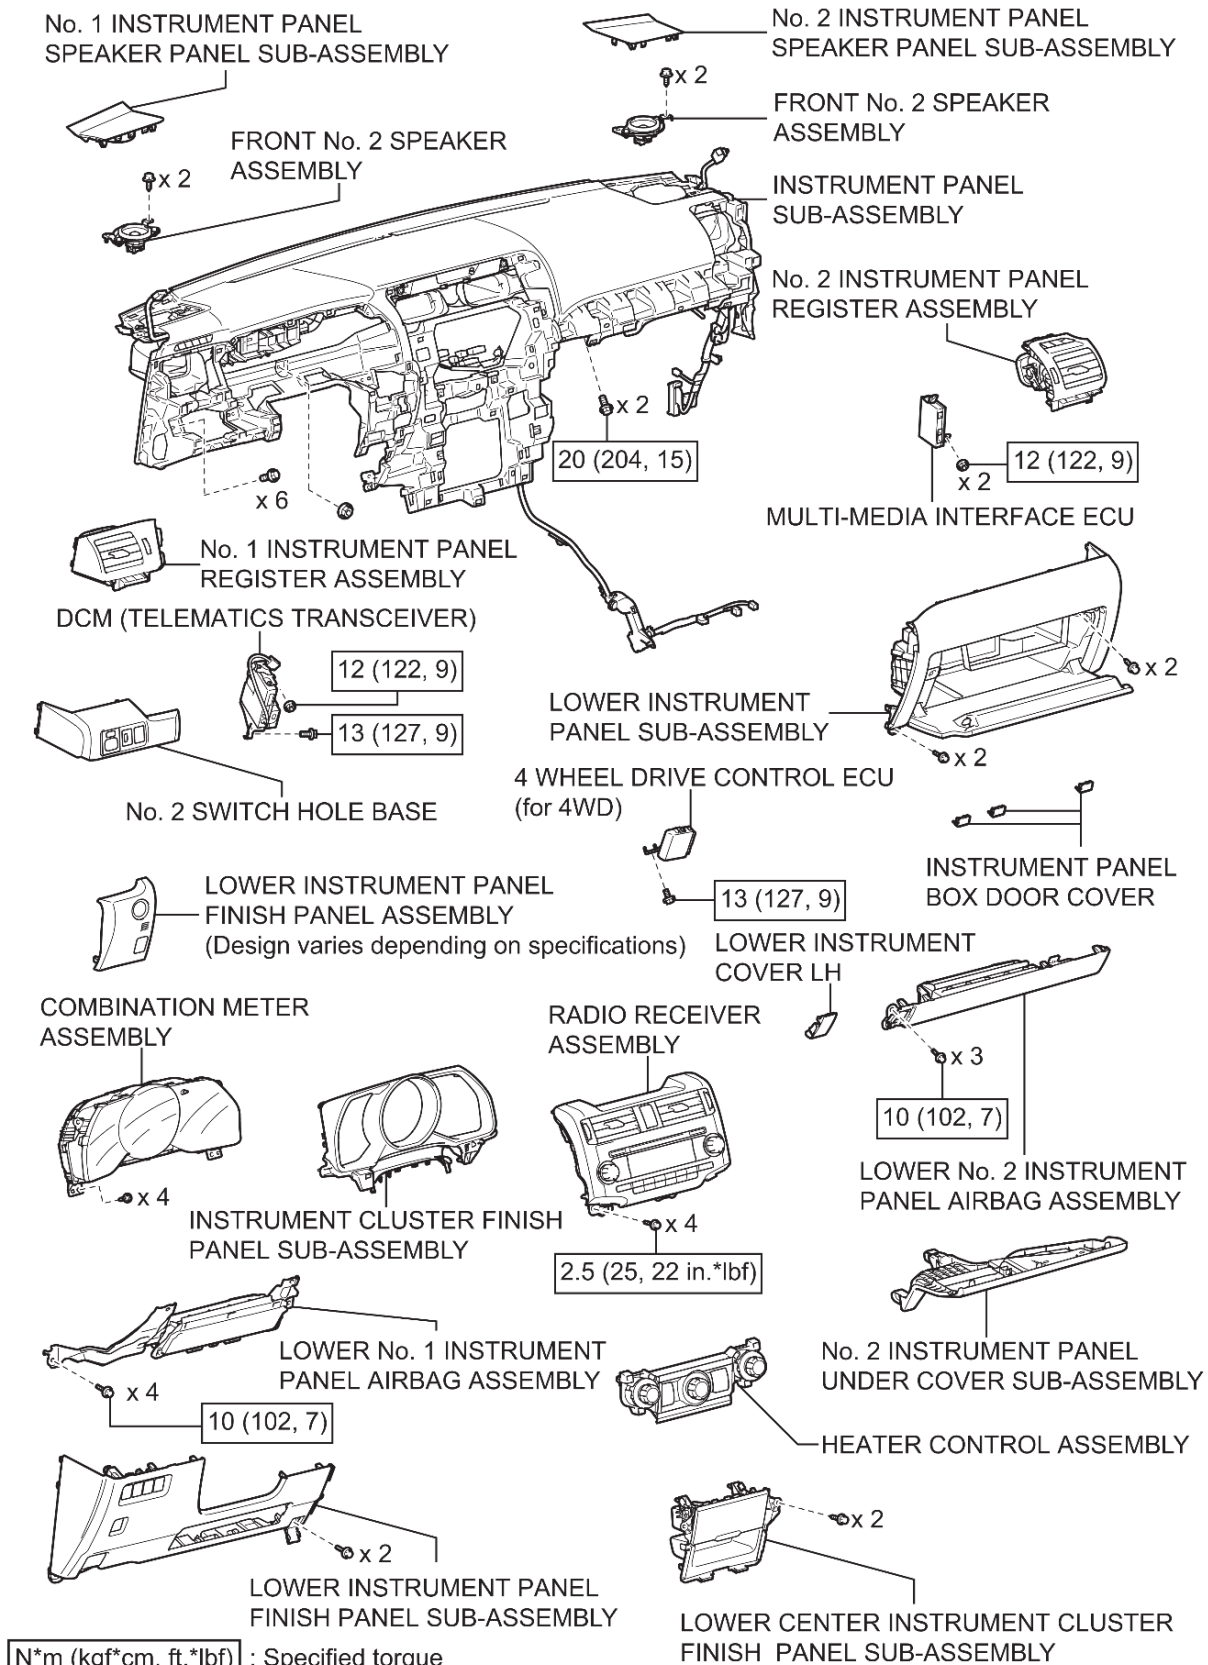
R1703160012

**CAUTION-PLASTIC RETAINING CLIPS ARE FRAGILE. REMOVE WITH CARE**

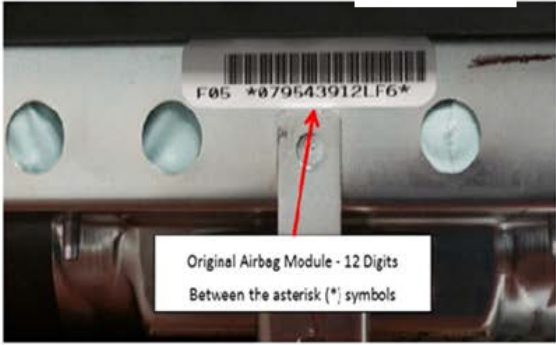
a) If the airbag serial number cannot be scanned or is not present check the box as shown below.

Check this box if the label is damaged or missing

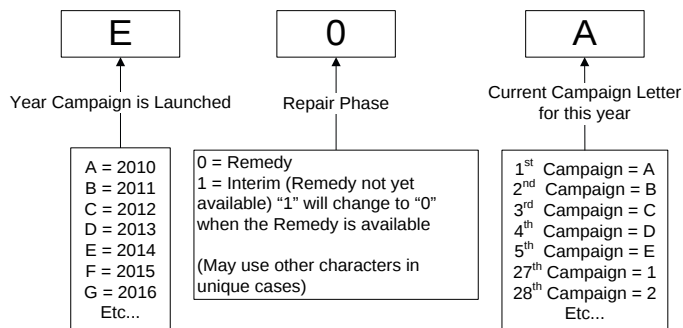
### A. CAMPAIGN DESIGNATION DECODER

Examples:

A0D = Launched in 2010, Remedy Phase, 4<sup>th</sup> Campaign Launched in 2010

B1E = Launched in 2011, Interim Phase, 5<sup>th</sup> Campaign Launched in 2011

C1C = Launched in 2012, Interim Phase, 3<sup>rd</sup> Campaign Launched in 2012
