**TECHNICAL INSTRUCTIONS
FOR
SAFETY RECALL G0P
FRONT PASSENGER AIRBAG INFLATOR MODULE
CERTAIN 2009 MODEL YEAR MATRIX**

I. OPERATION FLOW CHART

II. BACKGROUND

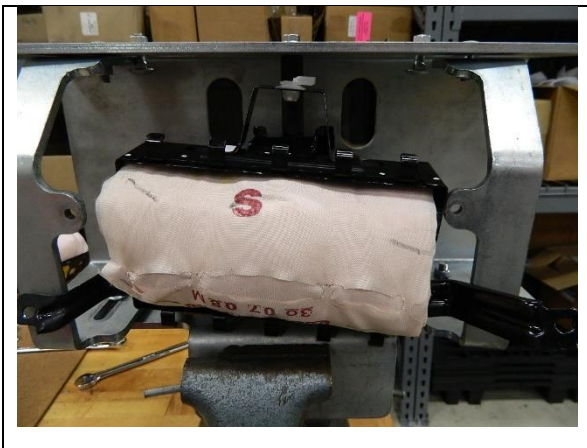
e) Use the long adaptor shown.

f) Thread the adaptor into the airbag as shown.
Note: Use the same mounting nut on the airbag that attaches the airbag to the vehicles cross tube.

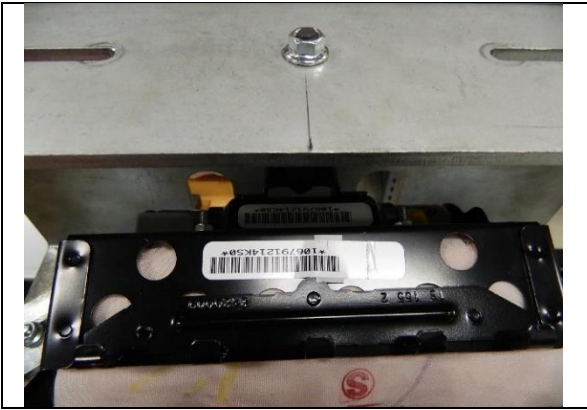
R1702270637

g) Mount the airbag into the mounting bracket as shown. Pass the stud on the adaptor through the hole in the middle of the bracket with the nut.
