## TECHNICAL INSTRUCTIONS FOR SAFETY RECALL GLG/GLH/HLA FRONT PASSENGER AIRBAG INFLATOR REPLACEMENT CERTAIN 2007 – 2012 MY ES 350

### UPDATE 1-15-2019

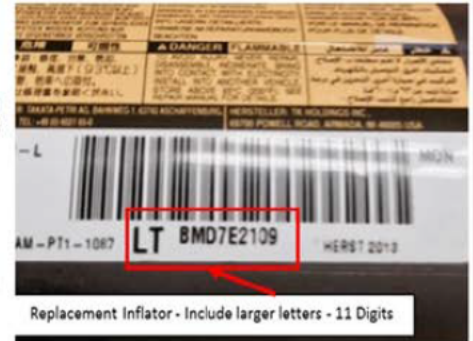
### Replacement Inflator

The first two characters of the Replacement Inflator Serial code will be either 'LT' or 'LR'.

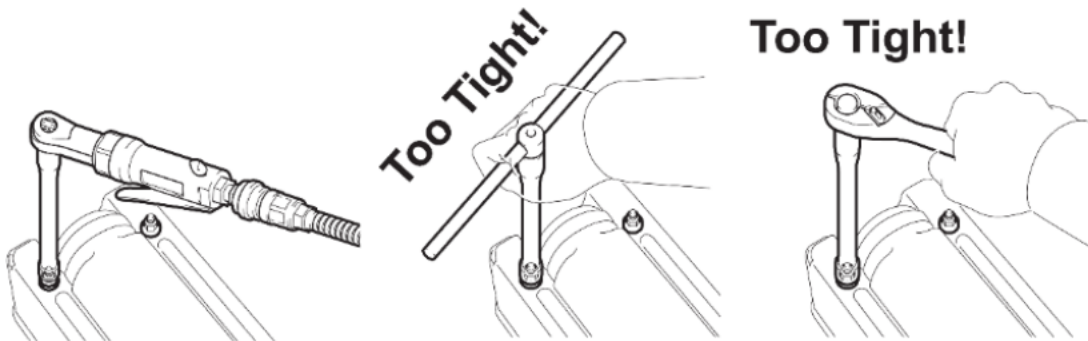
R1701260011Z01

- There will be some resistance when tightening the nuts because they are self-locking, confirm the nuts are tightened correctly.
- **DO NOT** use a power tool, T-handle, or ratchet when tightening the nuts to avoid over torqueing and deforming the studs.
- You may need to slide the airbag to the left or right with in the mounting bracket to access the center nut.

**OK**

**NG**

**These tools cause overtightening !**
