TECHNICAL INSTRUCTIONS
FOR
SAFETY RECALL GLH
FRONT PASSENGER AIRBAG MODULE
CERTAIN 2007 – 2009 MY ES 350
UPDATED 11-2-2017

Update 11-2-17
- Added 2009 MY

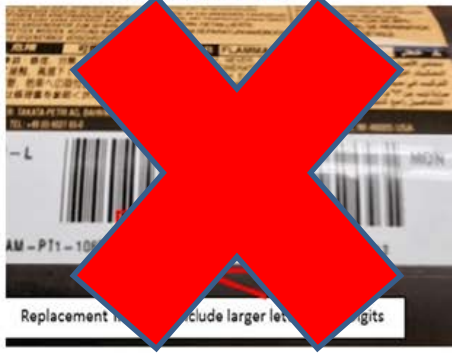
Replacement Inflator

The first two characters of the **Replacement Inflator Serial code** will be either 'LT' or 'LR'.

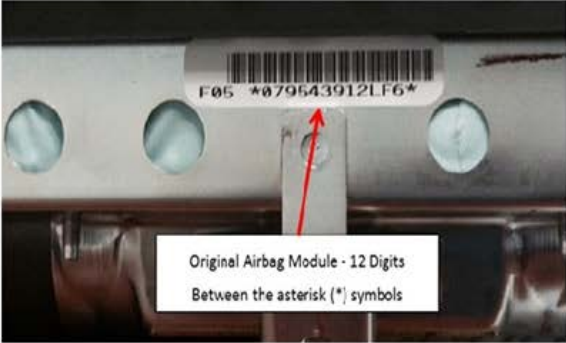
Original Airbag Module - 12 Digits
Between the asterisk (*) symbols

The Airbag module Assembly serial number is a **12 digit code**. It can be found along with a bar code on opening the Airbag assembly unit. To manually enter these details into the application, the technician has to identify the 12 digit code between two Asterisks (*) inside the Airbag assembly unit. The first seven characters of this 12 digit code are numbers and the 10th digit is either 'K' or 'L' always.

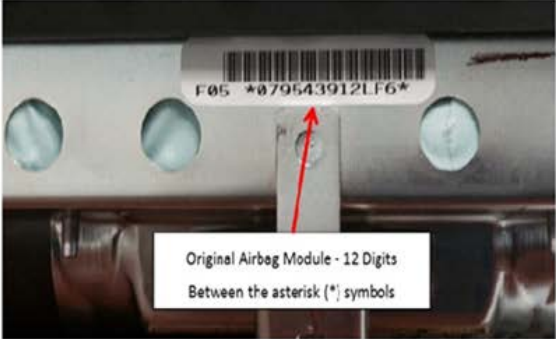
Original Airbag Module - 12 Digits
Between the asterisk (*) symbols

If the airbag serial number and barcode are not legible or are not present, check the box in the application indicating the serial number is not legible.

a) If the airbag serial number cannot be scanned or is not present check the box as shown below.

Check this box if the label is damaged or missing
