# TECHNICAL INSTRUCTIONS FOR SAFETY RECALL G0P FRONT PASSENGER AIRBAG INFLATOR MODULE CERTAIN 2011-2013 MODEL YEAR SIENNA

**Updated 1-9-18**

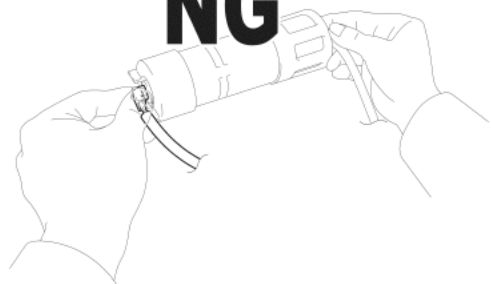
**NG**

- DO NOT** connect the inflator harness at this time. It is **CRITICAL** to first confirm that the inflator is installed in the correct position before connecting the harness.

DO NOT CONNECT PREMATURELY  
CANNOT DISCONNECTED

**NOTE:** Once connected the inflator harness cannot be disconnected without damaging the connector, and would require that the inflator and harness be replaced.
