# IMPORTANT UPDATE

## TECHNICAL INSTRUCTIONS FOR SAFETY RECALL G0P FRONT PASSENGER AIRBAG INFLATOR MODULE CERTAIN 2009 –2013 MODEL YEAR MATRIX

**Updated 7-17-18**

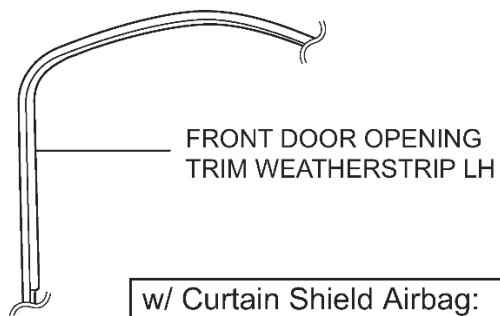
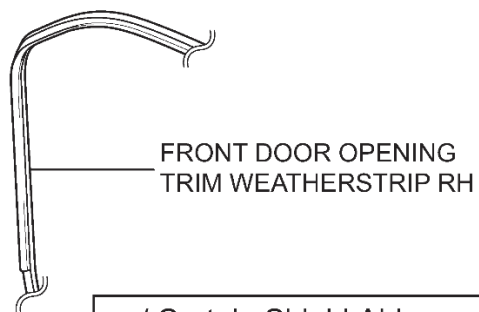
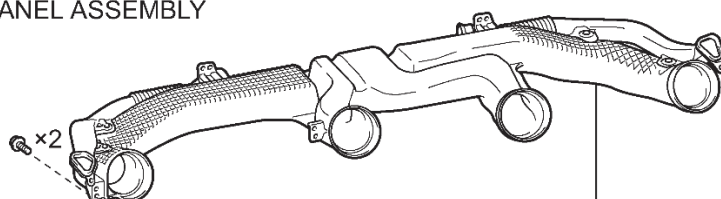
R1703010003

FRONT PILLAR GARNISH LH

FRONT PILLAR GARNISH RH

FRONT PASSENGER AIRBAG ASSEMBLY

No. 1 INSTRUMENT PANEL BOX DOOR SUB-ASSEMBLY

LOWER INSTRUMENT PANEL FINISH PANEL ASSEMBLY

20 (204, 15)

GLOVE COMPARTMENT DOOR ASSEMBLY

HEATER TO REGISTER DUCT ASSEMBLY

● : Replacement part

N\*m (kgf\*cm, ft.\*lbf) : Specified torque

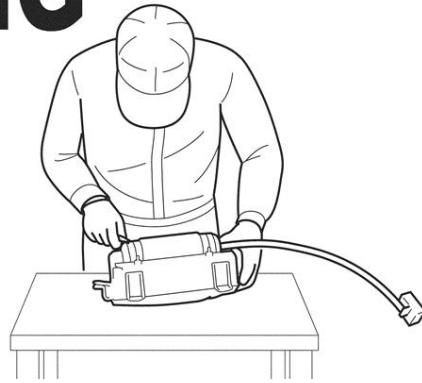
R1301230008E

- Carefully place the airbag on the bench inflator side up.

**NOTE: Place clean sheet(s) of paper on the bench to protect the airbag.**

- Avoid standing directly over the inflator.

# OK

# NG

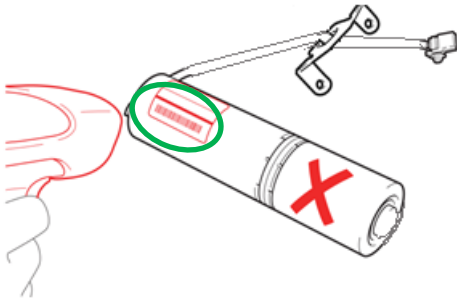
### Step a) Old Inflator (bar code)

- Scan the **OLD** inflator bar code.
- Scan the **NEW** inflator QR code.

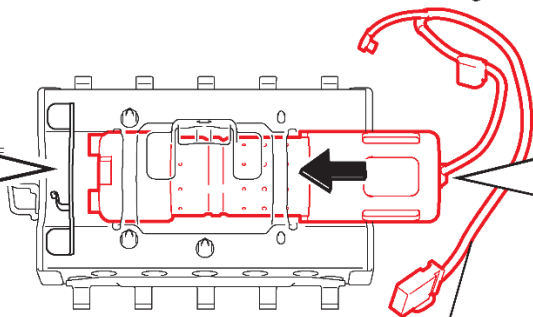
R1702270040

- a) Carefully slide the new inflator into the airbag assembly and align as shown.

- DO NOT** connect the inflator harness at this time. It is **CRITICAL** to first confirm that the inflator is installed in the correct position before connecting the harness.

**DO NOT insert fully.**

Check orientation

Upper side

Bottom

Instrument panel wire

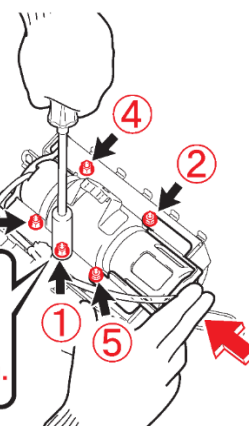
R1702270046

- a) Tighten the 5 nuts evenly in several increments in the sequence shown. Use a socket driver or torque wrench to tighten the nuts.

Torque: 35in. lbf (3.9N·m)

- There will be some resistance when tightening the nuts because they are self-locking, confirm the nuts are tightened correctly.
- **DO NOT** use a power tool, T-handle, or ratchet when tightening the nuts to avoid over torqueing and deforming the studs.
- You may need to turn the airbag to the left or right with in the mounting bracket to access the center nut.

**OK**

Socket Driver

3.9 N·m  
Be careful  
not to  
overtighten.

**NG**

**These tools cause overtightening !**

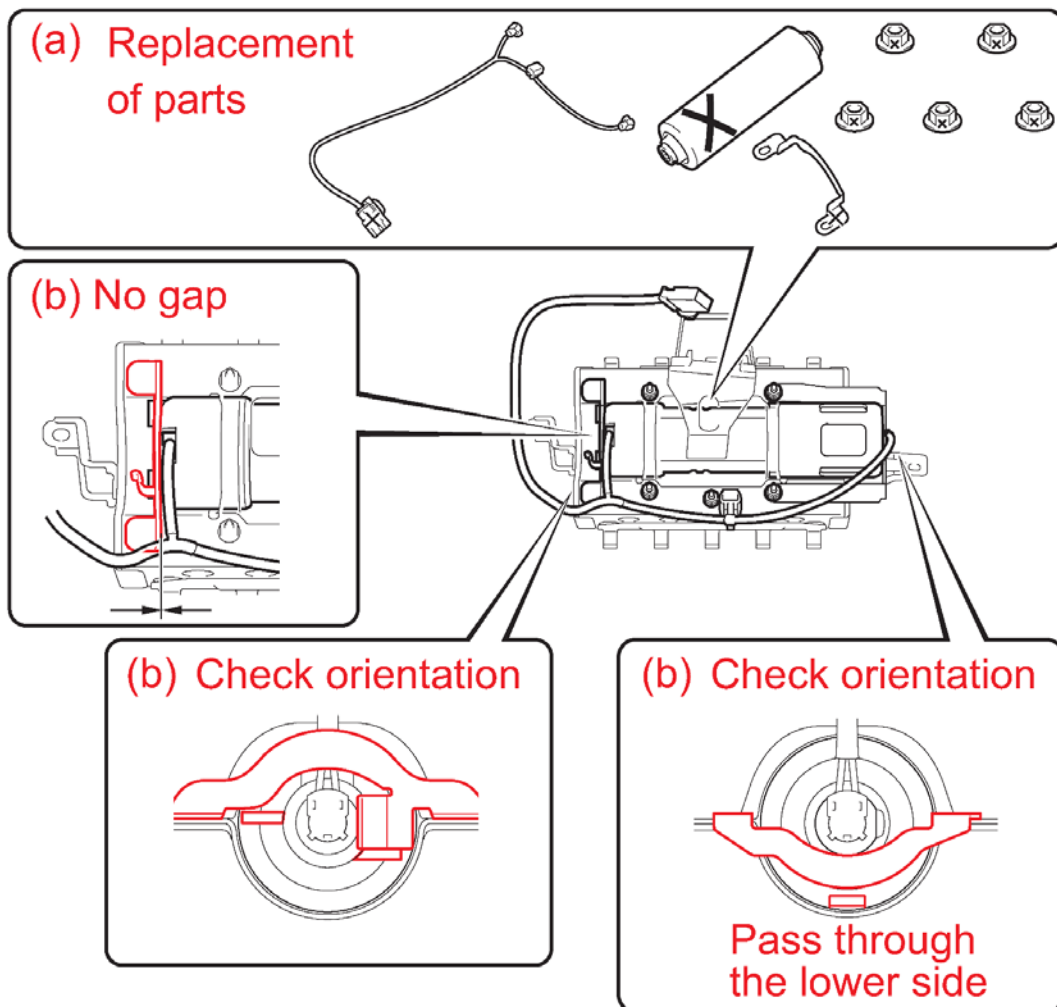
R1703080022

- a) Confirm the **NEW** inflator and 5 **NEW** nuts have been installed.
- b) Confirm the position of the inflator and position determining plates are correct.
- c) Confirm the routing of the inflator wire harness.
