## **TECHNICAL INSTRUCTIONS**

### **SAFETY RECALL GLG/GLH and HLA**

### **FRONT PASSENGER AIRBAG MODULE**

**CERTAIN 2006 – 2011 MY IS 250/350 and 2008 – 2011 MY IS F**

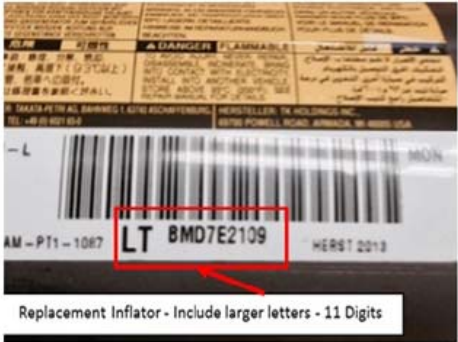
Replacement Inflator - Include larger letters - 11 Digits

The first two characters of the **Replacement Inflator Serial code** will be either 'LT' or 'LR'.
