TECHNICAL INSTRUCTIONS
FOR
SAFETY RECALL GLG
FRONT PASSENGER AIRBAG INFLATOR REPLACEMENT
CERTAIN 2010-2012 MY IS 250/350 CONVERTIBLE

UPDATED SEPTEMBER 21, 2017

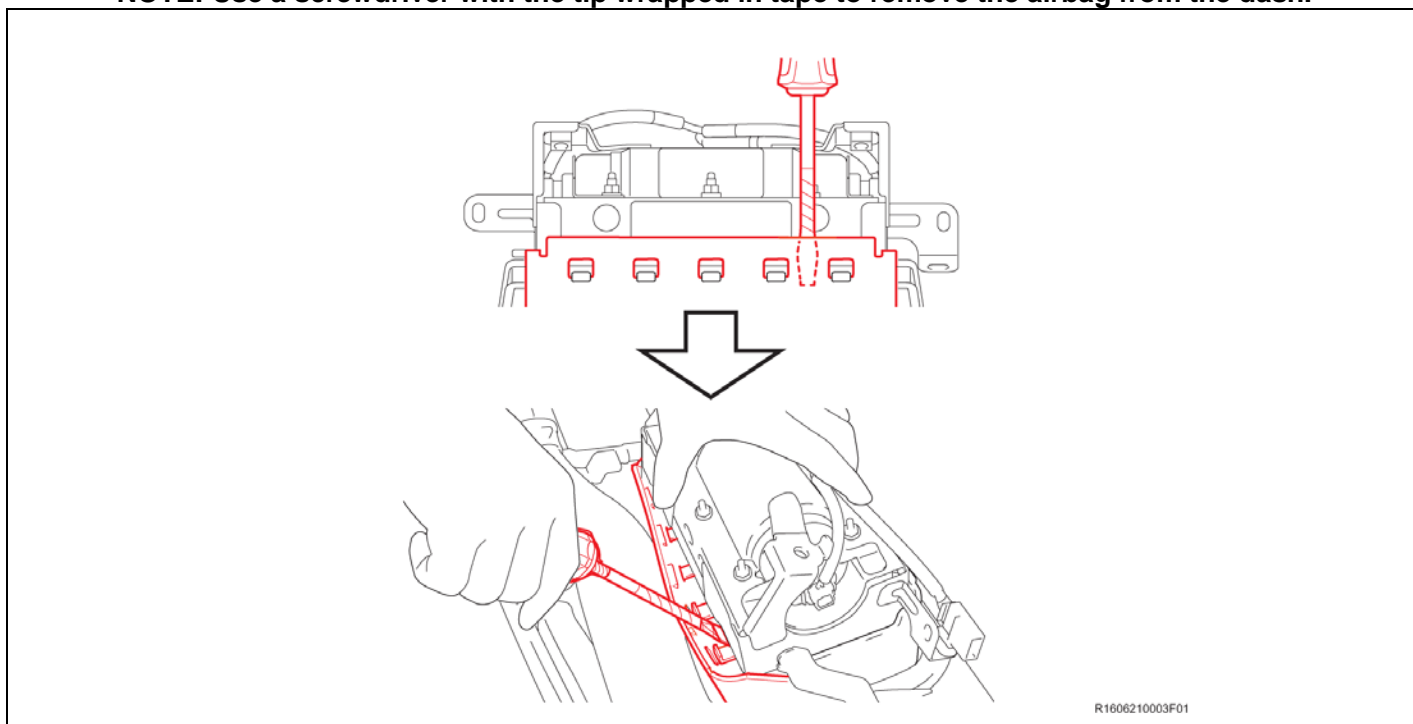
- c) Remove the 4 bolts, disengage the straps, and then remove the airbag assembly.

NOTE: Use a screwdriver with the tip wrapped in tape to remove the airbag from the dash.

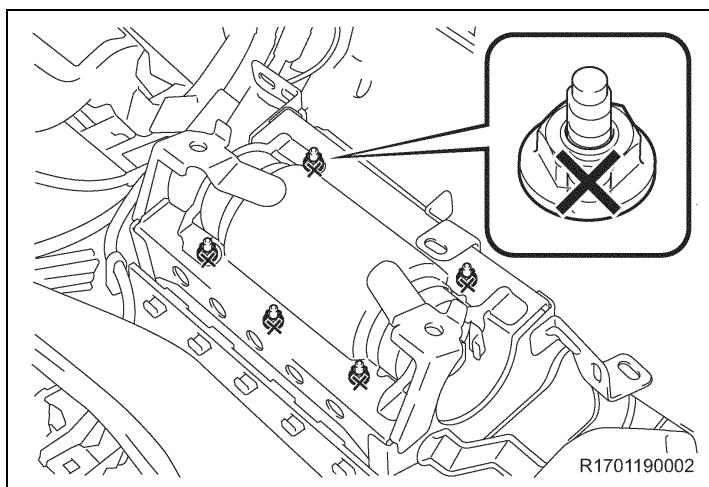
- d) Using a screwdriver to release the lock button of the connector.

- e) Disconnect the 2 connectors.

- f) Disengage the 2 clamps.

NOTE: The removed instrument panel wire will not be reused.

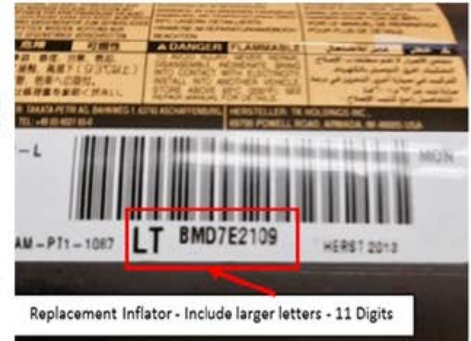
The first two characters of the Replacement Inflator Serial code will be either 'LT' or 'LR'.

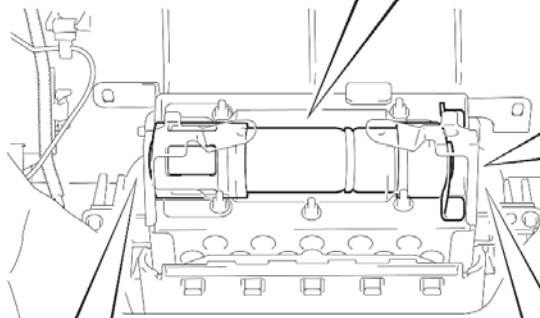
- j) Push the inflator towards the position determining plate and eliminate any gaps.

- If any gaps exist, the flats may move apart and could result in abnormal operation during airbag deployment.
