## TECHNICAL INSTRUCTIONS FOR SAFETY RECALL GLG/GLH and HLA

### FRONT PASSENGER AIRBAG INFLATOR REPLACEMENT CERTAIN 2006 – 2013 MY IS 250/350 and 2008 – 2013 MY IS F

#### UPDATE 4-18-18

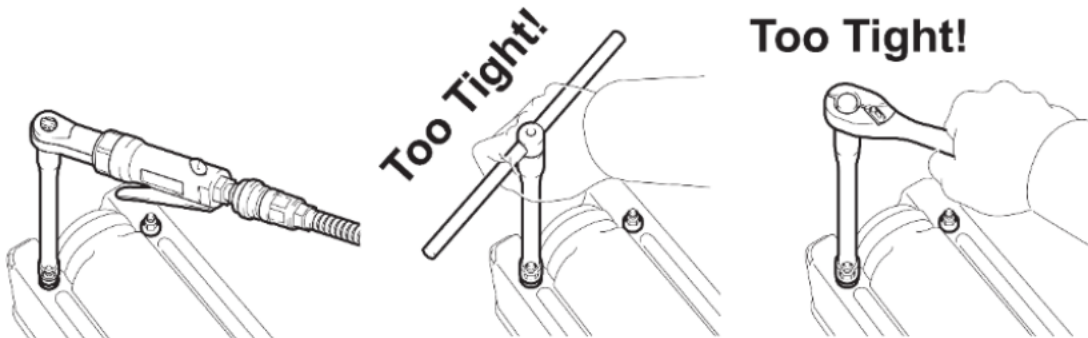
**NG**

**These tools cause overtightening !**
