# TECHNICAL INSTRUCTIONS FOR SAFETY RECALL G0P/G0R/H0A FRONT PASSENGER AIRBAG INFLATOR MODULE CERTAIN 2011-2014 MODEL YEAR SIENNA

**Updated 1-9-2019**

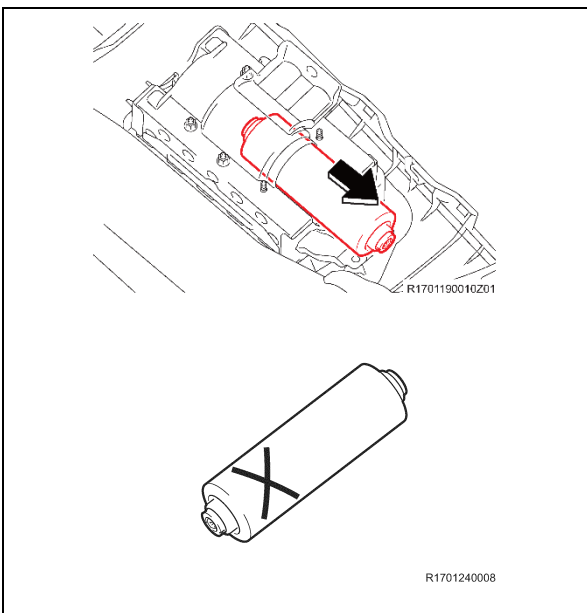
- a) Gently push the inflator in the direction shown.

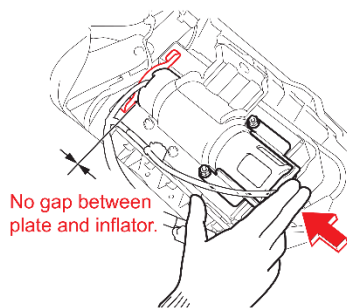
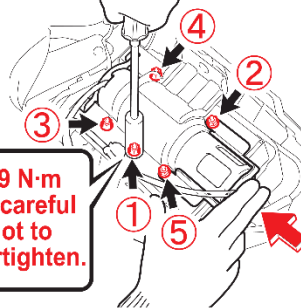
R1702010002H

- a) Tighten the 5 nuts evenly in several increments in the sequence shown. Use a socket driver or torque wrench to tighten the nuts.

**Torque: 35in. lbf (40 kgf.cm, 3.9N·m)**

- There will be some resistance when tightening the nuts because they are self-locking, confirm the nuts are tightened correctly.
- **DO NOT** use a power tool, T-handle, or ratchet when tightening the nuts to avoid overtorqueing and deforming the studs.
- You may need to turn the airbag to the left or right with in the mounting bracket to access the center nut.

Socket Driver

**These tools cause overtightening !**

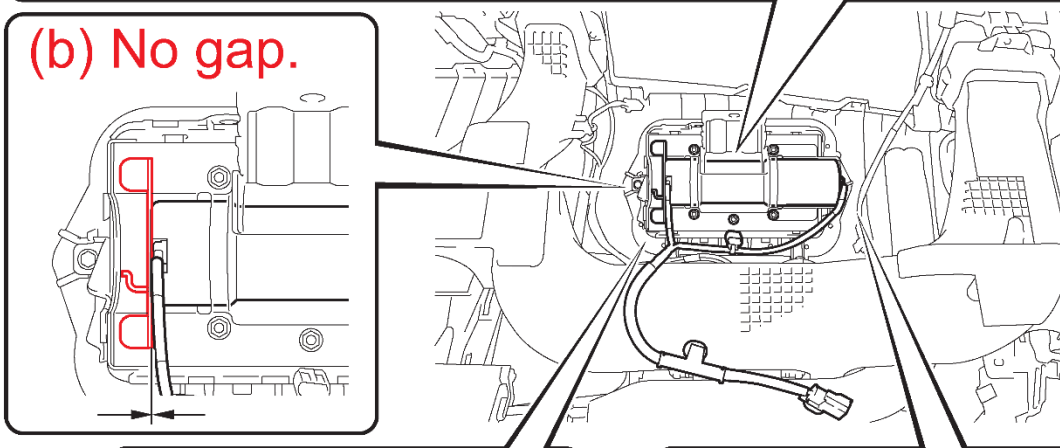
(b) No gap.

- If any gaps exist, the flats may move apart and could result in abnormal operation during airbag deployment.

- a) Confirm the **NEW** inflator and 5 **NEW** nuts have been installed.
- b) Confirm the position of the inflator and position determining plates are correct.
- c) Confirm the routing of the inflator wire harness.
