## TECHNICAL INSTRUCTIONS FOR SAFETY RECALL GLG/GLH and HLA

### FRONT PASSENGER AIRBAG INFLATOR REPLACEMENT CERTAIN 2006 – 2013 MY IS 250/350 and 2008 – 2013 MY IS F

#### UPDATE 6-14-18

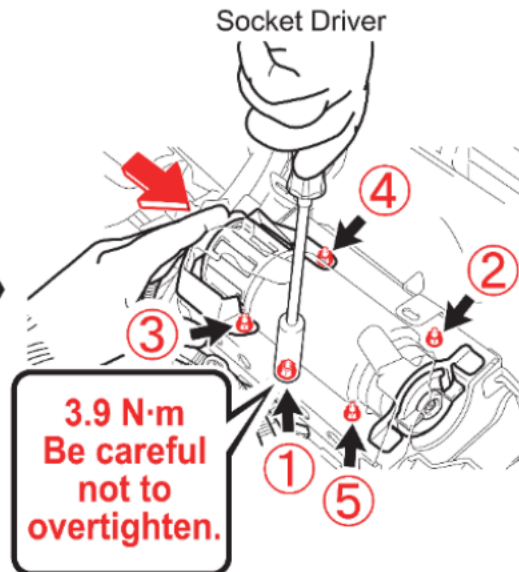
R1701260011Z01

- j) Tighten the 5 nuts evenly in several increments in the sequence shown. Use a socket driver or torque wrench to tighten the nuts.

- There will be some resistance when tightening the nuts because they are self-locking, confirm the nuts are tightened correctly.
- **DO NOT** use a power tool, T-handle, or ratchet when tightening the nuts to avoid over torqueing and deforming the studs.
- You may need to slide the airbag to the left or right with in the mounting bracket to access the center nut.

**OK**

No gap between plate and inflator.

**NG**

**Too Tight!**

**These tools cause overtightening !**
