### SAFETY RECALL GLG/GLH and HLA

### FRONT PASSENGER AIRBAG MODULE

**CERTAIN 2006 – 2013 MY IS 250/350 and 2008 – 2013 MY IS F**

**Updated 4-18-18**

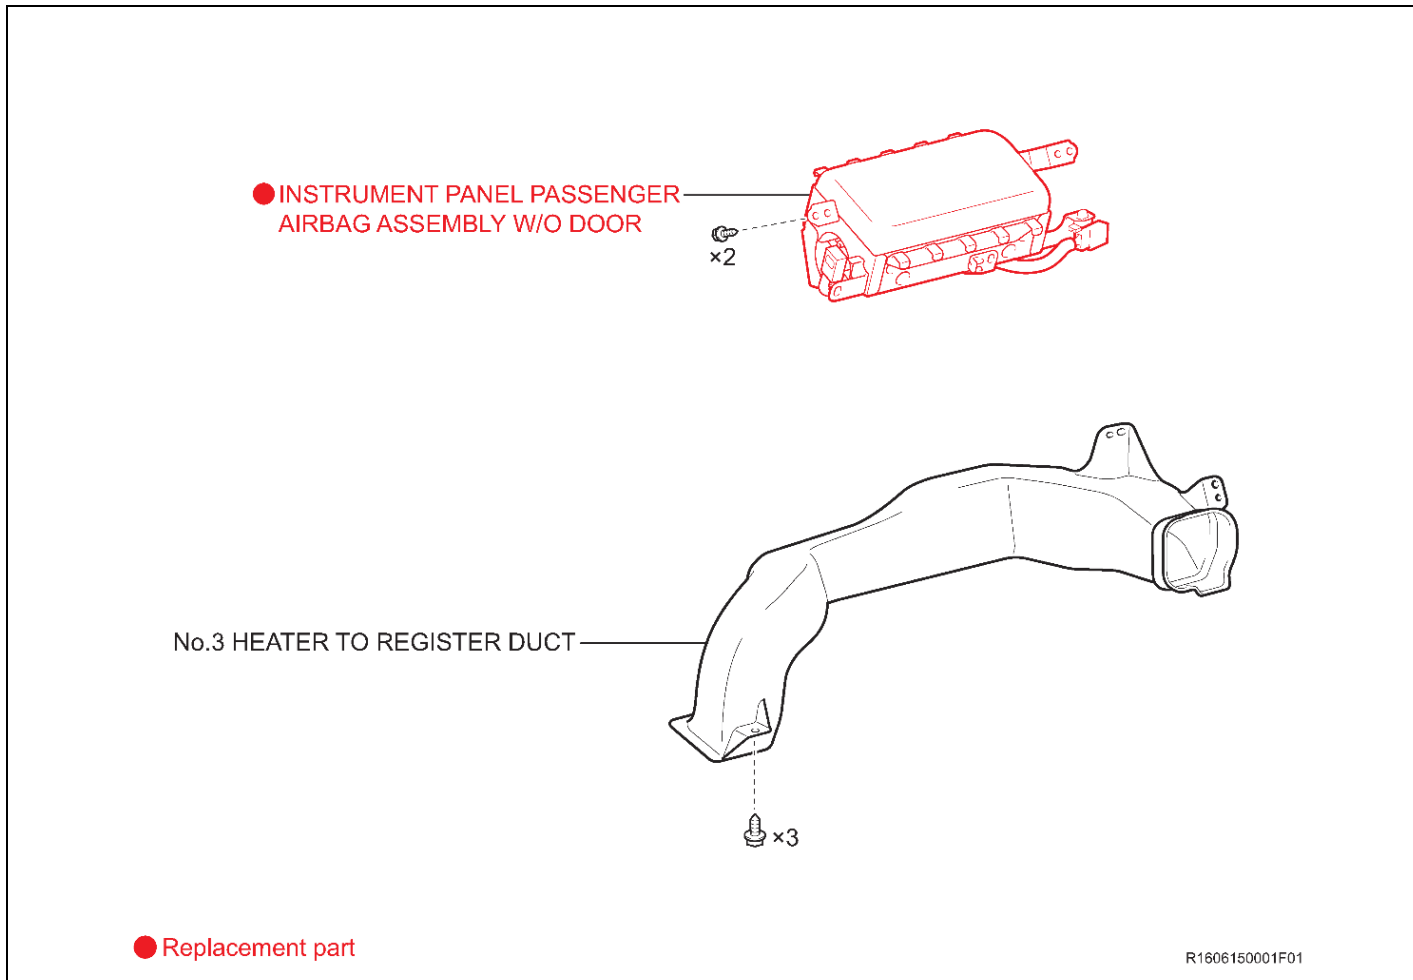
- a) Remove the 3 screws and the side defroster nozzle.
- b) Remove the 2 screws and the heater to register duct.

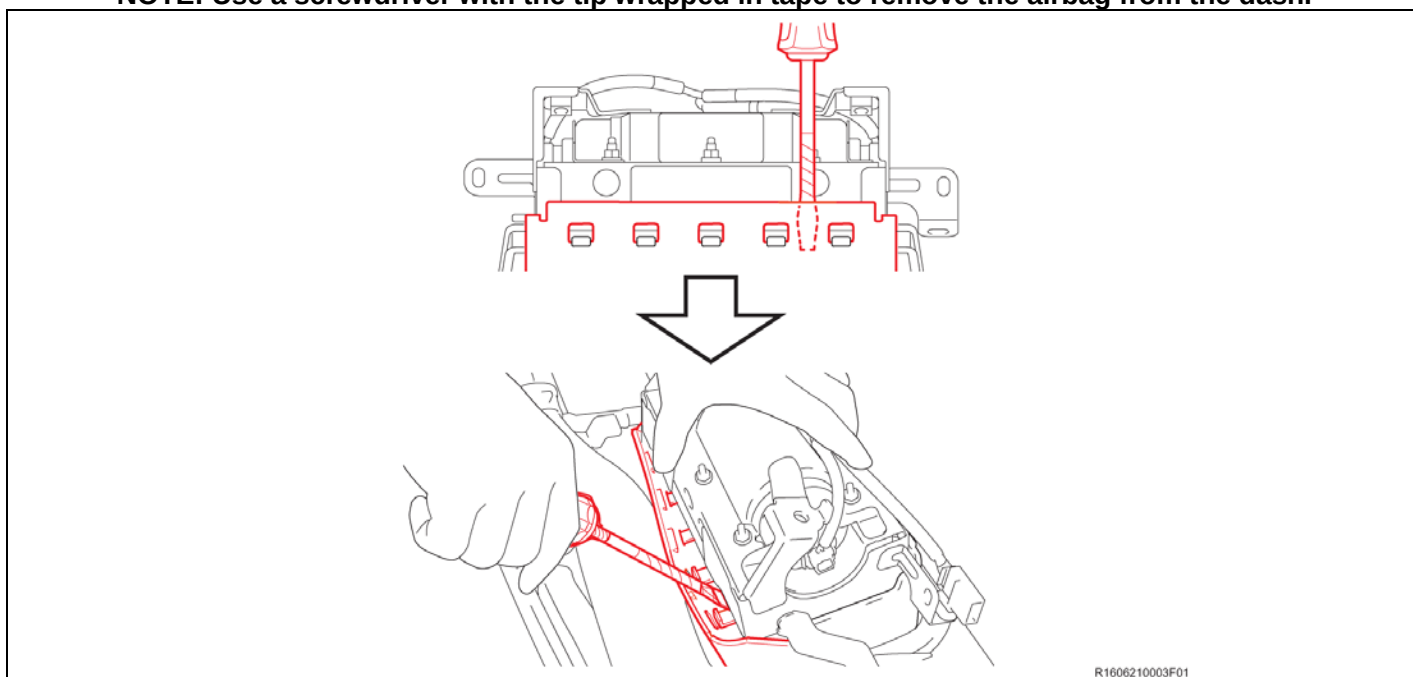
- c) Remove the 4 bolts, disengage the straps, and then remove the airbag assembly.

**NOTE: Use a screwdriver with the tip wrapped in tape to remove the airbag from the dash.**

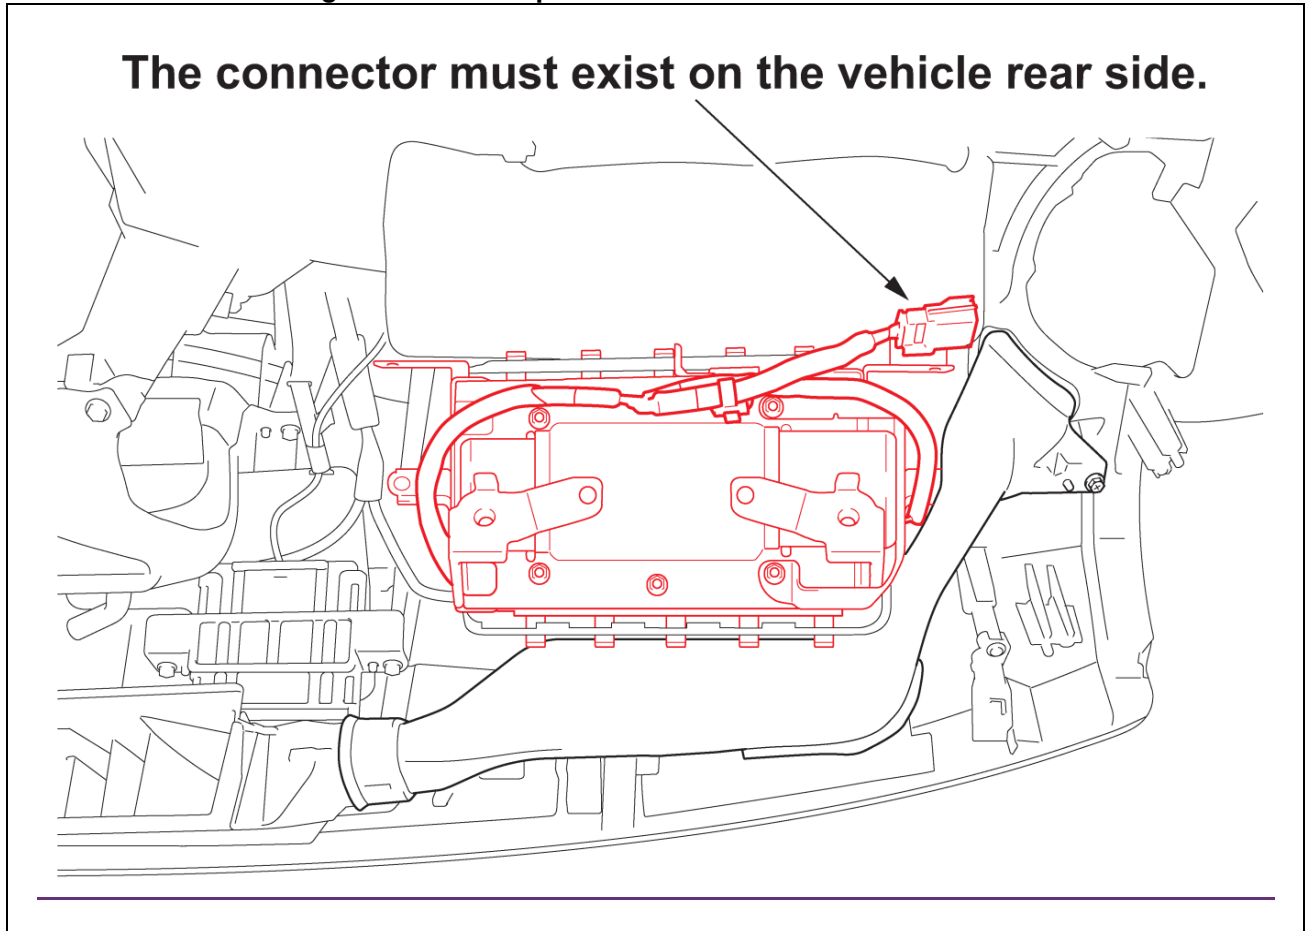
- a) Position the airbag assembly in the instrument panel, engage the straps, and then install the 4 bolts.

**NOTE:** Ensure the airbag connectors is positioned as shown
