# TECHNICAL INSTRUCTIONS FOR SAFETY RECALL GLG/GLH/HLA FRONT PASSENGER AIRBAG MODULE CERTAIN 2010-2017 MY GX 460 **UPDATED 1-15-2019**

## II. BACKGROUND

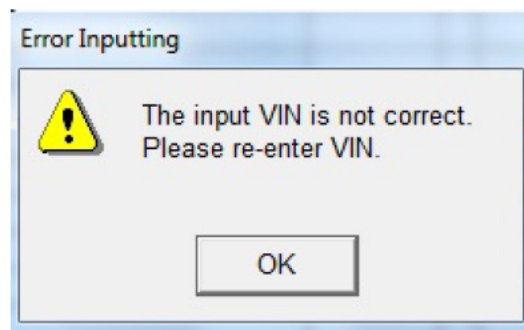
- After the health check has completed, run a diagnostic report by clicking on the link on the health check screen.

**NOTE: If the VIN was not entered in ALL CAPS when Techstream was launched, an error will be displayed and there will be a prompt to reenter the VIN**

- Enter the vehicle mileage and repair order information, then click the 'report' button.

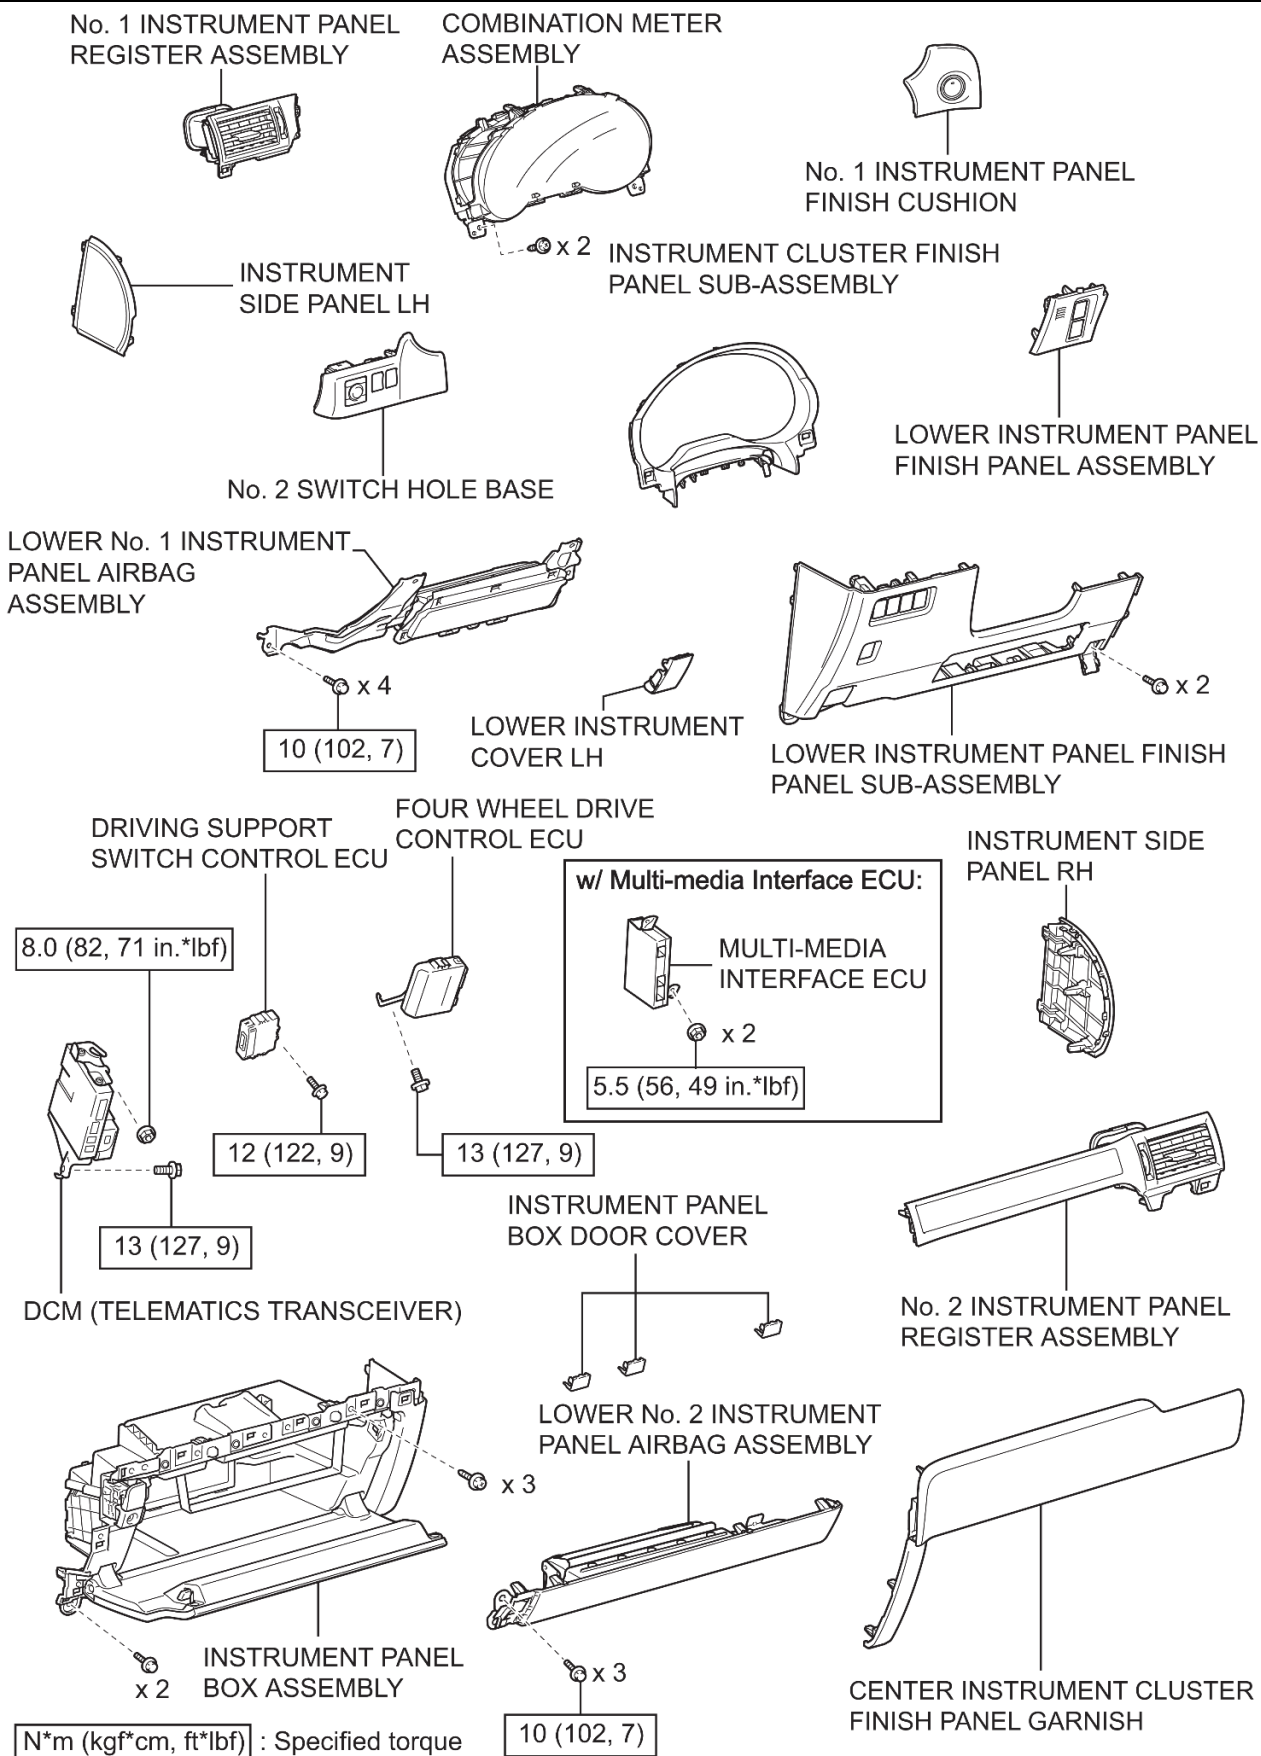
## VII. FRONT PASSENGER AIRBAG REMOVAL COMPONENTS

N\*m (kgf\*cm, ft\*lbf) : Specified torque

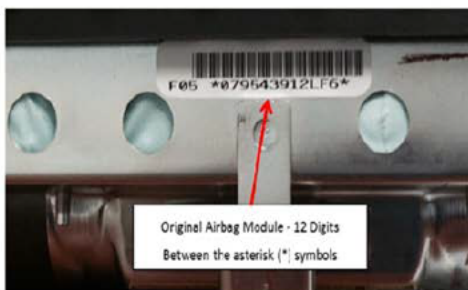
#### Airbag Serial Number Label Example

- The airbag serial number is **ALWAYS** the 12 **DIGITS** located between the asterisks.
- The 3 digits before the asterisk **ARE NOT** part of the serial number, and **SHOULD NOT** be entered or an inaccurate response may be returned.

The Airbag module Assembly serial number is a 12 digit code. It can be found along with a bar code on opening the Airbag assembly unit. To manually enter these details into the application, the technician has to identify the 12 digit code between two Asterisks (\*) inside the Airbag assembly unit. The first seven characters of this 12 digit code are numbers and the 10<sup>th</sup> digit is either 'K' or 'L' always.

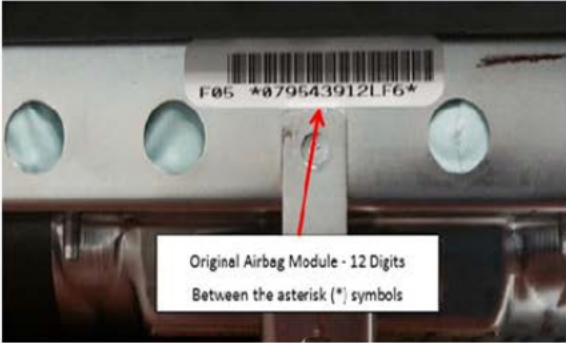
Original Airbag Module - 12 Digits  
Between the asterisk (\*) symbols

The Airbag module Assembly serial number is a **12 digit code**. It can be found along with a bar code on opening the Airbag assembly unit. To manually enter these details into the application, the technician has to identify the 12 digit code between two Asterisks (\*) inside the Airbag assembly unit. The first seven characters of this 12 digit code are numbers and the 10<sup>th</sup> digit is either 'K' or 'L' always.

e) Scan the **NEW** Airbag barcode in the Serial Number Recording Application.

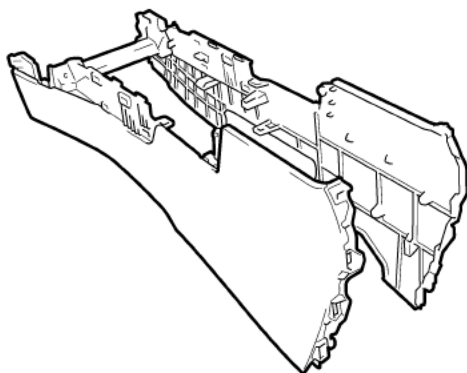
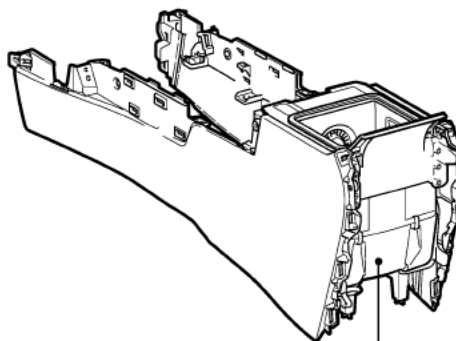
R1703300004

NOTE: The trim around the cool box can be removed and installed without disconnecting the refrigerant lines.

# OK

# NG

Leave the cooling box on the vehicle.

COOLING BOX

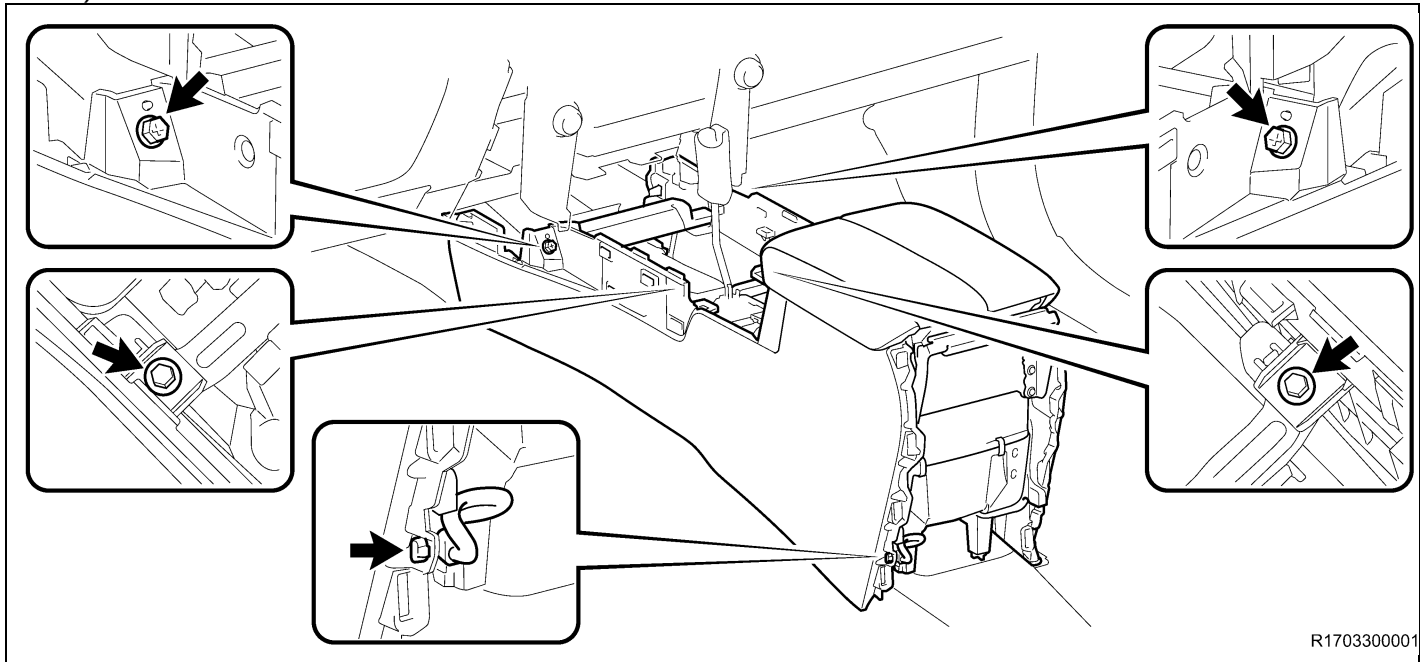
R1703300001

- g) Reengage the clamp.
- h) Reinstall the 2 bolts and 2 screws.
