### SAFETY RECALL GLG/GLH and HLA

### FRONT PASSENGER AIRBAG MODULE

**CERTAIN 2006 – 2013 MY IS 250/350 and 2008 – 2013 MY IS F**

**Updated 1-9-18**

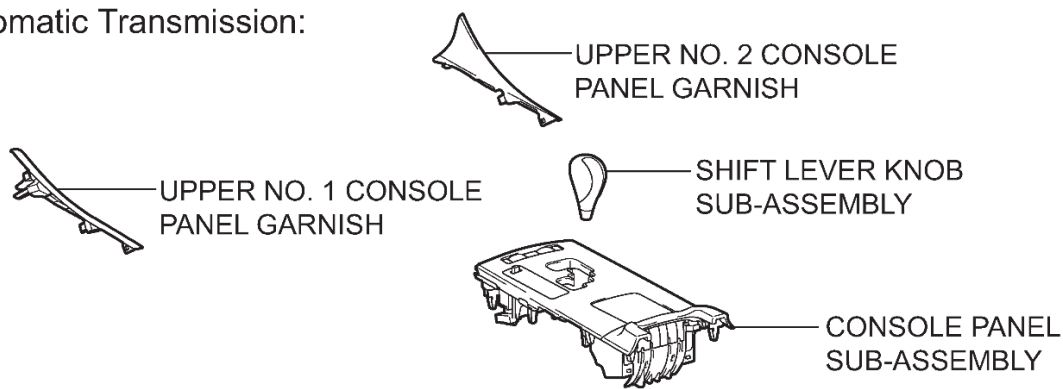
for Automatic Transmission:

**VII. FRONT PASSENGER AIRBAG REMOVAL**  
**COMPONENTS**

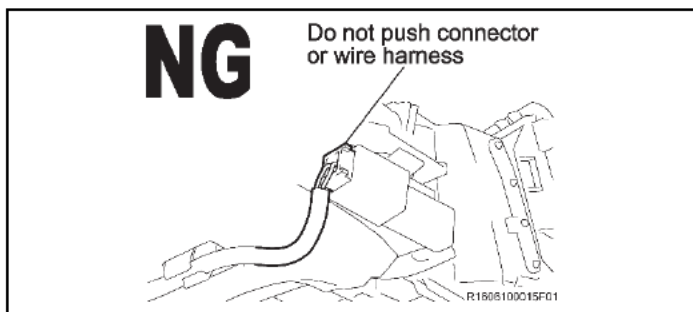
### Removing the No. 3 air register

Remove any peripheral parts on left and right side of the register to allow access to the back of the register.

Wrap the tip of a screwdriver with tape.

Lock the 4 claws inside the register as shown.

**NOTE:** Do not use a molding removal tool to remove the register it could be damaged.

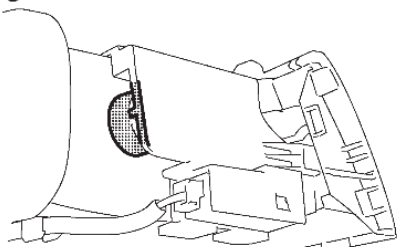
Back side of part manufactured  
before August 2008:

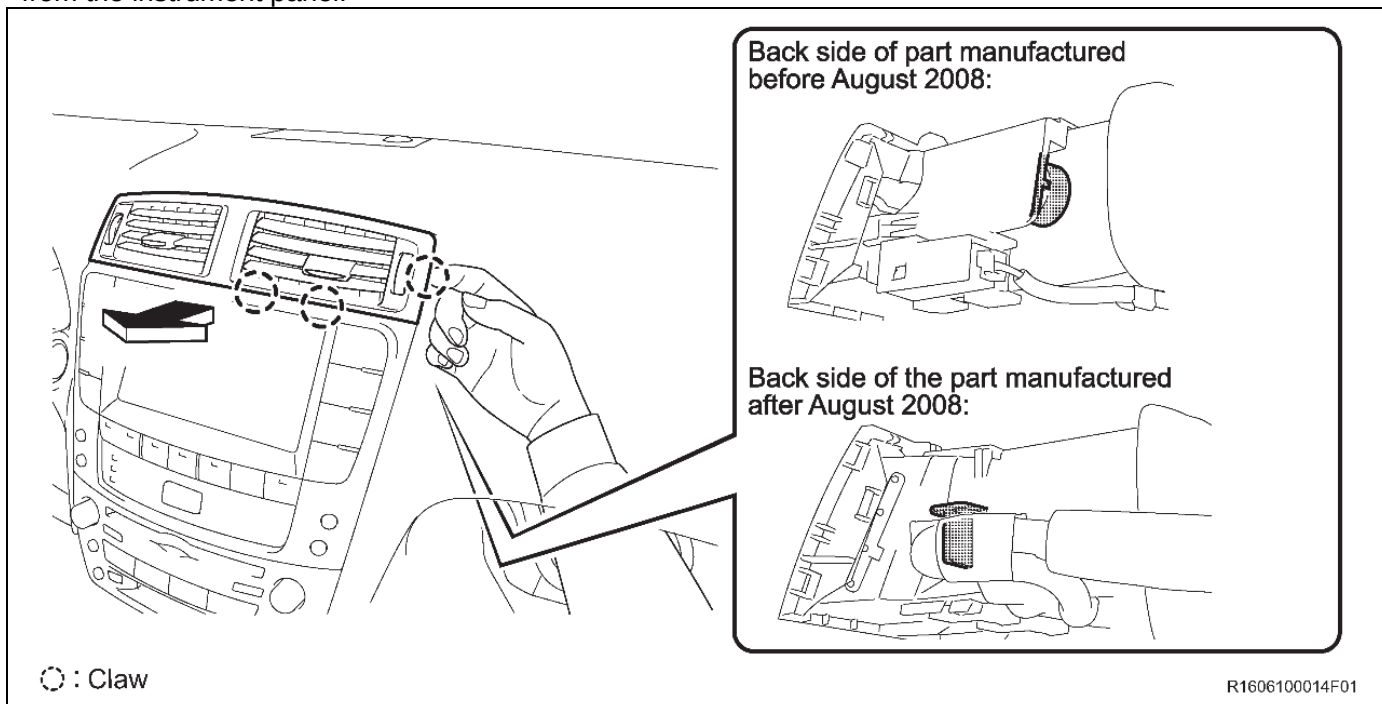
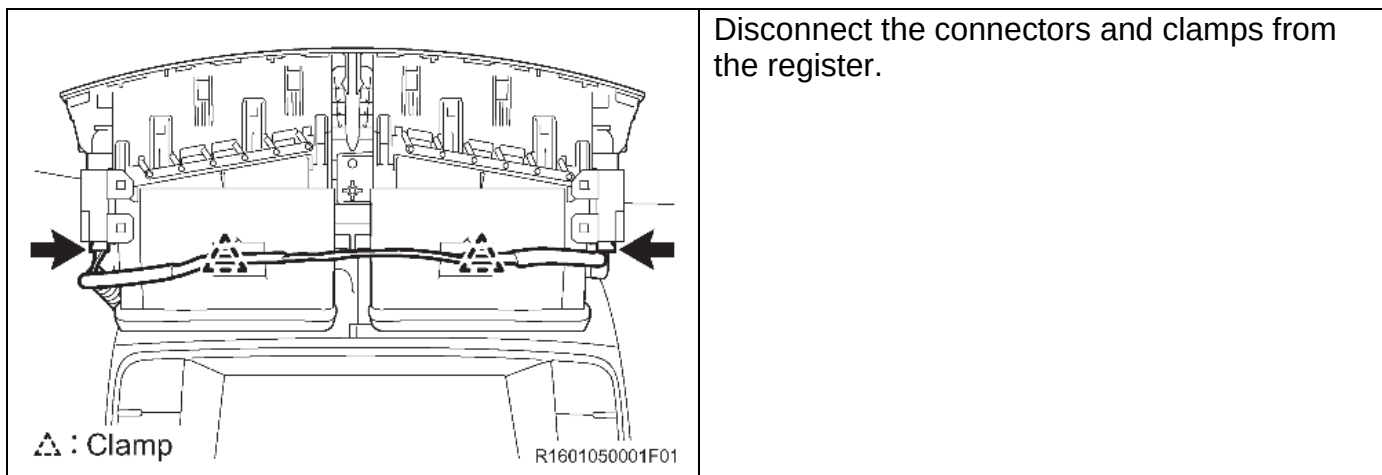
Using your finger on the right side push out at the point shown to disengage the 3 claws and remove the register from the instrument panel.

**NOTE: DO NOT** contact the positioning tabs while removing the instrument panel as the panel could be damaged.

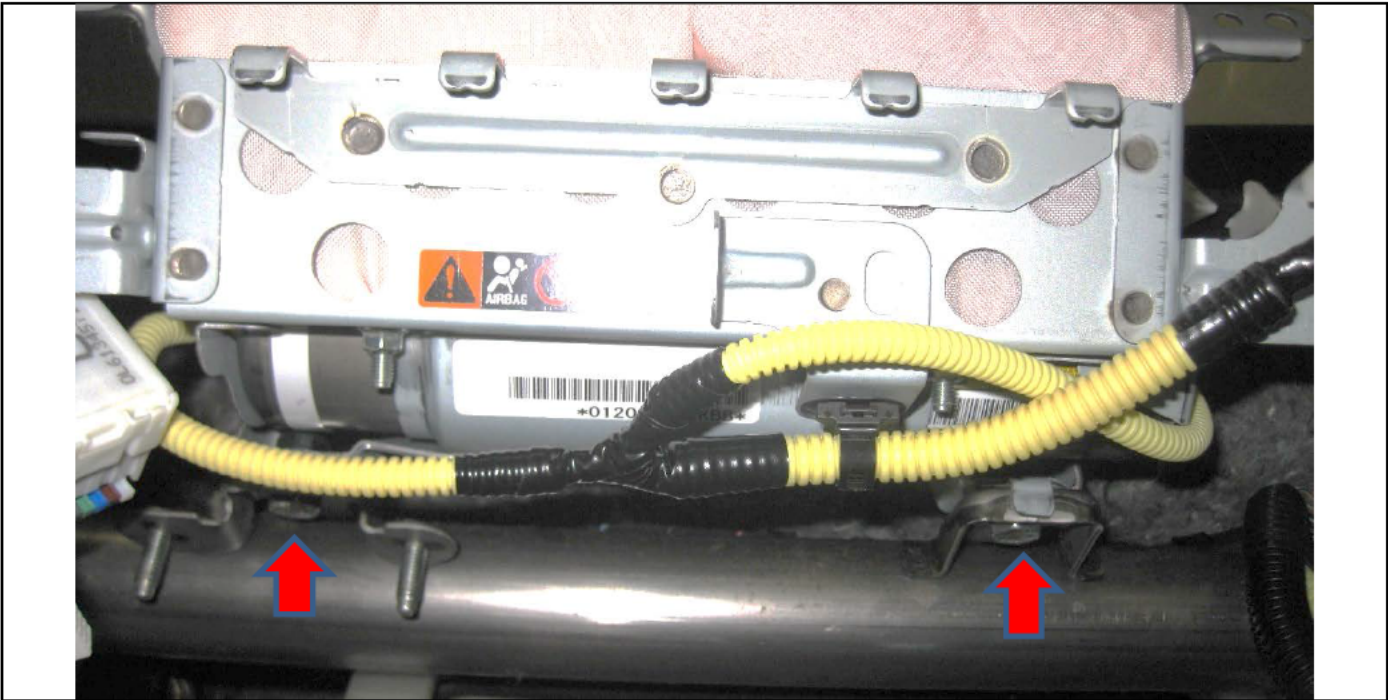
During dash removal, discard the 2 bolts that attach the airbag to the cross tube.  
NEW bolts will be installed during reassembly.

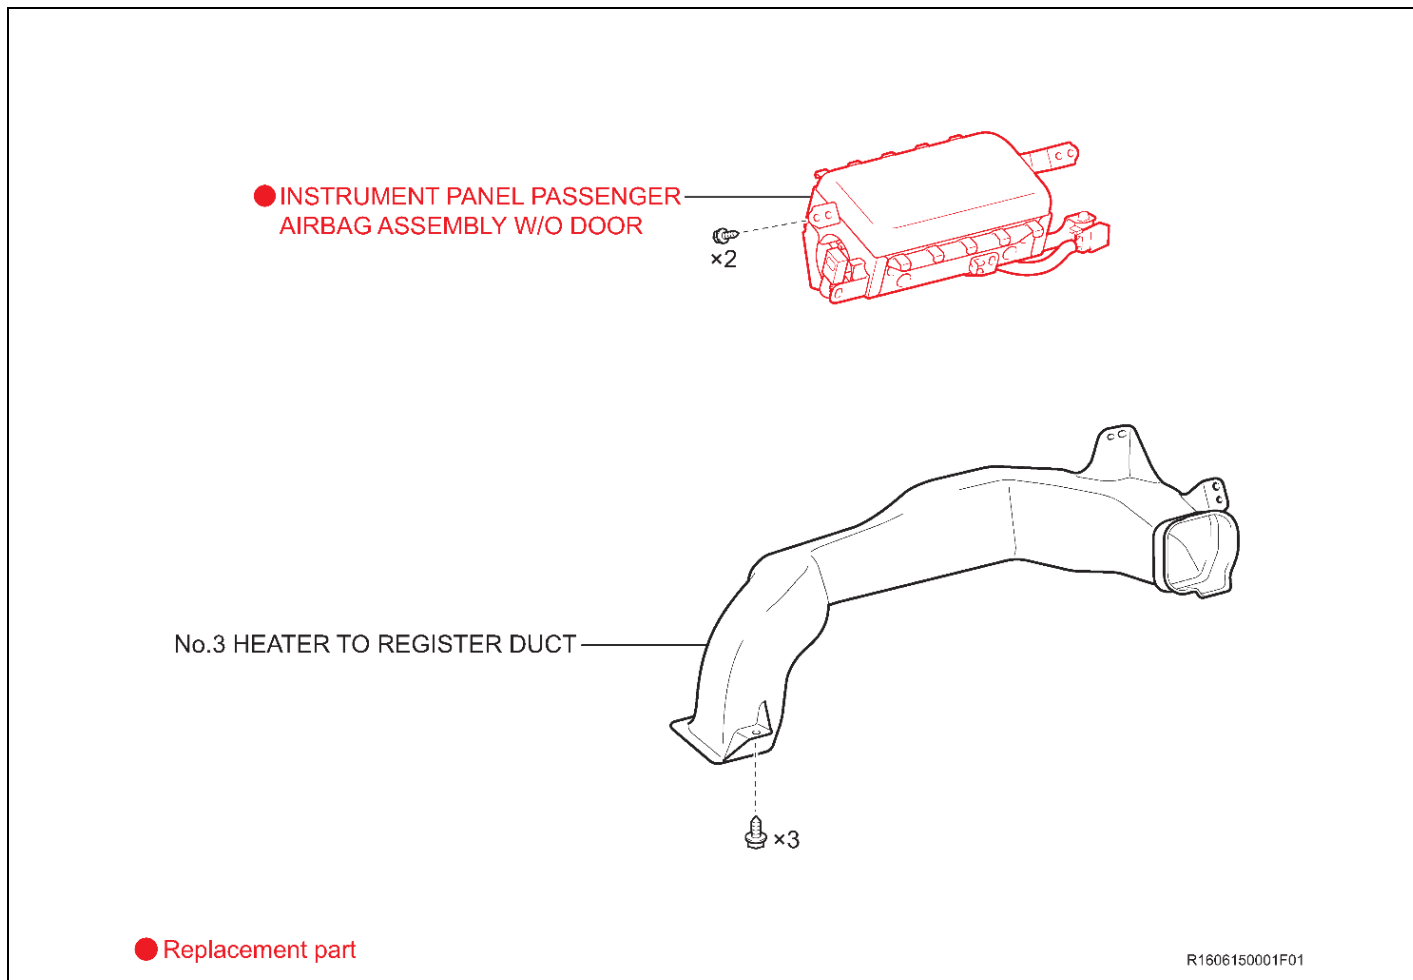
### 3. REMOVE THE AIRBAG FROM THE DASH

- a) Remove the 3 screws and the side defroster nozzle.
- b) Remove the 2 screws and the heater to register duct.

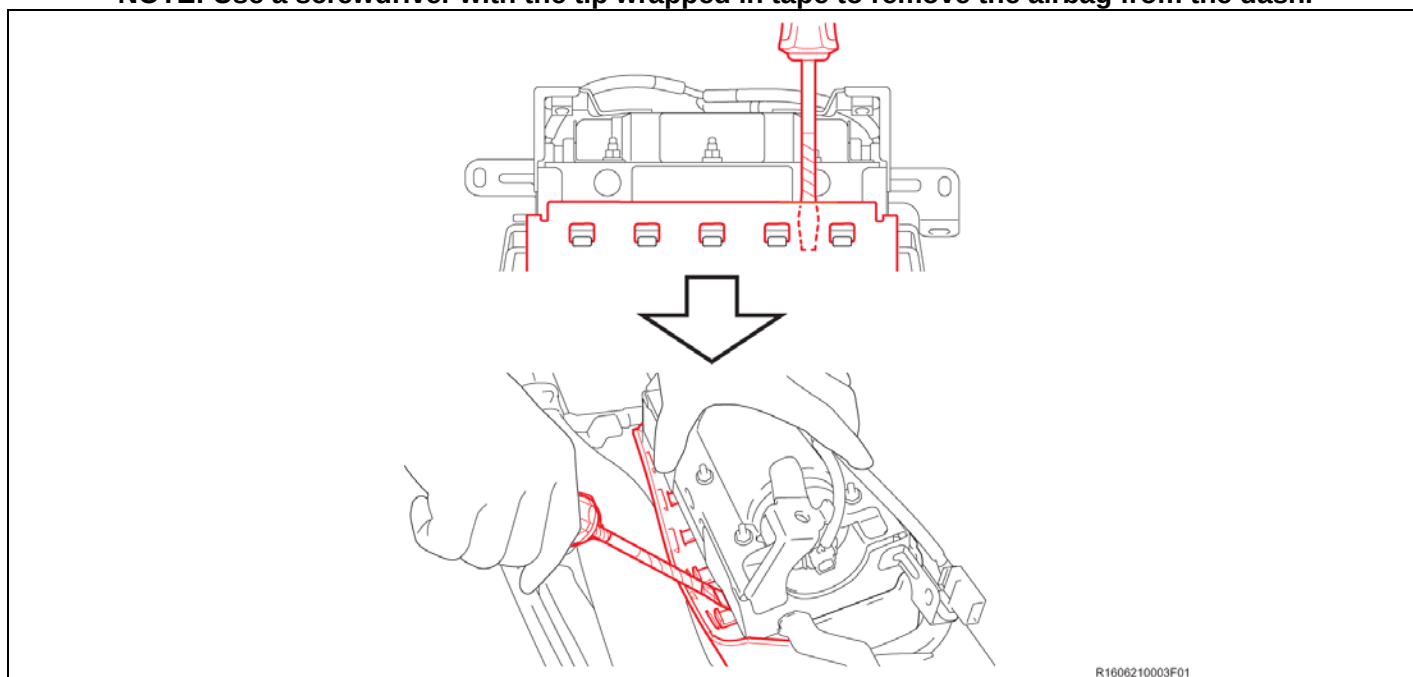
- c) Remove the 4 bolts, disengage the straps, and then remove the airbag assembly.

**NOTE: Use a screwdriver with the tip wrapped in tape to remove the airbag from the dash.**

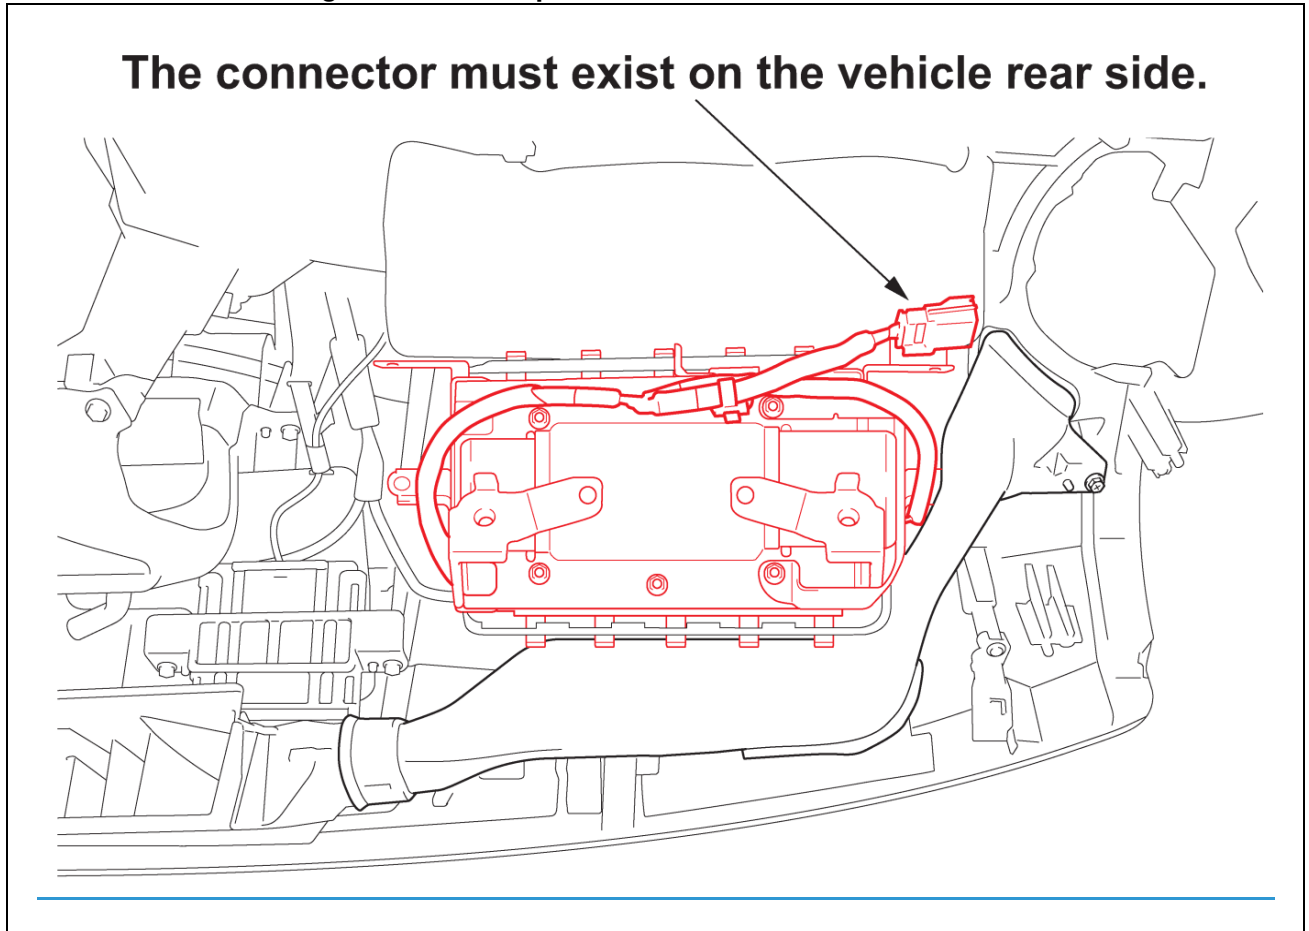
- a) Position the airbag assembly in the instrument panel, engage the straps, and then install the 4 bolts.

**NOTE:** Ensure the airbag connectors is positioned as shown

- b) Install the 2 screws and the heater to register duct.
- c) Install the 3 screws and the side defroster nozzle.
