**TECHNICAL INSTRUCTIONS
FOR
SAFETY RECALL G0P
FRONT PASSENGER AIRBAG INFLATOR MODULE
CERTAIN 2010-2011 MY 4Runner**

UPDATE – 8/31/17

The subject vehicles are equipped with front passenger airbag inflators produced by Takata. According to Takata, the propellant in these inflators may degrade after prolonged exposure to high absolute humidity and fluctuating high temperatures. Degraded propellant can cause inflator rupture during airbag deployment. In the event of an inflator rupture, metal fragments could pass through the airbag cushion material, striking the vehicle occupants, and result in serious injury or death.

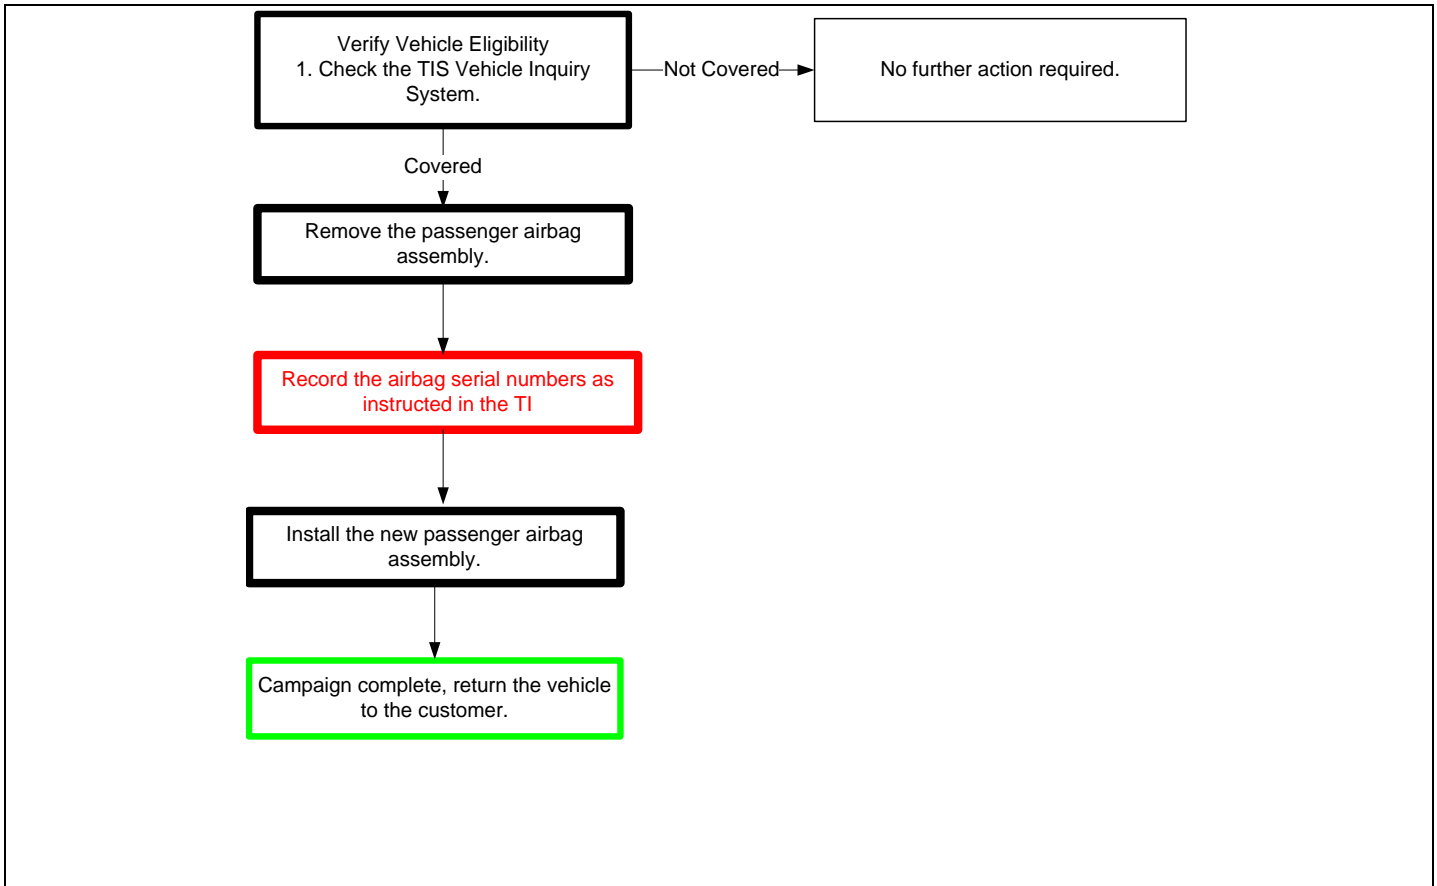
I. OPERATION FLOW CHART

The flow chart is for reference only. **DO NOT** use it in place of the full technical instructions. Follow **ALL** steps as outlined in the full technical instructions to confirm the campaign is completed correctly.

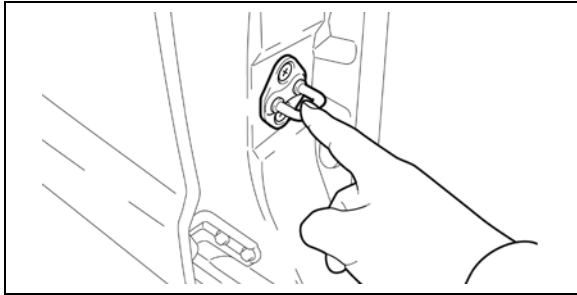
1. ELIMINATE STATIC ELECTRICITY

- a) Before starting work and periodically while working on the vehicle, touch a metallic part of the vehicle to discharge static electricity in the body.

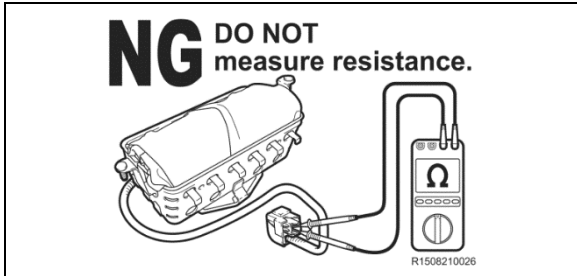
2. DO NOT MEASURE RESISTANCE

- a) **DO NOT** measure resistance of airbag components, this may cause accidental activation.

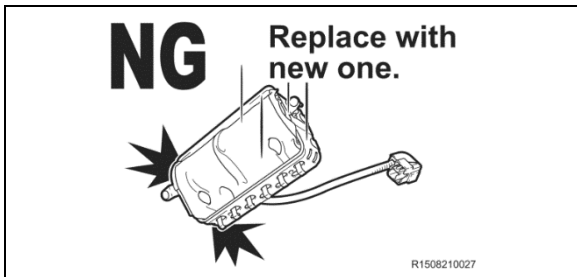
3. HANDLE THE AIRBAG CAREFULLY

- a) If an airbag is dropped, replace it with a **NEW** one.

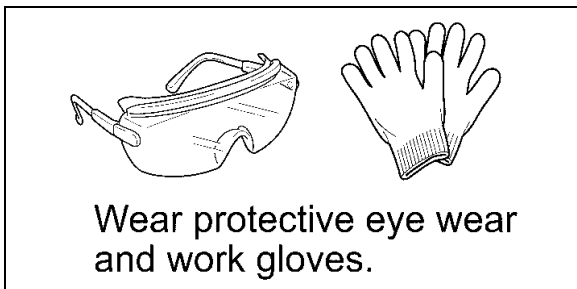
4. WEAR PROTECTIVE EQUIPMENT

- a) Always wear appropriate protective equipment when working on the SRS.

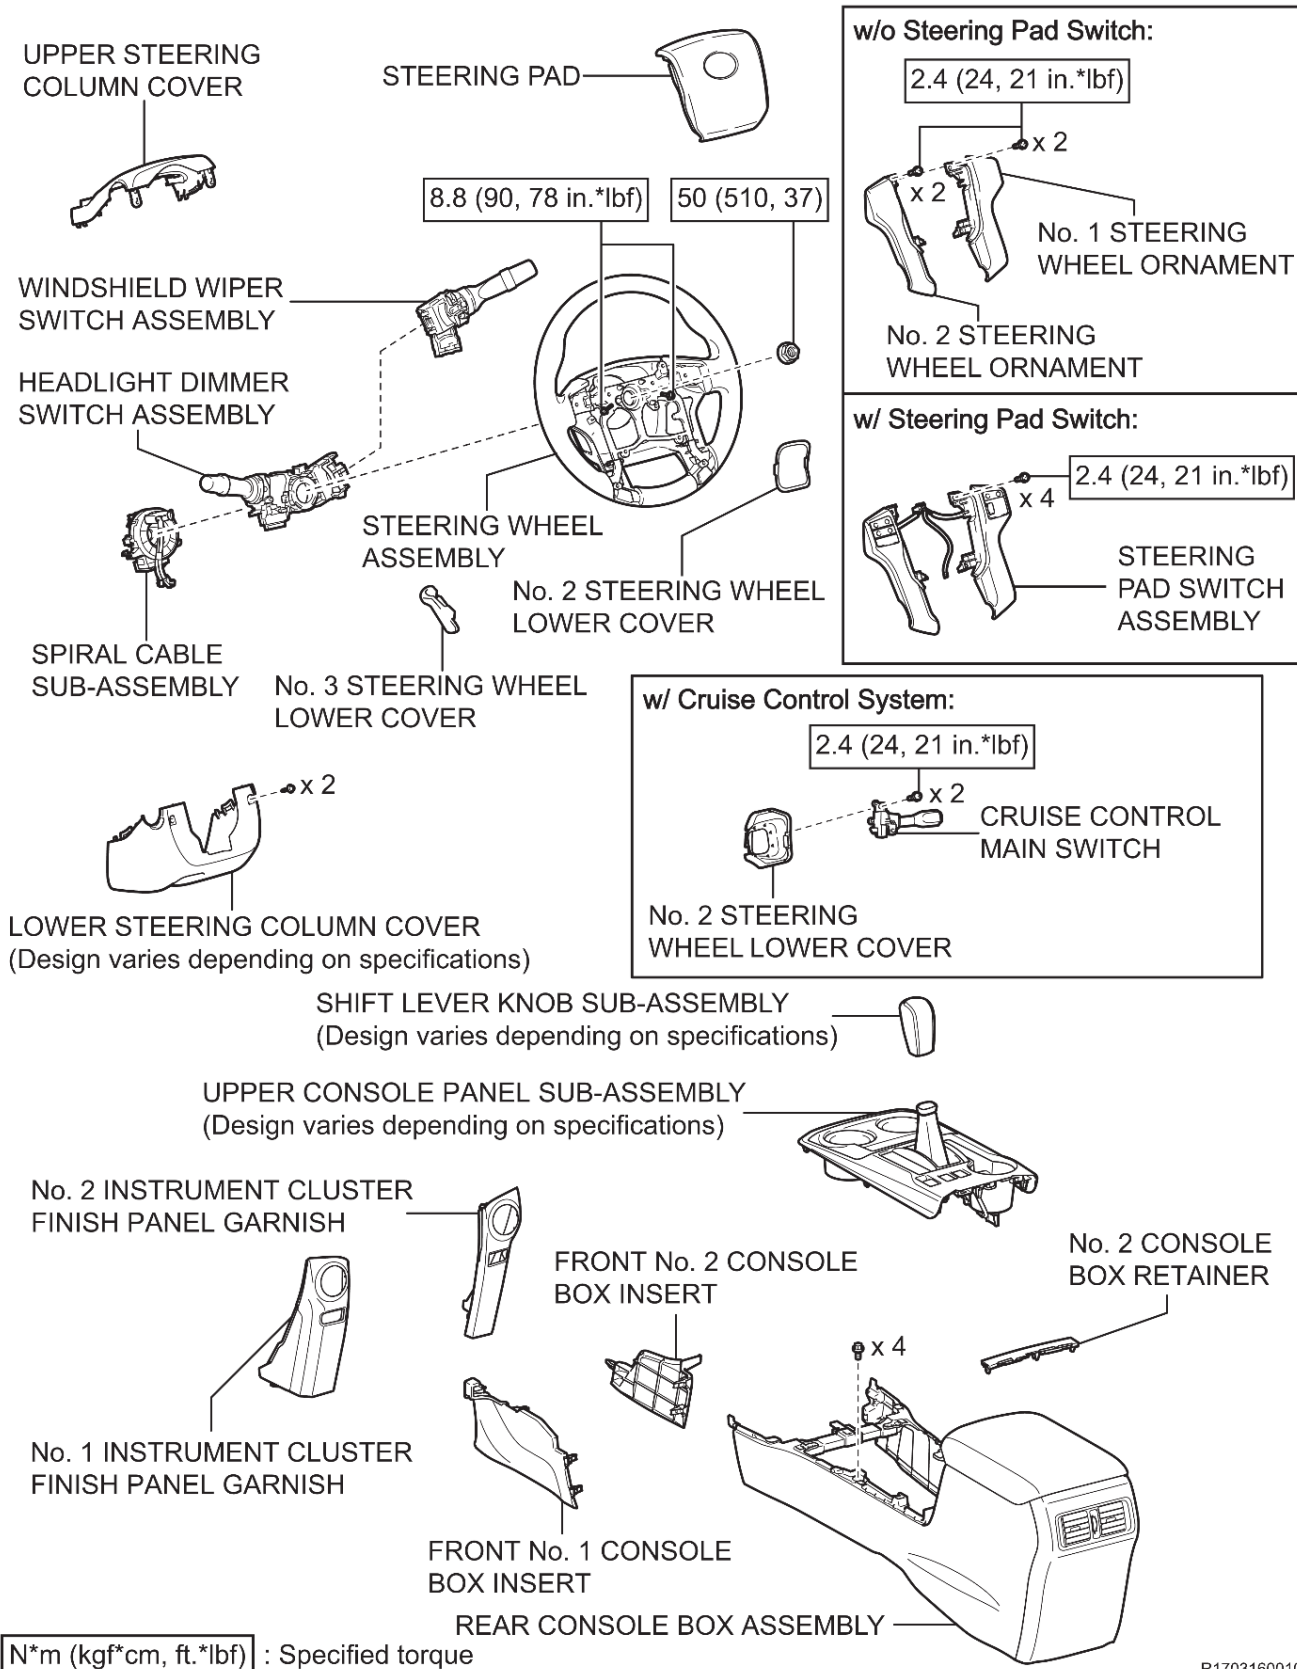
R1703160010

CAUTION-PLASTIC RETAINING CLIPS ARE FRAGILE. REMOVE WITH CARE

FRONT PILLAR
GARNISH RH

FRONT DOOR OPENING TRIM
WEATHERSTRIP RH

COWL SIDE TRIM BOARD RH

DOOR SCUFF PLATE ASSEMBLY RH

Part manufactured
before August 2013:

Part manufactured
after August 2013:

● FRONT PILLAR
GARNISH LH

No. 1 FRONT PILLAR
GARNISH COVER LH

FRONT PILLAR
GARNISH LH

FRONT DOOR OPENING TRIM
WEATHERSTRIP LH

COWL SIDE TRIM BOARD LH

DOOR SCUFF PLATE ASSEMBLY LH

● Replacement part

NOTE: The left front A-Pillar garnish needs to be replaced on vehicles manufactured prior to August 2013. Only one garnish is required per vehicle depending upon color code. The kit contains the garnish and the non-reusable clip. (see parts information)

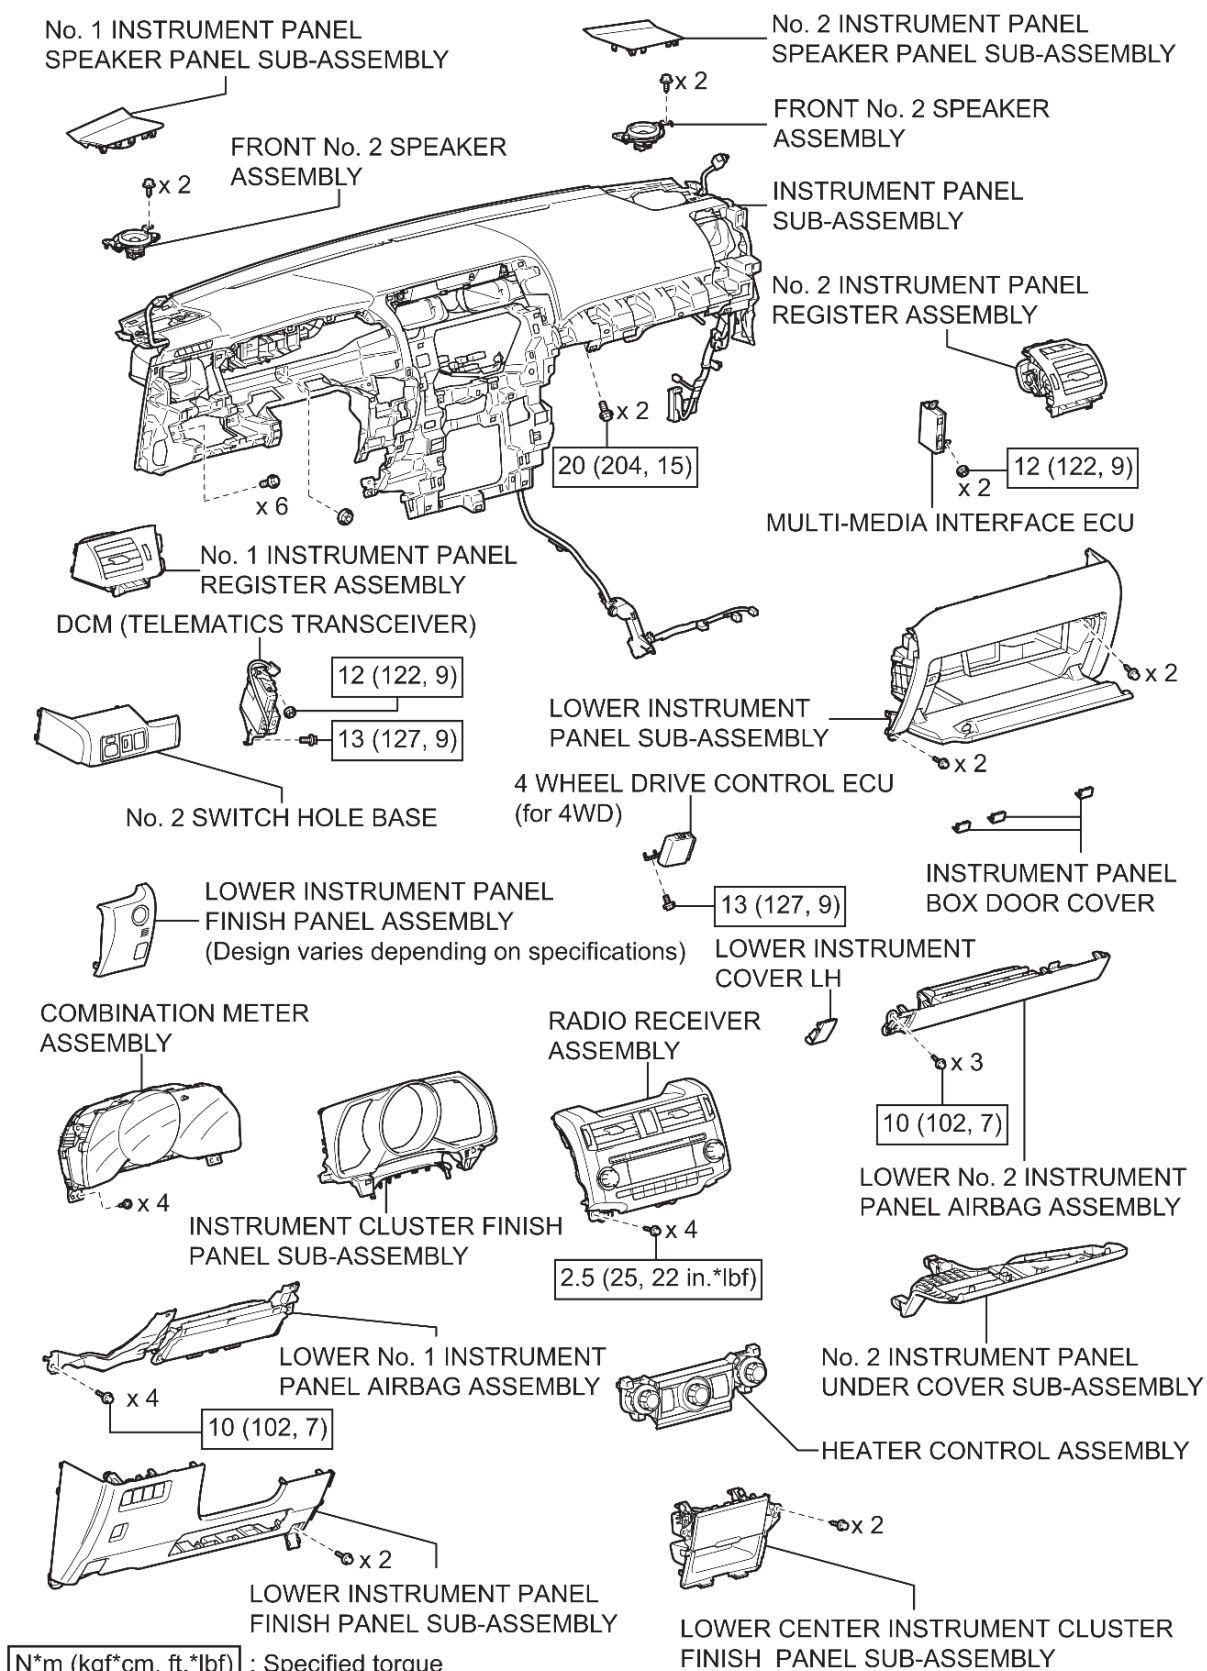
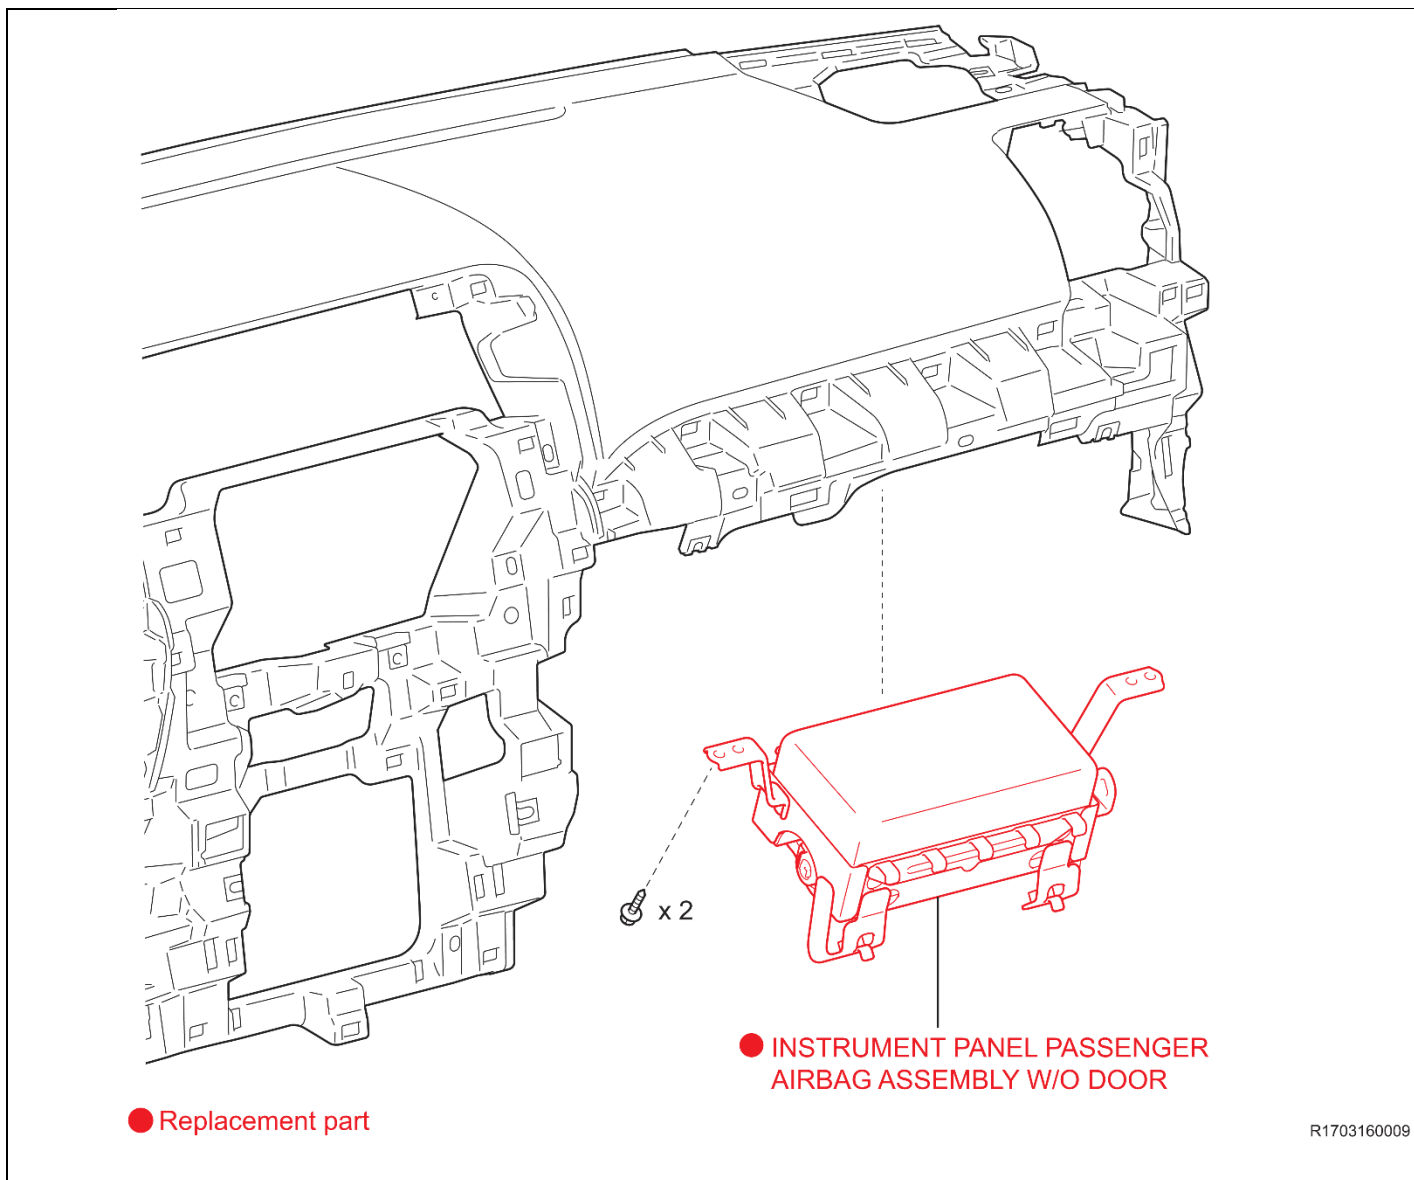
R1703160011

CAUTION-PLASTIC RETAINING CLIPS ARE FRAGILE. REMOVE WITH CARE

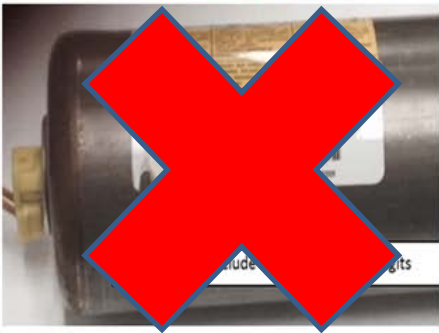
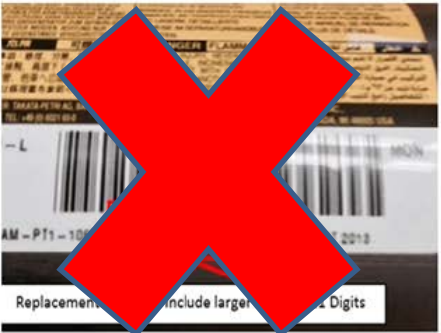
Original Inflator

Replacement Inflator

How to Identify the Inflator serial code on the Original and Replacement Inflator can?

The Inflator serial code is an 11 digit code on the Inflator can. It can be found with a bar code on removing the Inflator can from the Airbag Assembly unit.

The first two characters of the Original Inflator Serial code will be from [AA, AB, AJ, FD or JD].

The first two characters of the Replacement Inflator Serial code will be either 'LT' or 'LR'.

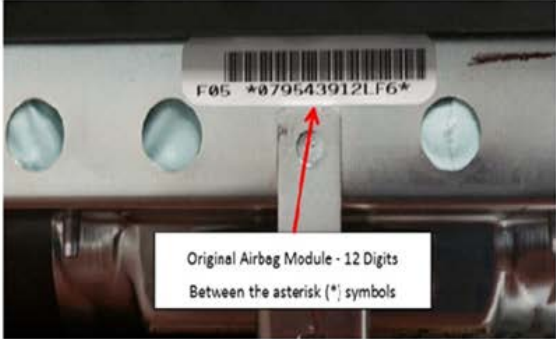
a) If the airbag serial number cannot be scanned or is not present check the box as shown below.

Check this box if the label is damaged or missing

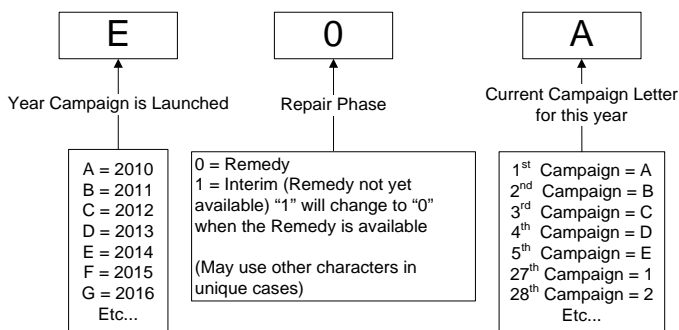
A. CAMPAIGN DESIGNATION DECODER

Examples:

A0D = Launched in 2010, Remedy Phase, 4th Campaign Launched in 2010

B1E = Launched in 2011, Interim Phase, 5th Campaign Launched in 2011

C1C = Launched in 2012, Interim Phase, 3rd Campaign Launched in 2012
