# IMPORTANT UPDATE

## TECHNICAL INSTRUCTIONS FOR SAFETY RECALL G0R FRONT PASSENGER AIRBAG INFLATOR MODULE CERTAIN 2010 MY 4RUNNER

### UPDATE 7-17-18

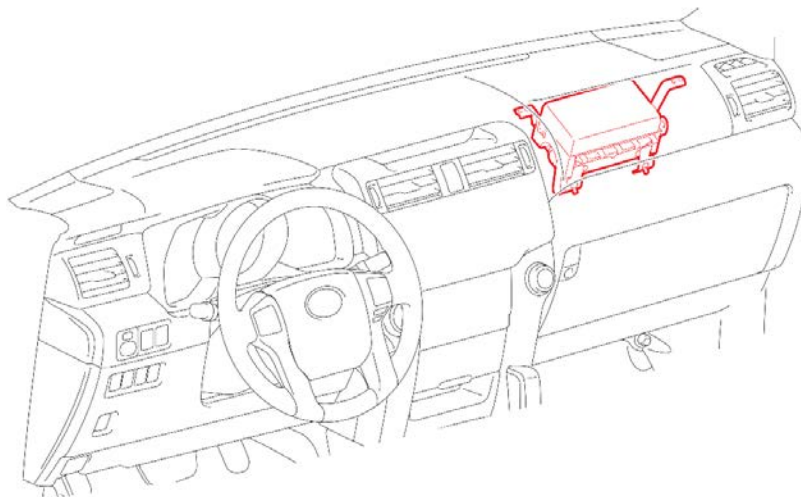
R1703160006A01

The subject vehicles are equipped with front passenger airbag inflators produced by Takata. According to Takata, the propellant in these inflators may degrade after prolonged exposure to high absolute humidity and fluctuating high temperatures. Degraded propellant can cause inflator rupture during airbag deployment. In the event of an inflator rupture, metal fragments could pass through the airbag cushion material, striking the vehicle occupants, and result in serious injury or death.

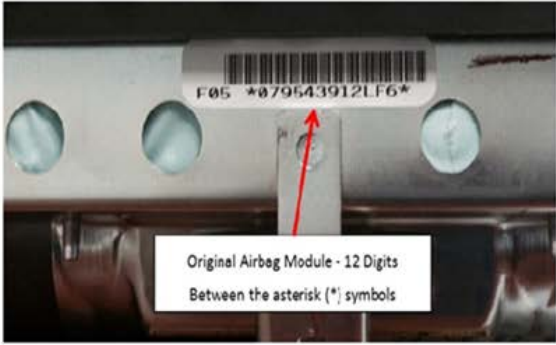
a) If the airbag serial number cannot be scanned or is not present check the box as shown below.

Check this box if the label is damaged or missing
