# TECHNICAL INSTRUCTIONS FOR SAFETY RECALL G0R FRONT PASSENGER AIRBAG INFLATOR MODULE CERTAIN 2008 - 2010 MY SCION xB

**UPDATED 4-18-2018**

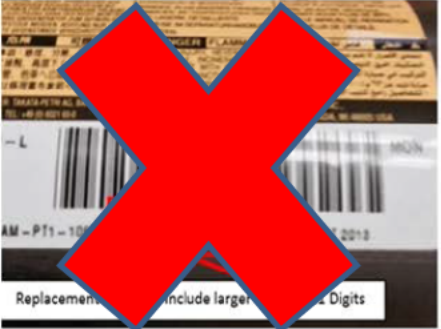
**Replacement Inflator**

The Inflator serial code is an 11 digit code on the Inflator can. It can be found with a bar code on removing the Inflator can from the Airbag Assembly unit.

The first two characters of the Replacement Inflator Serial code will be either 'LT' or 'LR'.

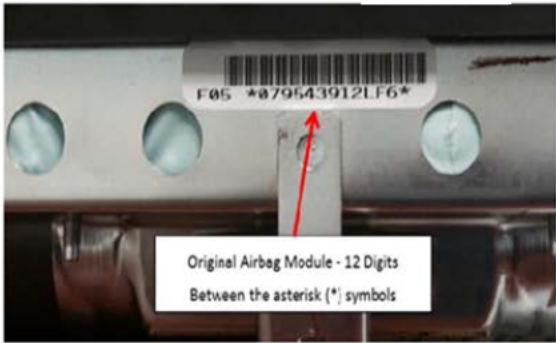
Original Airbag Module - 12 Digits  
Between the asterisk (\*) symbols

Check this box if the label is damaged or missing

a) If the airbag serial number cannot be scanned or is not present check the box as shown below.
