## TECHNICAL INSTRUCTIONS FOR SAFETY RECALL GLG FRONT PASSENGER AIRBAG INFLATOR REPLACEMENT CERTAIN 2010-2013 MY IS 250/350 CONVERTIBLE

**UPDATED 4-18-2018**

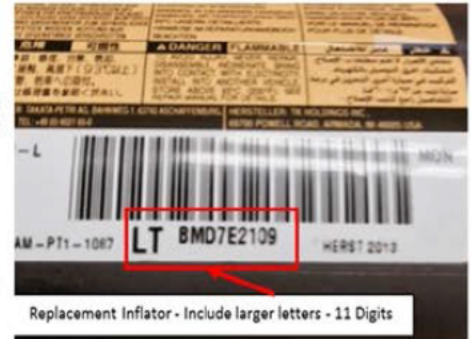
The first two characters of the Replacement Inflator Serial code will be either 'LT' or 'LR'.

Replacement Inflator - Include larger letters - 11 Digits
