**TECHNICAL INSTRUCTIONS**  
**FOR**  
**SAFETY RECALL GLH**  
**FRONT PASSENGER AIRBAG MODULE**  
**CERTAIN 2007 – 2008 MY ES 350**

## II. BACKGROUND

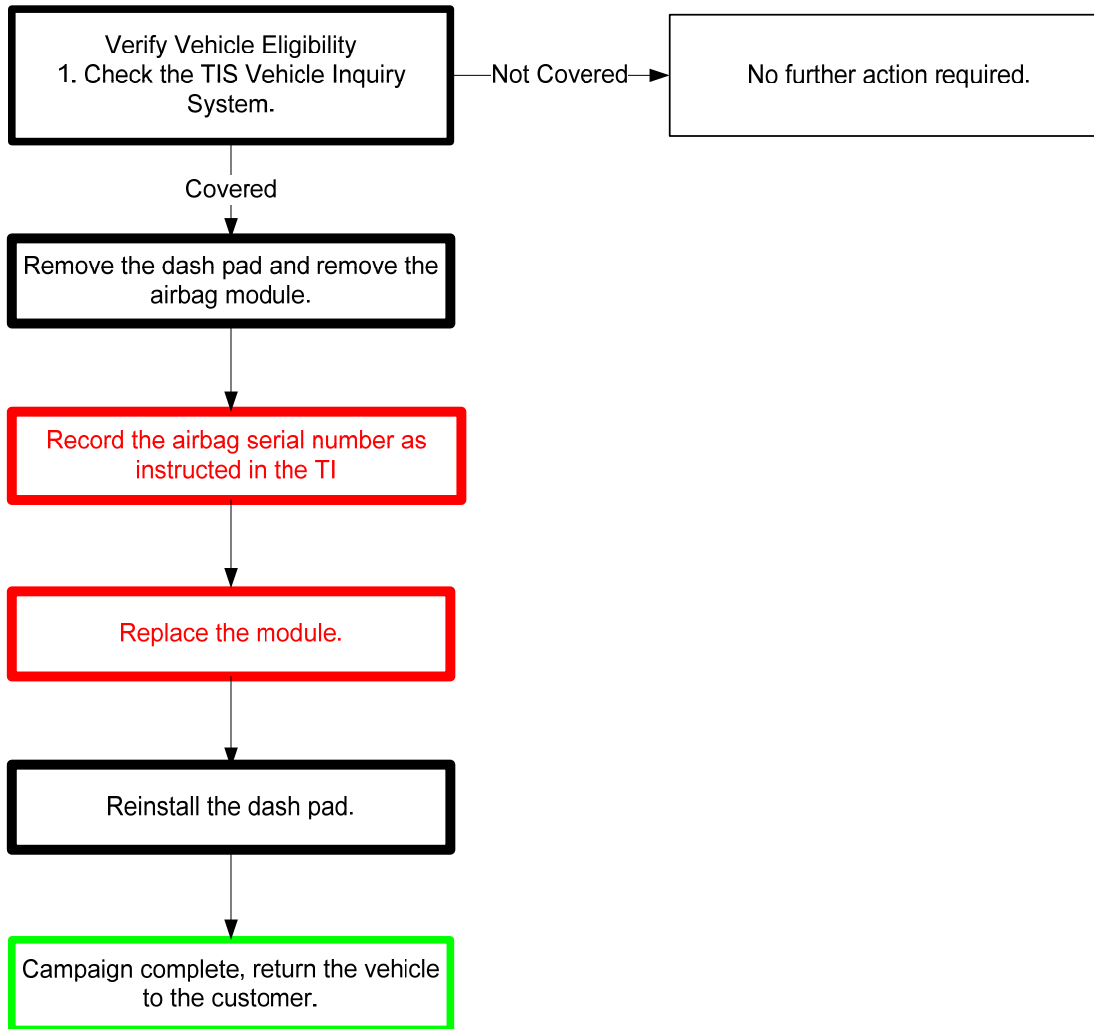
## I. OPERATION FLOW CHART

The flow chart is for reference only. **DO NOT** use it in place of the full technical instructions. Follow **ALL** steps as outlined in the full technical instructions to confirm the campaign is completed correctly.

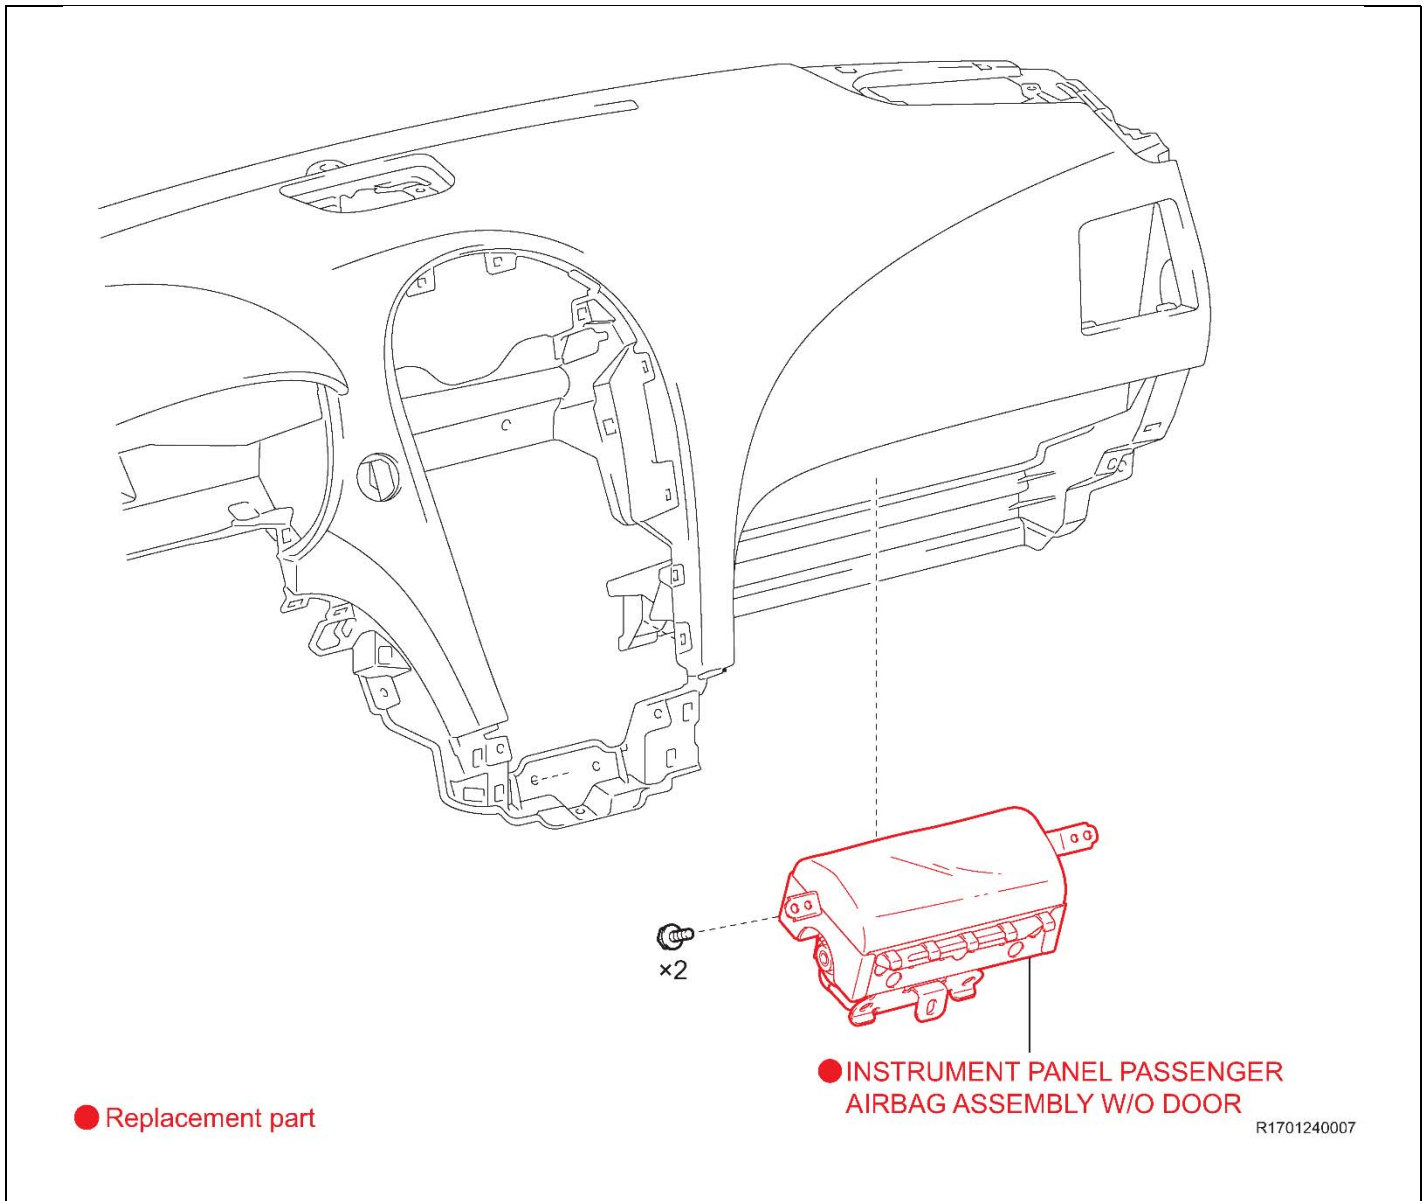
R1701240006

INSTRUMENT PANEL  
SAFETY PAD ASSEMBLY

● Replacement part

N\*m (kgf\*cm, ft\*lbft) : Specified torque

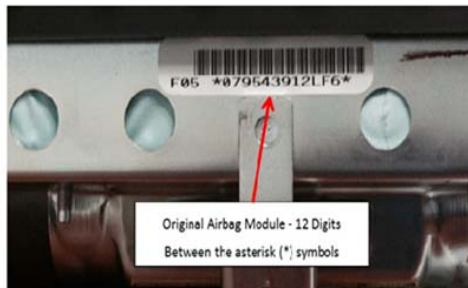
#### Airbag Serial Number Label Example

- The airbag serial number is **ALWAYS** the 12 **DIGITS** located between the asterisks.
- The 3 digits before the asterisk **ARE NOT** part of the serial number, and **SHOULD NOT** be entered or an inaccurate response may be returned.

Original Airbag Module - 12 Digits  
Between the asterisk (\*) symbols

The Airbag module Assembly serial number is a 12 digit code. It can be found along with a bar code on opening the Airbag assembly unit. To manually enter these details into the application, the technician has to identify the 12 digit code between two Asterisks (\*) inside the Airbag assembly unit. The first seven characters of this 12 digit code are numbers and the 10<sup>th</sup> digit is either 'K' or 'L' always.

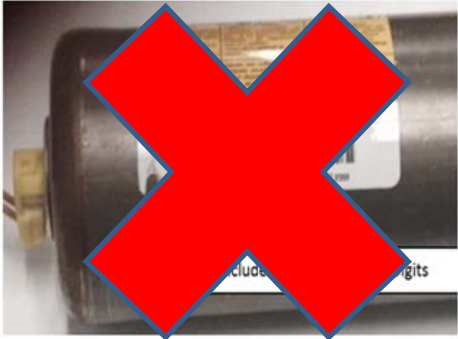
**Original Inflator**

The Inflator serial code is an **11 digit code** on the Inflator can. It can be found with a bar code on removing the Inflator can from the Airbag Assembly unit.

The first two characters of the **Original Inflator Serial code** will be from [AA, AB, AJ, FD or JD].

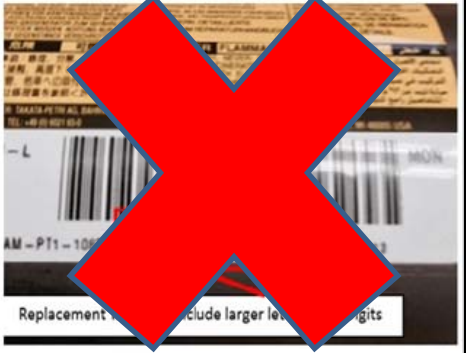
**Replacement Inflator**

The first two characters of the **Replacement Inflator Serial code** will be either 'LT' or 'LR'.

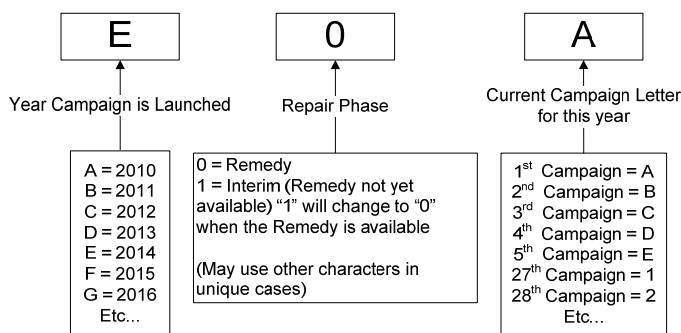
### A. CAMPAIGN DESIGNATION DECODER

Examples:

A0D = Launched in 2010, Remedy Phase, 4<sup>th</sup> Campaign Launched in 2010

B1E = Launched in 2011, Interim Phase, 5<sup>th</sup> Campaign Launched in 2011

C1C = Launched in 2012, Interim Phase, 3<sup>rd</sup> Campaign Launched in 2012
