**TECHNICAL INSTRUCTIONS**  
**FOR**  
**SAFETY RECALL G0S**  
**FRONT STRUT BEARING INSPECTION**  
**CERTAIN 2015 MY YARIS HATCHBACK**

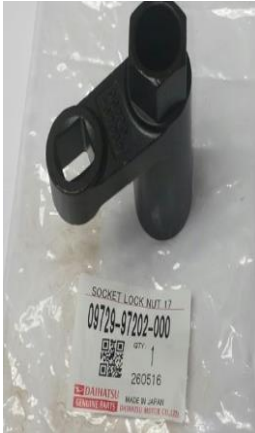
SST 09729-97202\* Socket Lock Nut

\*This tool was provided to the dealer prior to launch of this campaign.

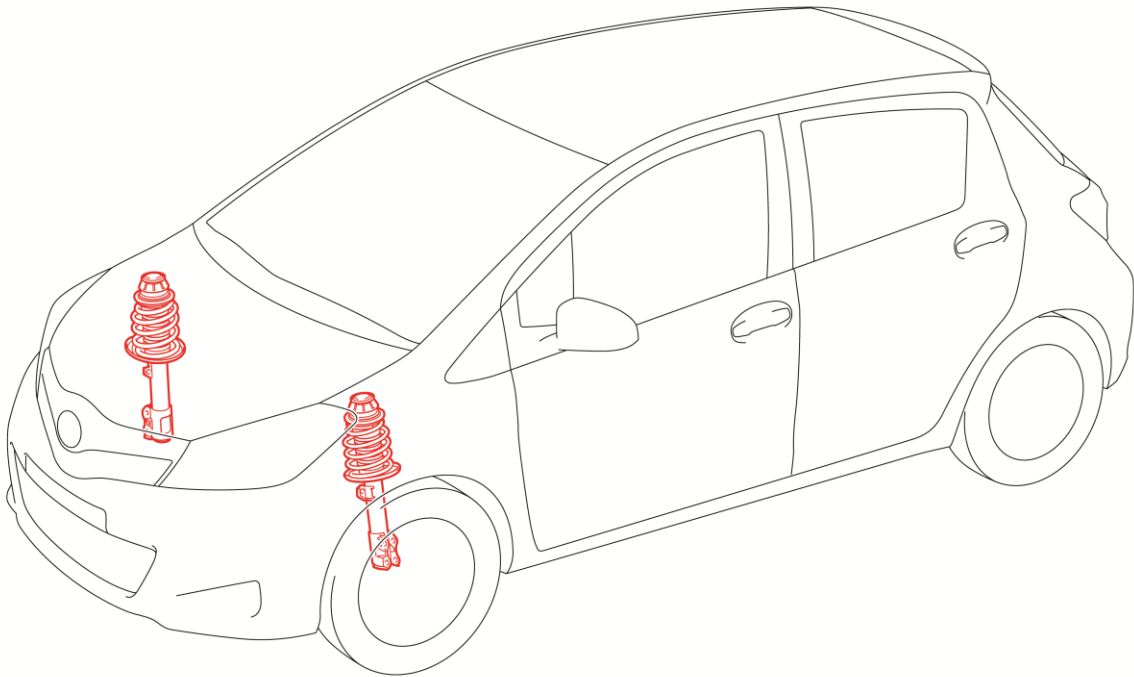
152154010003a

In the subject vehicles, there is a possibility that a front upper shock assembly bearing could become damaged. If this occurs, the driver may experience abnormal noises while driving on rough road surfaces or when turning the steering wheel. If the vehicle continues to be operated in this condition, a front shock absorber piston rod could separate, causing a loss of vehicle stability and increasing the risk of a crash.

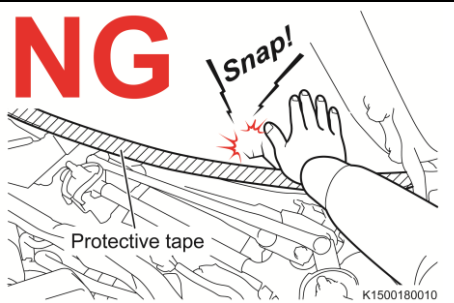
K1500180010

**NG**

Protective tape

To prevent the glass from breaking, clean it and apply protective tape to the bottom edge so that tools and other items **DO NOT** directly contact the glass.

**DO NOT** put your hand on the bottom edge of the glass to support your weight. The glass could break because there is no support under the lower edge of the glass.

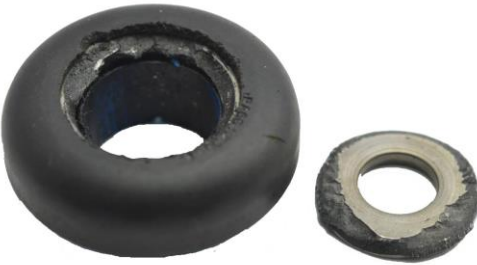
**NOTE: If the Strut Mounting Bearing is broken, upper surface will separate from bearing.**

<p data-bbox="610 426 1520 457"><b>Go to step 4 "REPLACE THE STRUT MOUNTING BEARING".</b></p>
<p data-bbox="240 600 435 642"><b>Damaged</b></p>

<p data-bbox="610 621 1503 653"><b>Go to step 3 "REPLACE THE FRONT SHOCK ABSORBER".</b></p> <p data-bbox="610 657 979 688"><b>Replace the following parts.</b></p> <ul data-bbox="610 690 1065 821" style="list-style-type: none"><li>- <b>Strut Mounting Bearing</b></li><li>- <b>Shock Absorber Support Nuts</b></li><li>- <b>Front Shock Absorber</b></li><li>- <b>Shock Absorber Support</b></li></ul> <p data-bbox="610 852 1422 915"><b>Note: It is anticipated that very few vehicles will have bearing damage.</b></p>
