Safety Recall

Code: 6901

Subject	Continental Airbag Control Module
Release Date	February 01, 2017
Revision Summary	Work procedure updated.
Affected Vehicles	<p>U.S.A. & CANADA: Certain 2008-2010 MY Audi vehicles</p> <ul style="list-style-type: none"> • 2009 MY Audi A4 Sedan • 2009 MY Audi A4 Avant • 2009 MY Audi Q5 • 2008-2009 MY Audi A5 Coupe • 2010 MY Audi A5 Cabriolet <p><i>Check Campaigns/Actions screen in Elsa on the day of repair to verify that a VIN qualifies for repair under this action. Elsa is the <u>only</u> valid campaign inquiry & verification source.</i></p> <ul style="list-style-type: none"> ✓ Campaign status must show "open." ✓ If Elsa shows other open action(s), inform your customer so that the work can also be completed at the same time the vehicle is in the workshop for this campaign.
Problem Description	In certain vehicles, a power supply component in the airbag control unit may corrode and cause the unit to fail. If the airbag control unit fails, the airbag warning light in the instrument panel will illuminate, and safety systems such as seat belt pretensioners and airbags may not deploy in the event of a crash, increasing the risk of occupant injury.

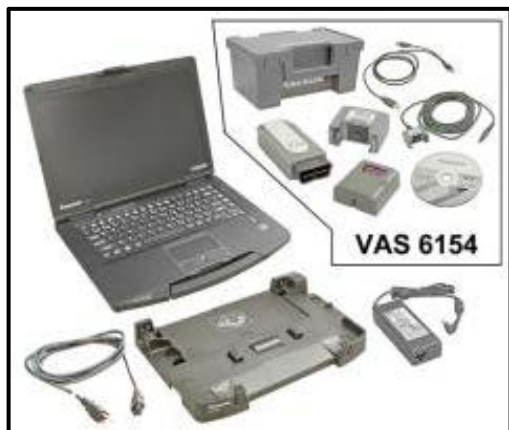
- VAS6150D - Diagnostic Tester (or equivalent)
- VAS6154 - Vehicle Communication Interface (or equivalent)

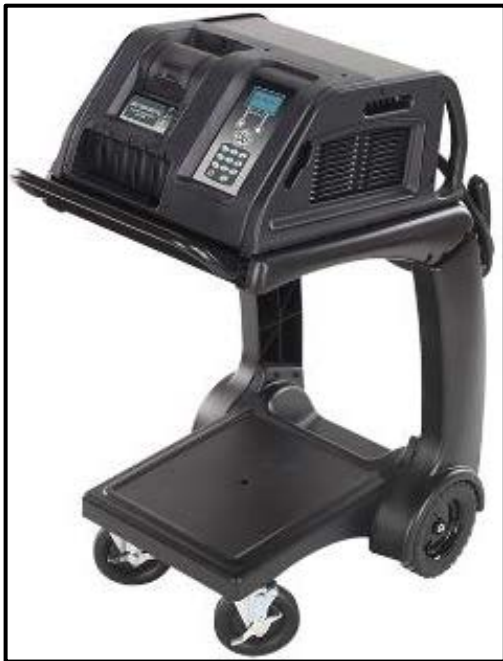
- GRX3000VAS – Battery Tester/Charger (or equivalent)

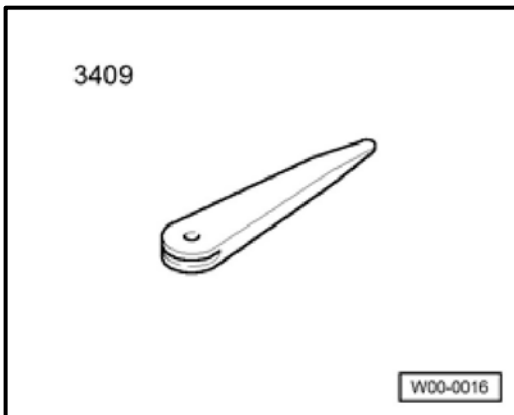
- Trim Removal Wedge -3409- (or equivalent)

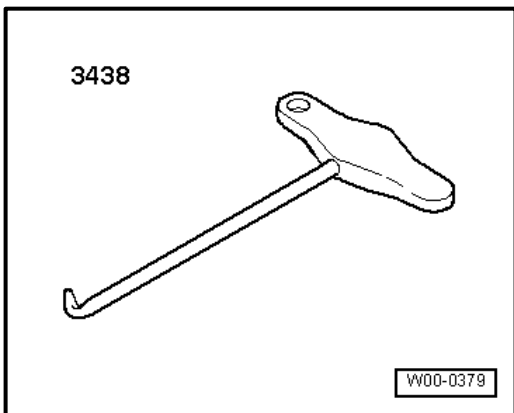
- T-Handle Hook -3438- (or equivalent)

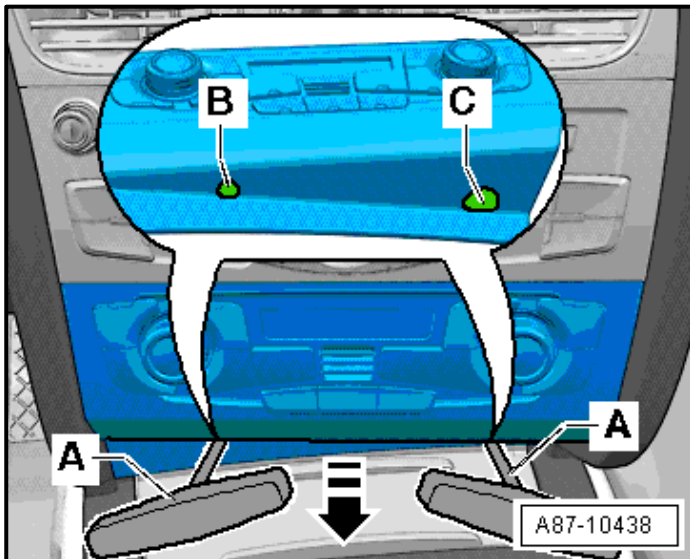
- Attach the T-Handle Hook -3438- <A> in one of the openings or <C> of the Climatronic Control Module -J255- A/C display and control head as illustrated.

The Climatronic Control Module -J255- A/C display and control head is held in the center console brackets with clamps (left and right).

- Carefully pull the Climatronic Control Module -J255- A/C display and control head in the direction of <arrow> out of center console.

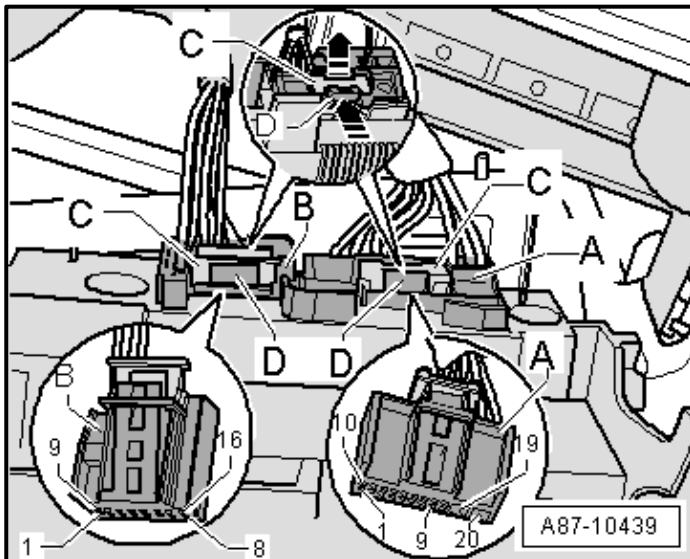
- Loosen the harness connector and release catch <C> for the connectors <A> and by pulling the direction of the <arrow>.
- Press the connector release catch <D> and remove the connectors <A> and and remove the Climatronic Control Module -J255-.

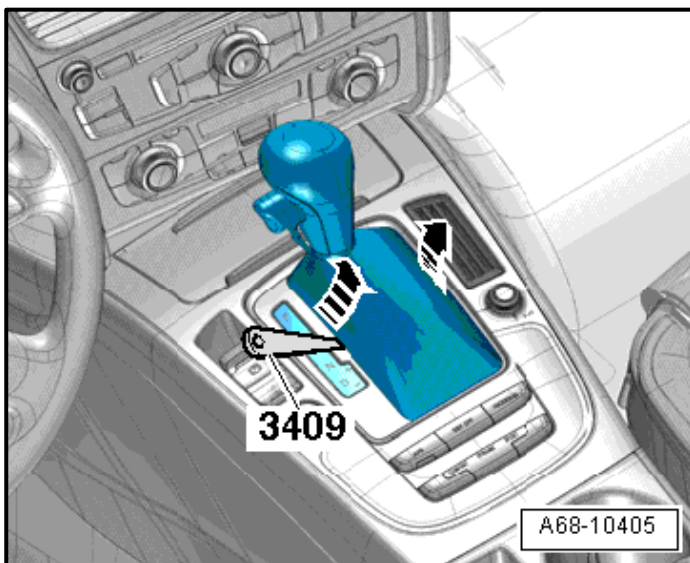
- Carefully pry out the selector lever/shift lever boot at the side using a Trim Removal Wedge -3409- and fold it upward <arrows>.
- Tape off the center console trim panel all around the center console insert using adhesive tape to avoid damaging the surface.

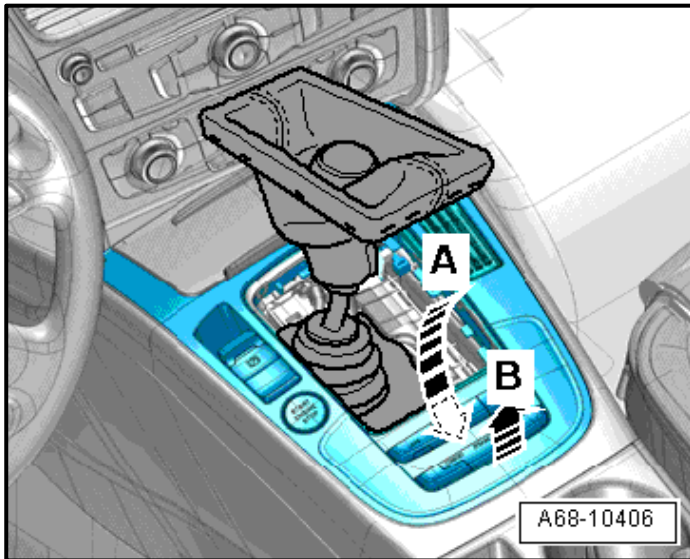
The retainer on the Access/Start Authorization Button -E408- can be damaged if the center console is lifted too high because the electrical wire to the button is short. Loosen and lift the center console insert carefully.

- Reach with the hand under the center console insert <arrow A> and carefully move it upward from the center console <arrow B>.
- Disconnect the connectors and carefully remove the center console insert over the selector lever/gearshift lever.

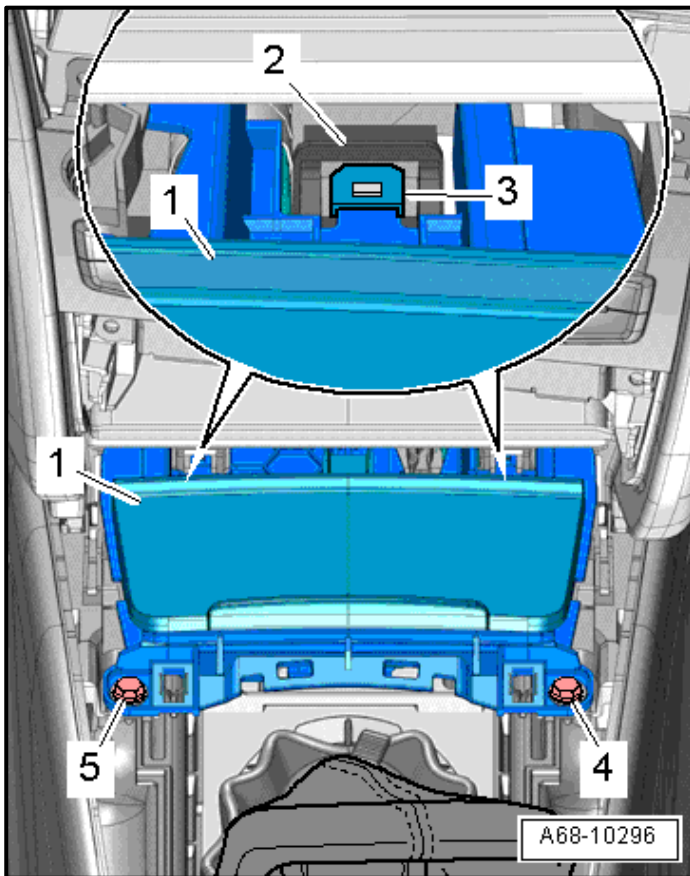
- Remove the screws <4> and <5> from the front storage compartment.
- Remove the front storage compartment <1> from the mount <2> by releasing tab <3> and disconnect the 12V outlet electrical connector.

The 12V outlet electrical connector is located approximately 15 cm away from the outlet, and the connector is protected by a foam wrap. Disconnect at this point. Do not attempt to remove the connector on the back of the outlet itself or damage can occur to the 12V outlet.

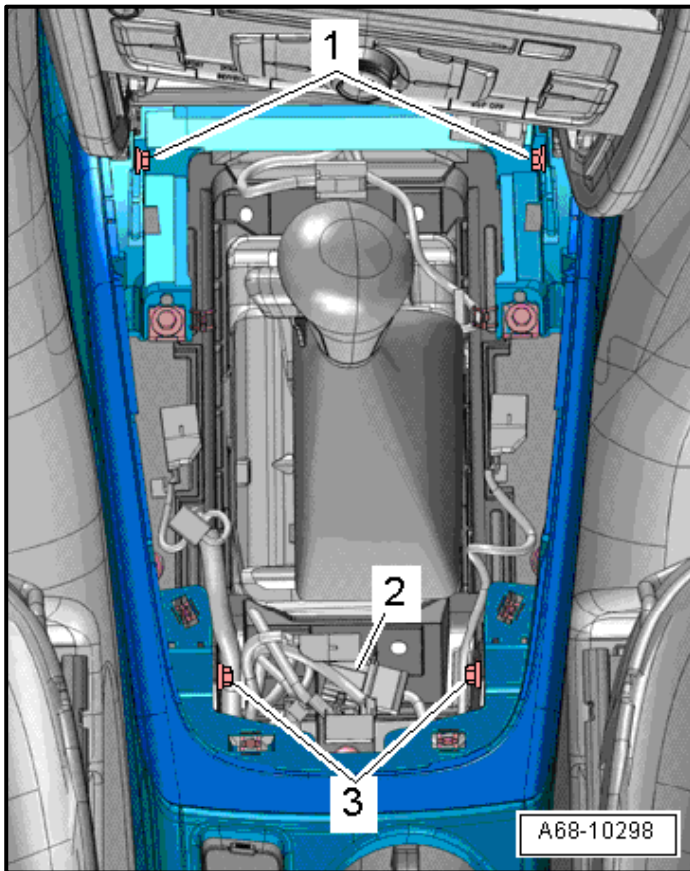
- Remove the bolts <1> and <3>.
 - If equipped with a center armrest, proceed to **Subsection A**.
 - If not equipped with a center armrest, proceed to **Subsection B**.

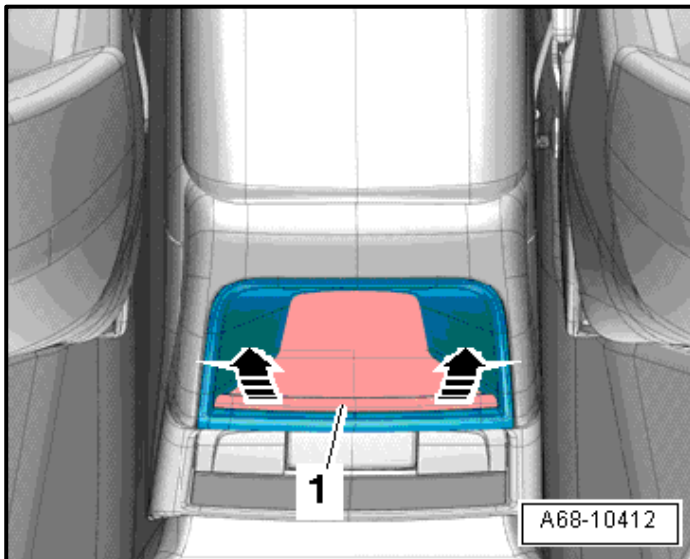
- Carefully remove the lining mat <1> from the retaining studs <arrows>.

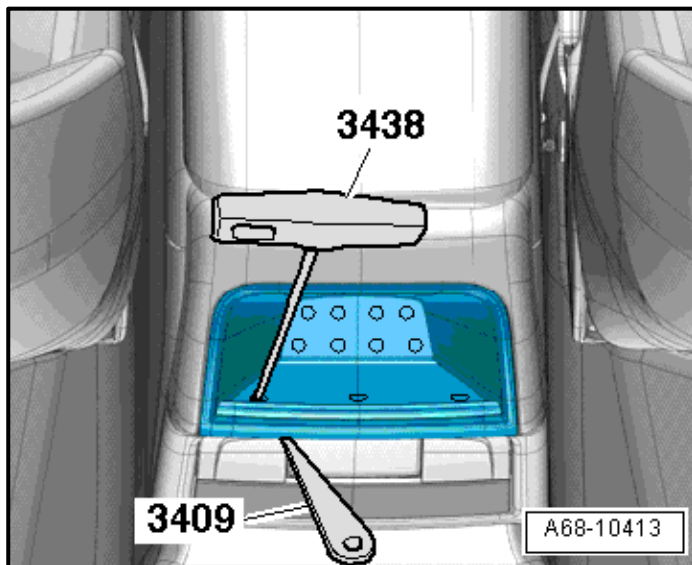
- Mount the T-Handle Hook -3438- into the lower holes in the storage compartment and at the same time push the Trim Removal Wedge -3409- into the gap between the storage compartment and the center console.
- Disengage the storage compartment all the way around and remove it.

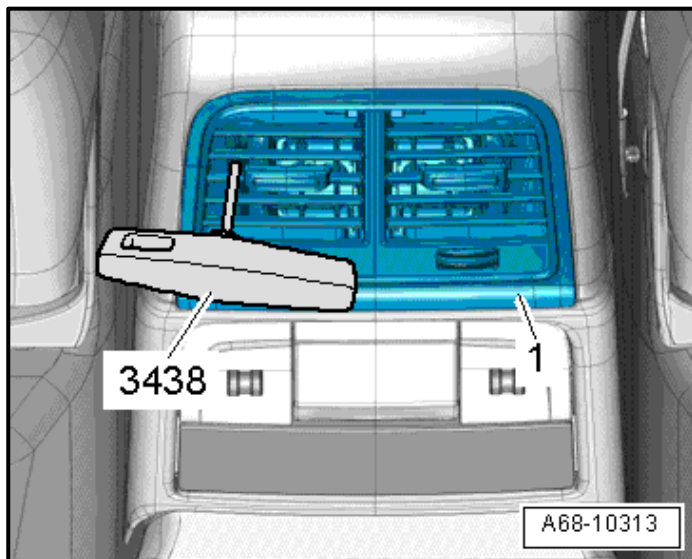
The vent has a hole on both sides for attaching the T-Handle Hook -3438-.

- Alternating between the sides, carefully remove the vent <1> from the installation opening using the T-Handle Hook -3438-.
- Vehicles with illumination: disconnect the connector.

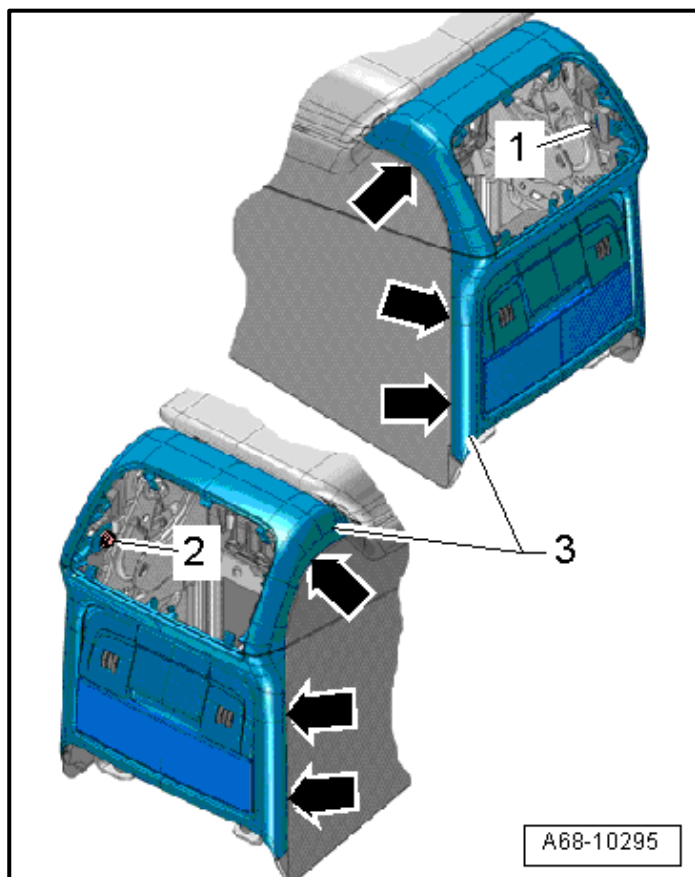
- On the center console rear trim, remove the bolt <2>.

On vehicles equipped with a center armrest, lift the armrest to reveal the location of bolt <2>. You will not be able to access and remove bolt <2> with the armrest in the down position.

- Carefully unclip the trim <3> using the Trim Removal Wedge -3409- beginning at the bottom <arrows>.

Insert trim removal wedge -3409- exactly at the <arrows>. There are six removal tabs that must be depressed at these exact locations.

- Tilt the trim upward while releasing the retaining tab <1> and remove from the center console.
- Disconnect the electrical connectors, if applicable.

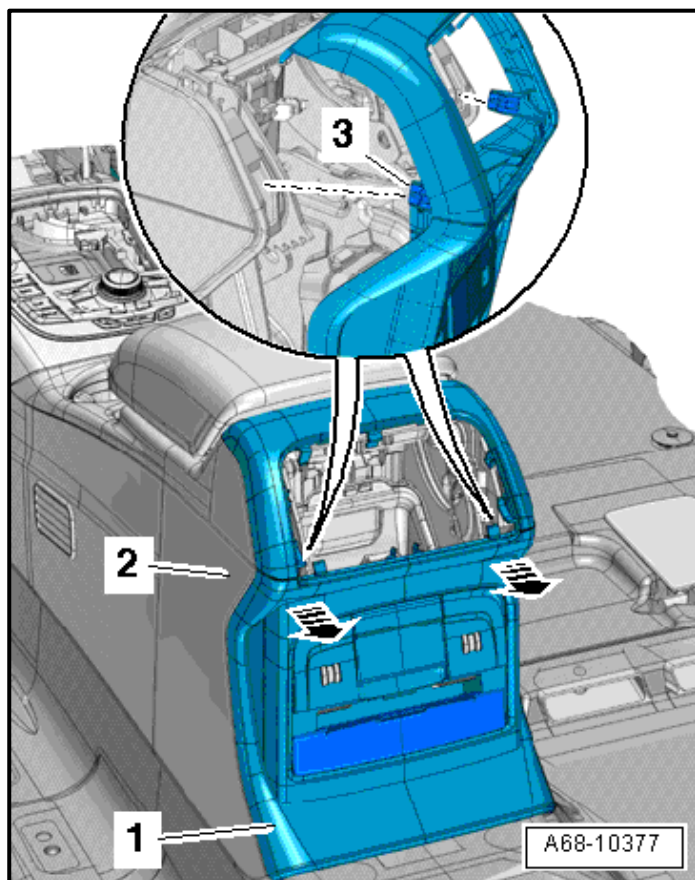
- Carefully unclip the centering pins <3> on the trim <1> from the center console <2> using the Trim Removal Wedge -3409- and pull in the direction of the <arrows>.
- Carefully unclip the tabs on the side using the Trim Removal Wedge -3409- and remove the trim.
- Disconnect the electrical connectors, if applicable.

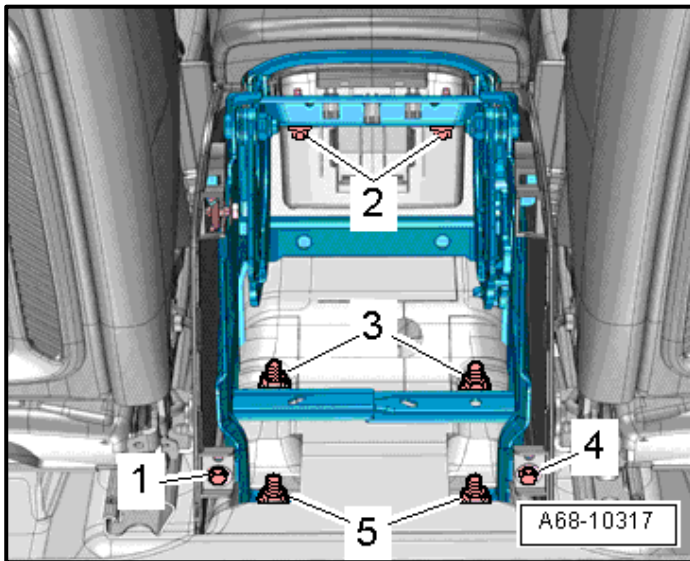
- Remove vent tube (if equipped).
- Remove the armrest support base bolts <1, 2 and 4>.
- Remove the nuts <3> and <5>.
- Disengage the top of the center console on the armrest support base by lifting the center console.
- Pull the armrest support base upward, guide it over the threaded pins and remove it toward the back.
- Lift the center console and remove it back out of the instrument panel and over the selector lever/shift lever.
- **Proceed to Subsection C.**

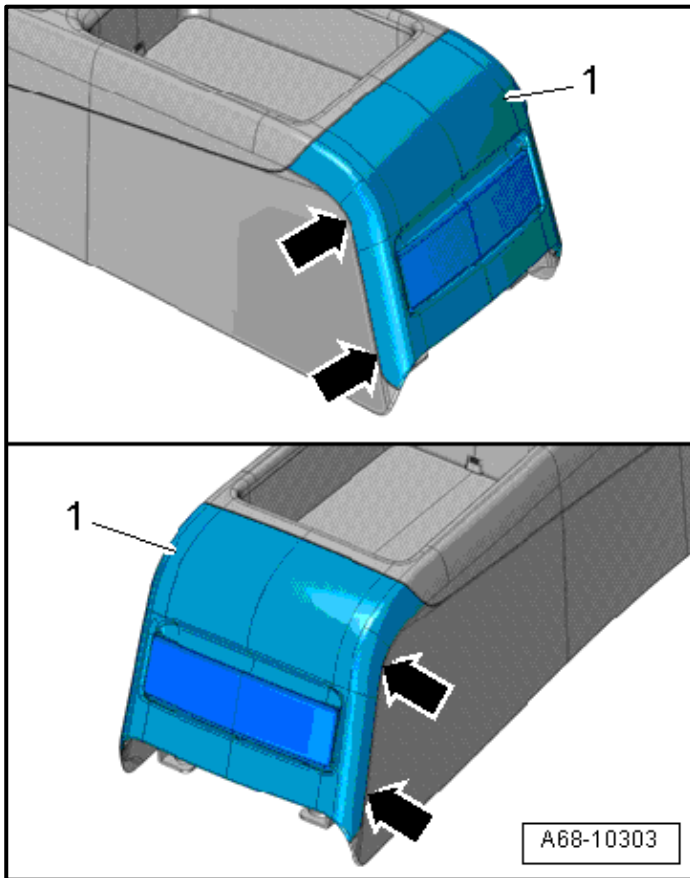
- Carefully unclip the cover <1> using the Trim Removal Wedge -3409- beginning at the bottom <arrows>.

Insert trim removal wedge -3409- exactly at the <arrows>. There are four removal tabs that must be depressed at these exact locations.

- Tilt the trim upward and remove it from the center console.
- Disconnect the electrical connectors, if applicable.

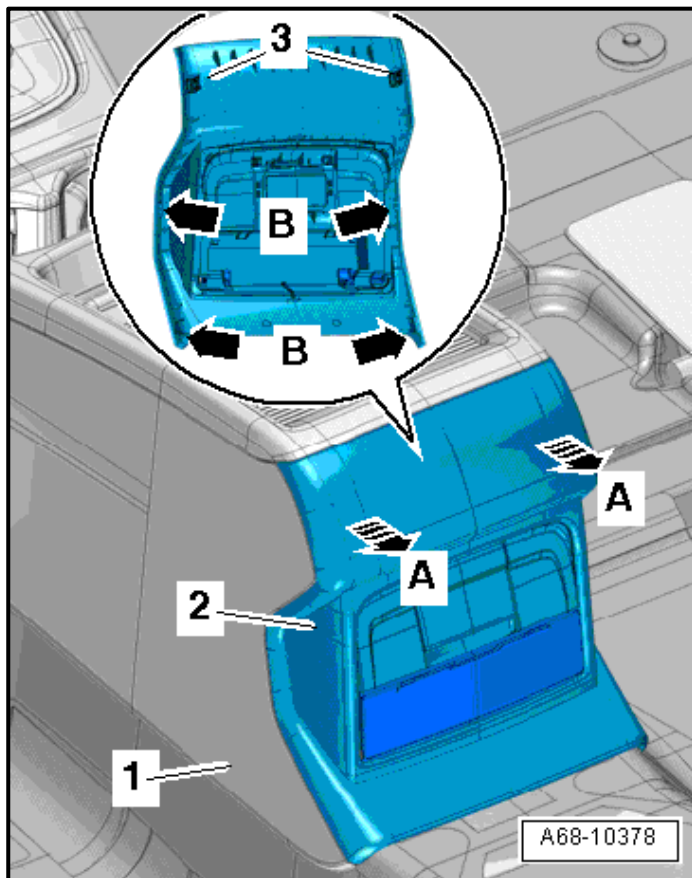
- Carefully unclip the centering pins <3> on the trim <2> from the center console <1> using the Trim Removal Wedge -3409- and pull in the direction of the <arrows>.
- Carefully unclip the tabs <B arrows> on the side using the Trim Removal Wedge -3409- and remove the trim.
- Disconnect the electrical connectors, if applicable.

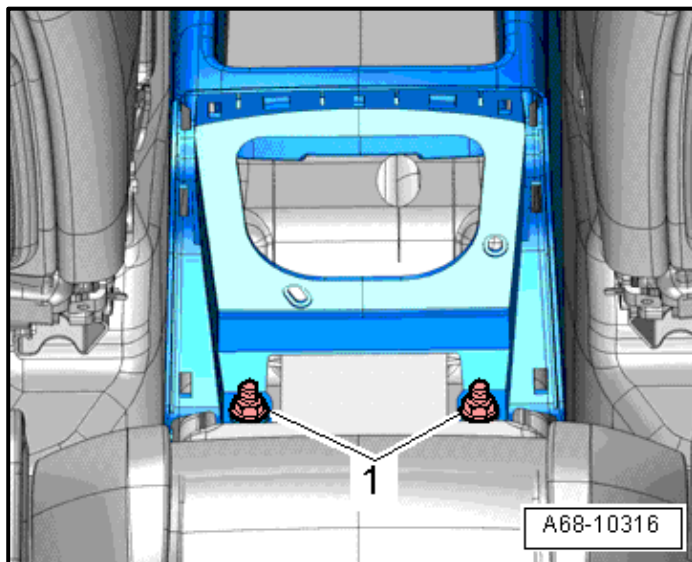
- Remove the nuts <2> from the center console.
- Lift the center console and remove it back out of the instrument panel and over the selector lever/shift lever.
- **Proceed to Subsection C.**

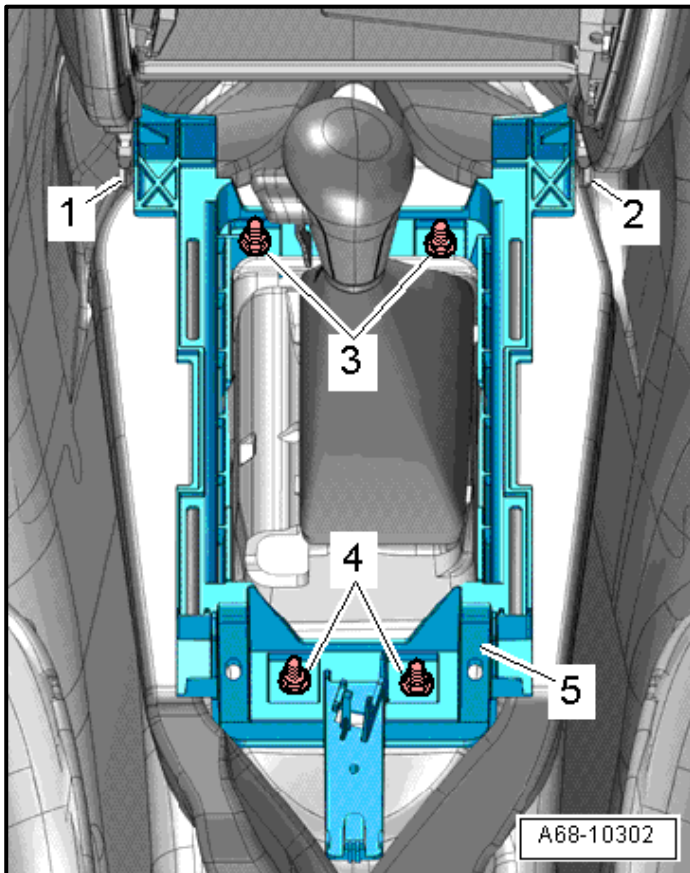
- Disconnect the two electrical connectors from the shifter body (if equipped).
- Remove the nuts <3> and <4> from the center console bracket.
- Disengage the bracket <5> at the tabs <1> and <2> and remove.

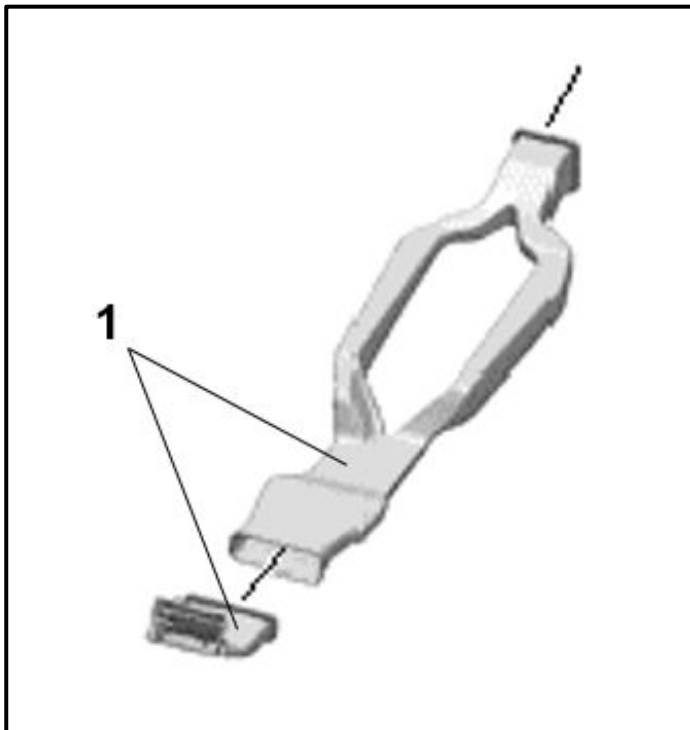
- If equipped, remove the air guide for the rear vent <1>.

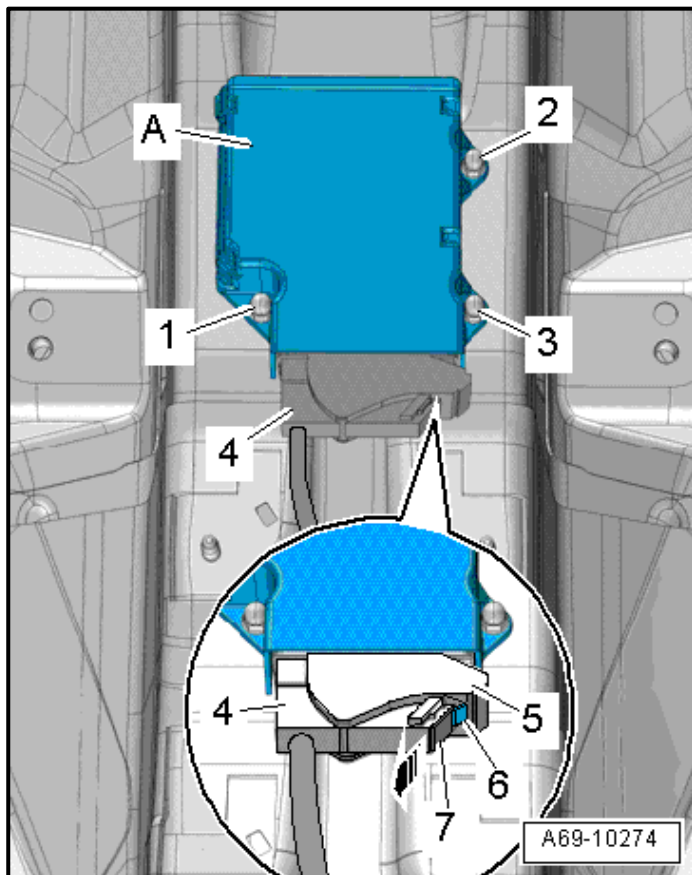
- Fold up the floor covering over the airbag control module. Cut the floor covering along the perforation if necessary.
- Slide the retainer <7> on the connector in the direction of the <arrow>.
- Press the release button <6>, opening the retainer <5> on the connector and remove the connector <4>.
- Remove the nuts <1 through 3> and remove the airbag control module <A> from the threaded pins.

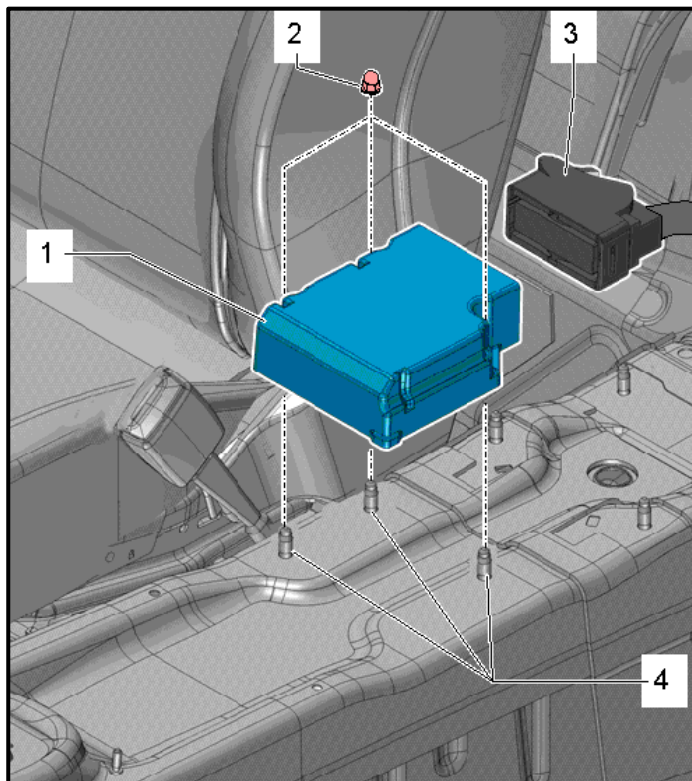
- Install the new airbag control module <1>.

- Make sure the connectors are installed correctly and are secure.
- All threads must be paint and contaminant free, as they serve as ground connection for the control module

- Install the nuts <2> and tighten to 9 Nm.
- Reconnect the connector, ensuring that the retainer is properly seated.

Make sure the airbag control module is properly secured before reconnecting the negative battery terminal, or reconnecting airbag control module connector <3>.

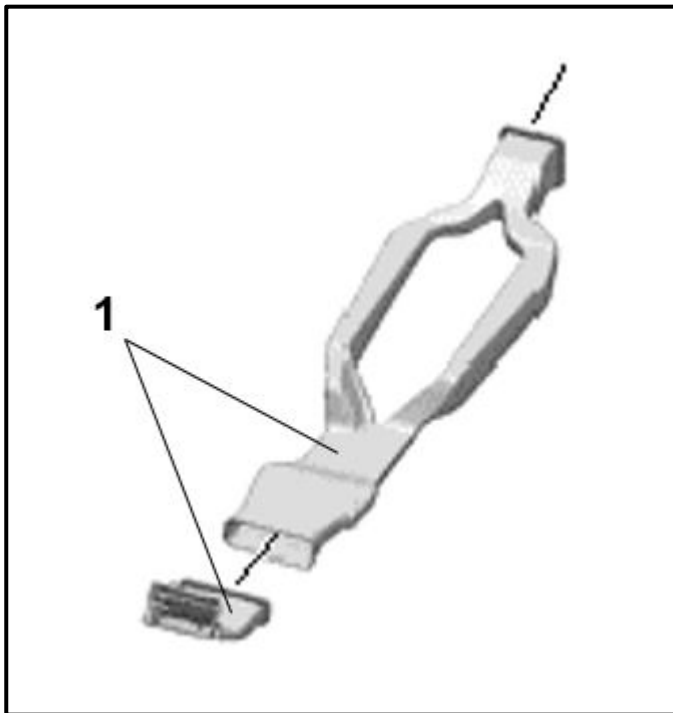
- If equipped, reinstall the air guide for the rear vent <1>.

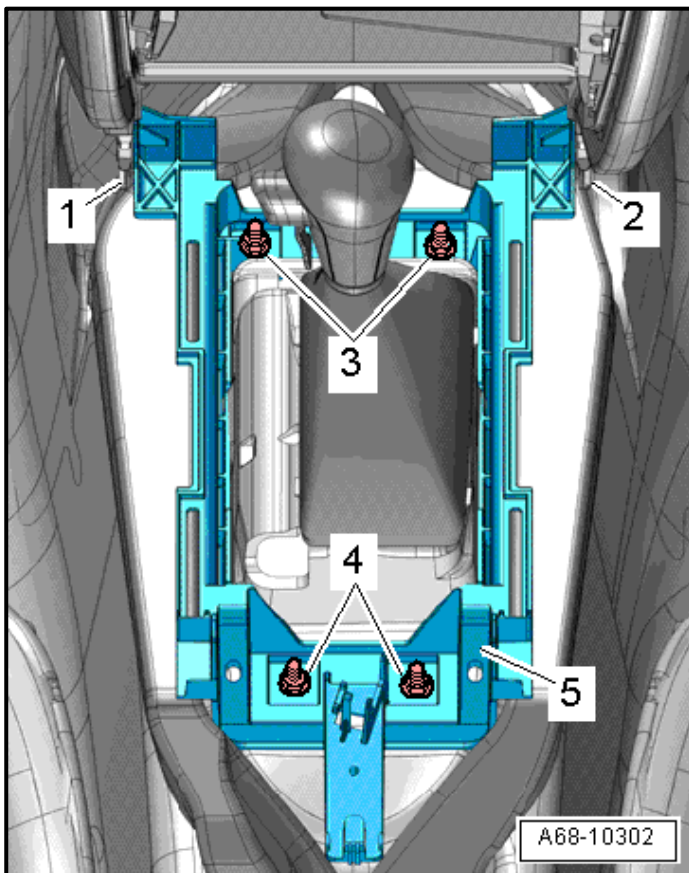
- Reinstall the front center console bracket <5> and reattach at the tabs <1> and <2>.
- Reinstall the nuts <3> and <4> to the bracket and tighten to 8Nm.
- Reconnect the two electrical connectors on the shifter (if equipped).
 - If equipped with a center armrest, proceed to **Subsection D**.
 - If not equipped with a center armrest, proceed to **Subsection E**.

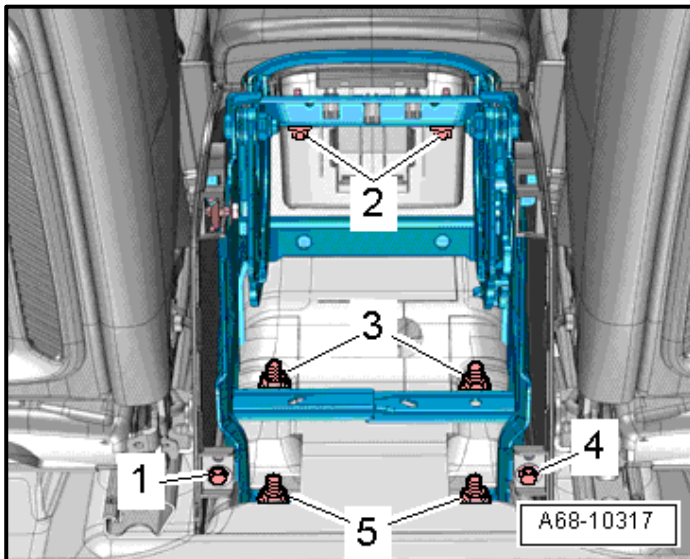
- Guide the center console over the selector lever/shift lever and back into position.
- Reinstall the armrest support base, guiding it over the threaded pins.
- Reinstall the nuts <3> and <5> and tighten to 20 Nm.
- Reinstall the armrest support base bolts <1, 2 and 4> and tighten to 3 Nm.
- Reinstall the vent tube (if equipped with rear vent).

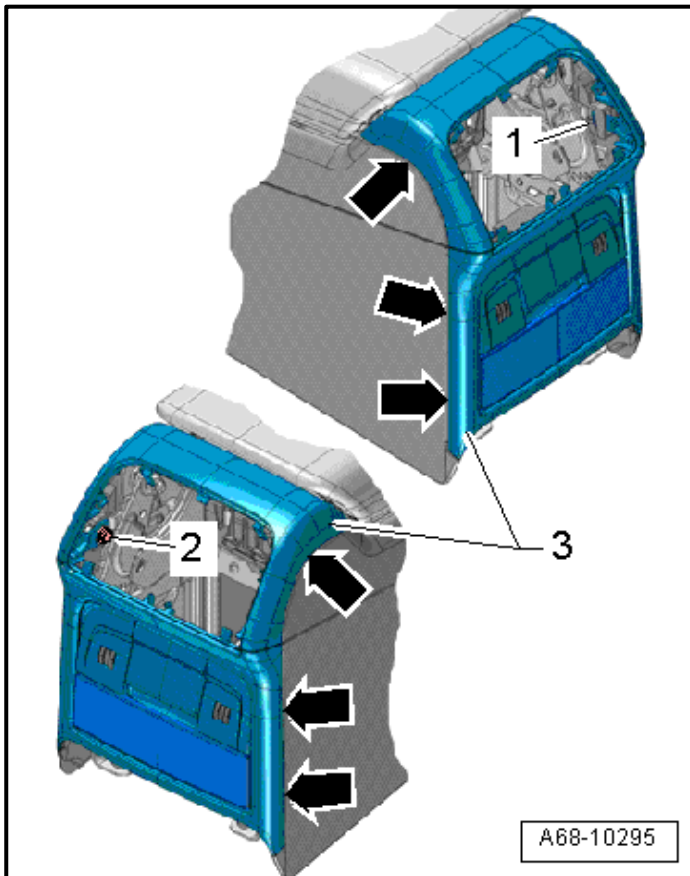
- Reconnect the electrical connectors, if applicable, to the center console trim.
- Insert the trim <3> at the top, tilt it down and clip it in at <1> and at <arrows>.
- Press the center console rear trim <3> onto the center console until it engages audibly.
- Reinstall the bolt <2> and tighten to 2.5 Nm.

On vehicles equipped with a center armrest, lift the armrest to reveal the reinstallation location of bolt <2>. You will not be able to access and reinstall bolt <2> with the armrest in the down position.

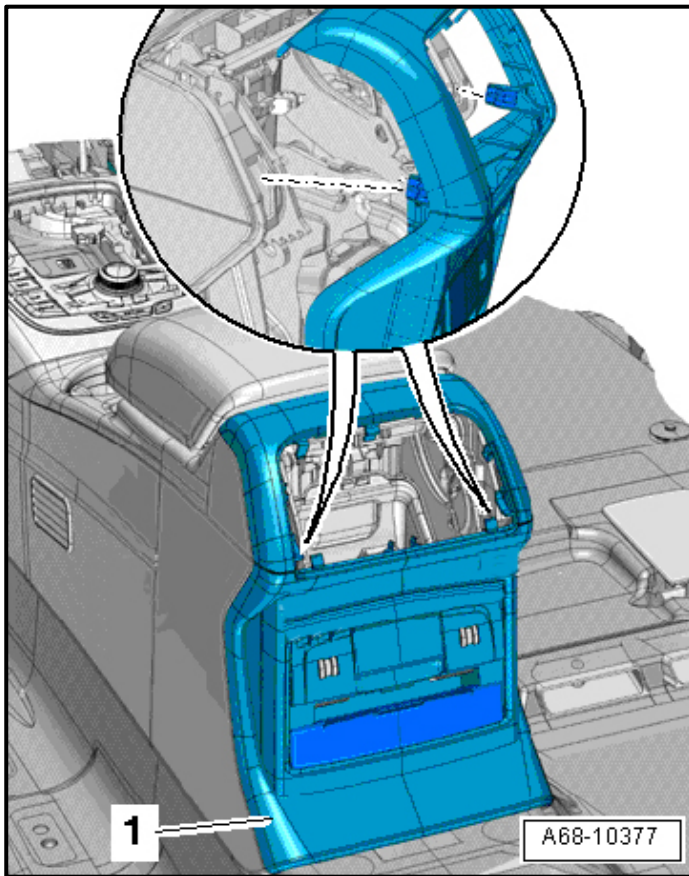
- Reconnect the electrical connectors, if applicable, to the center console trim.
- Insert the trim <1> at the bottom, tilt it upward and clip it in.
- Press the center console rear trim onto the center console until it engages audibly.

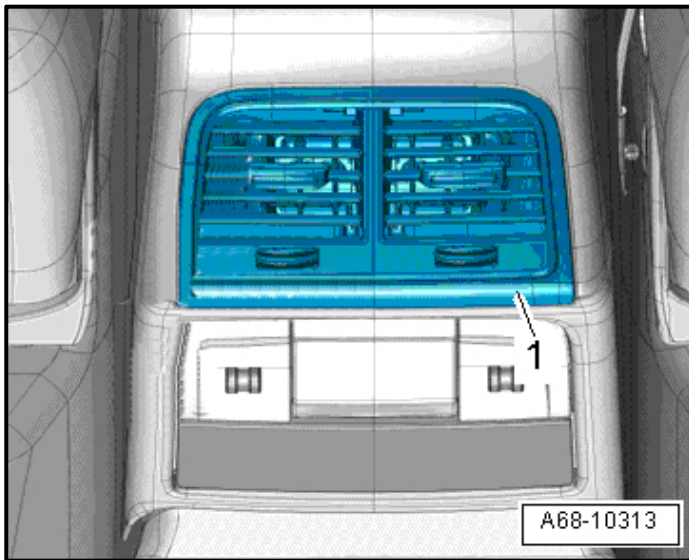
- Insert the vent <1>, tilting it upward and pressing it into the installation opening as far as the stop to ensure that the duct engages correctly.
- Proceed to **Subsection F**.

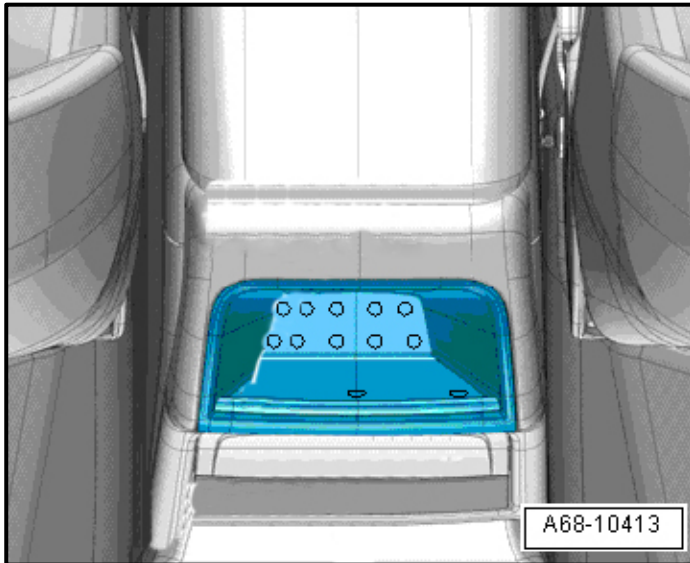
- Insert the lower storage compartment, tilt it upward and press it into the installation opening as far as the stop.

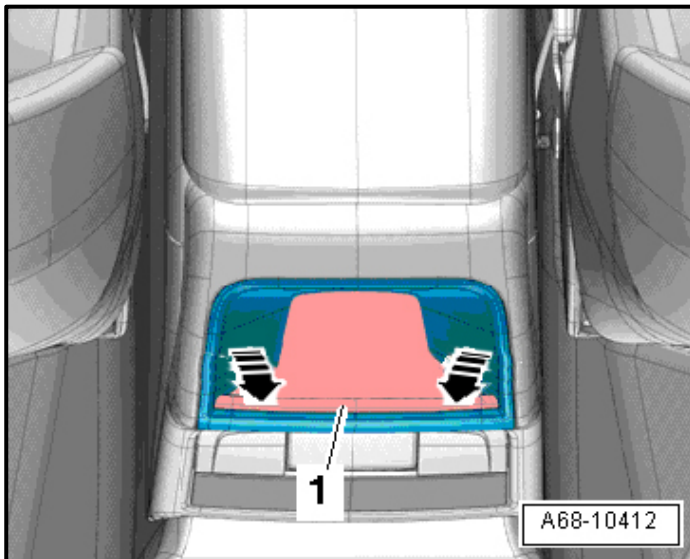
- Reinstall the lining mat <1> to the retaining studs <arrows>.
- Proceed to **Subsection F**.

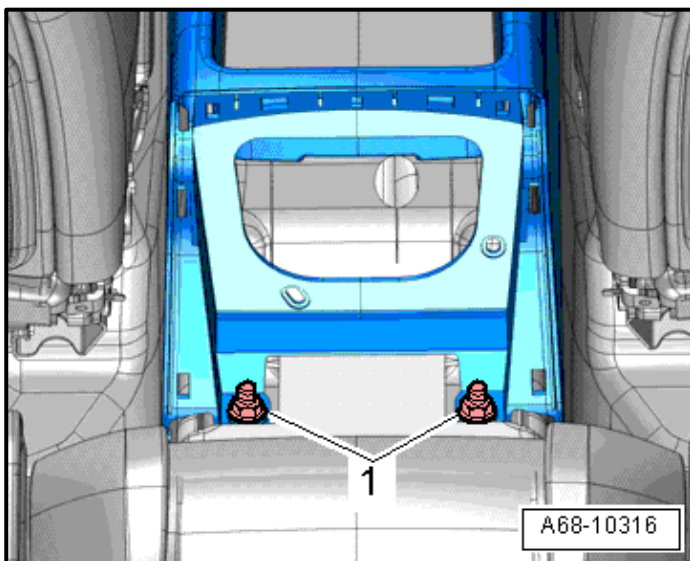
- Guide the center console over the selector lever/shift lever and back into position.
- Reinstall the nuts <1> to the center console and tighten to 4 Nm.

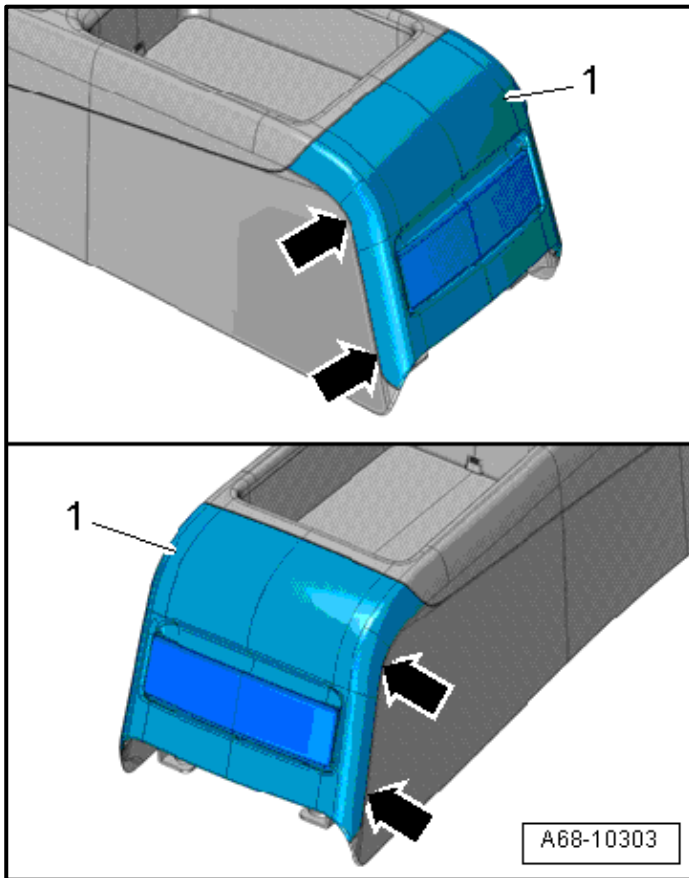
- Reconnect the electrical connectors, if applicable, to the center console trim.
- Insert the cover <1> at the top, tilt it down and clip it in.
- Press the center console cover onto the center console until it engages audibly.
- Proceed to **Subsection F**.

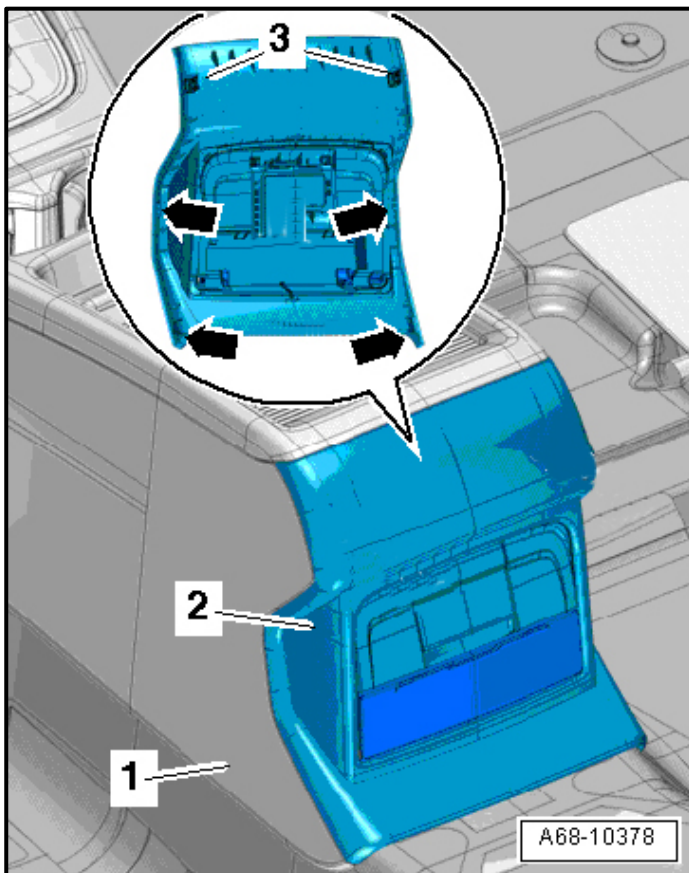
- Reconnect the electrical connectors, if applicable, to the center console trim.
- Insert the trim <2> at the top, tilt it down and clip it in at the retainers <3> and <arrows>.
- Press the center console trim onto the center console <1> until it engages audibly.
- Proceed to **Subsection F**.

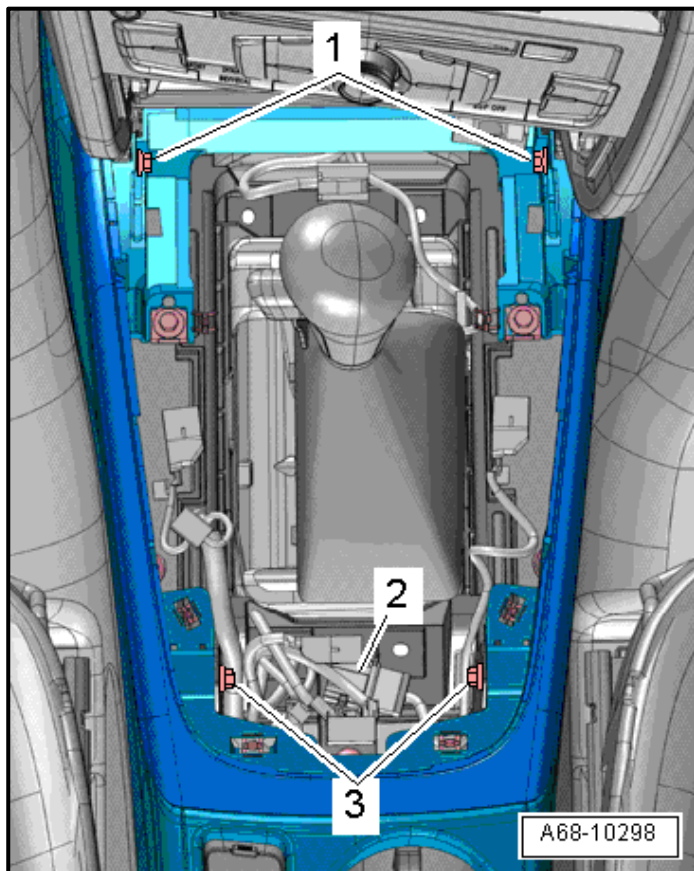
- Reinstall the bolts <1> and <3> and tighten to 3 Nm.
- Vehicles with a 12V outlet: reconnect the connector <2>.

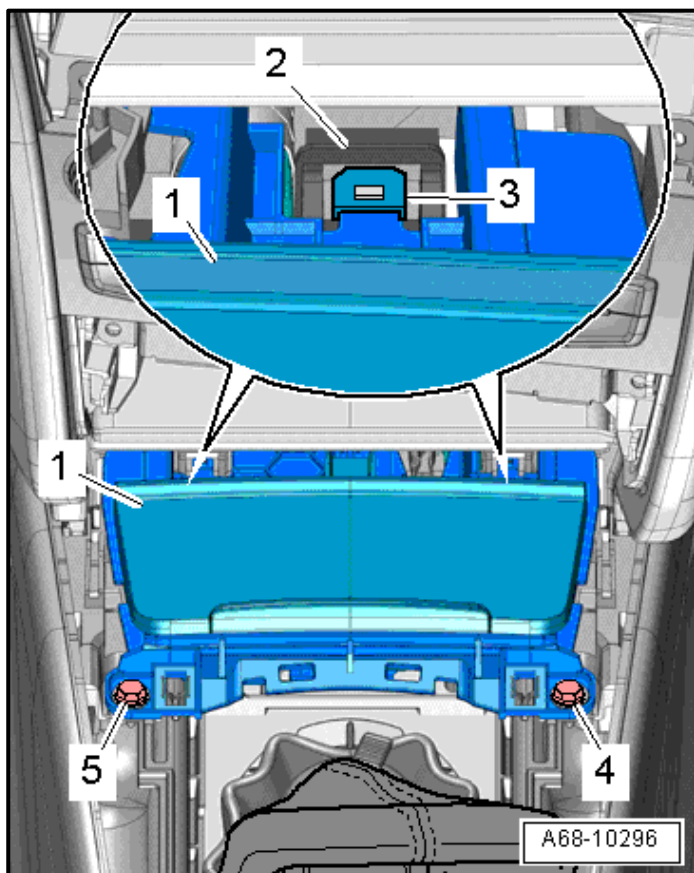
The 12V outlet electrical connector is located approximately 15 cm away from the outlet, and the connector is protected by a foam wrap. Reconnect at this point. Do not attempt to remove the connector on the back of the outlet itself or damage can occur to the 12V outlet.

- Insert the front storage compartment <1> with the rubber grommet <3> in the mount <2>.
- Reinstall the screws <4> and <5> and tighten to 2.5 Nm.

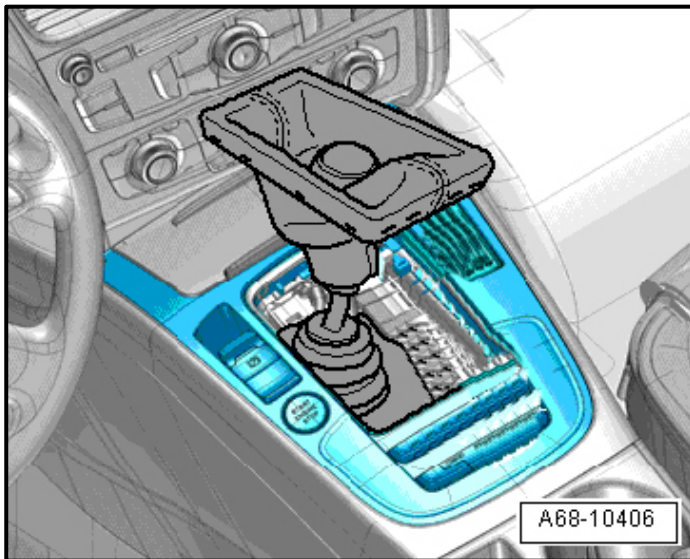
- Reconnect the connectors and carefully reinstall the center console insert over the selector lever/gearshift lever.

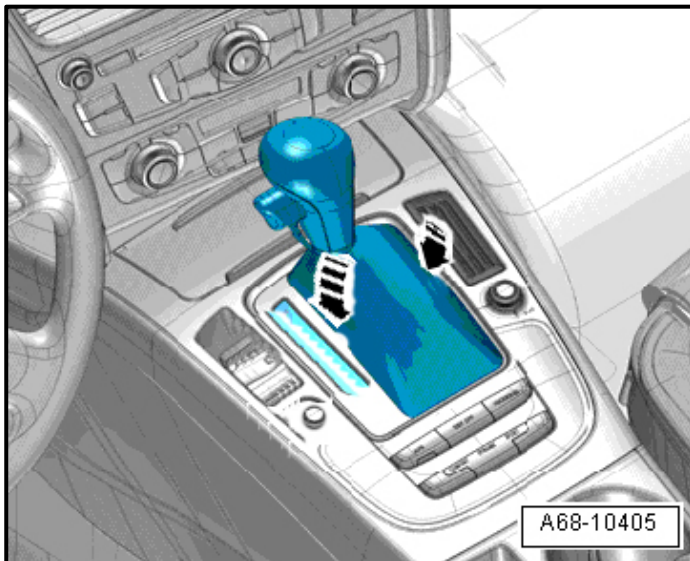
- Press the center console insert in until it engages audibly.

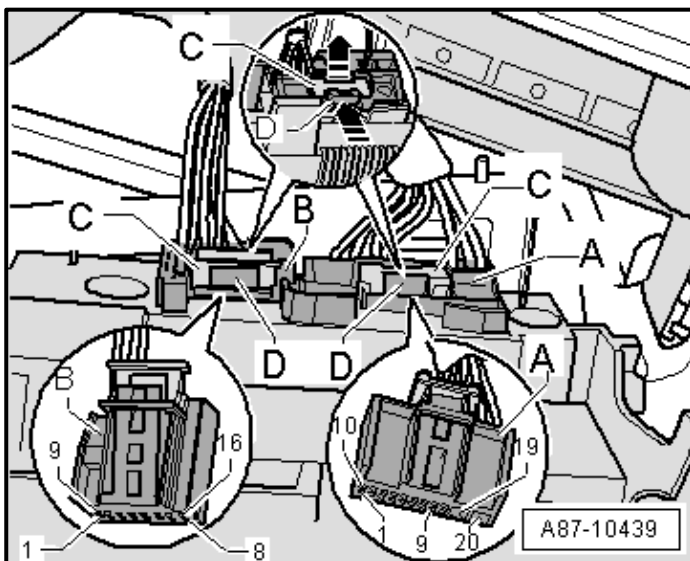
- Reconnect the Climatron Control Module -J255- connectors.

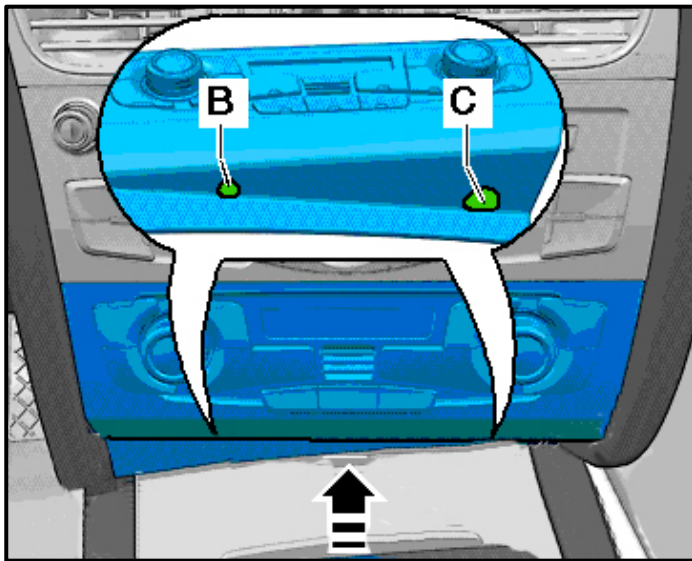
- Reinstall the Climatronic Control Module -J255-, ensuring the clamps and <C> are fully seated.
