Safety Recall

Code: 69O1

Subject	Continental Airbag Control Module
Release Date	October 25, 2016
Affected Vehicles	<p>U.S.A. & CANADA: Certain 2008-2010 MY Audi vehicles</p> <ul style="list-style-type: none"> • 2009 MY Audi A4 Sedan • 2009 MY Audi A4 Avant • 2009 MY Audi Q5 • 2008-2009 MY Audi A5 Coupe • 2010 MY Audi A5 Cabriolet <p><i>Check Campaigns/Actions screen in Elsa on the day of repair to verify that a VIN qualifies for repair under this action. Elsa is the <u>only</u> valid campaign inquiry & verification source.</i></p> <ul style="list-style-type: none"> ✓ Campaign status must show "open." ✓ If Elsa shows other open action(s), inform your customer so that the work can also be completed at the same time the vehicle is in the workshop for this campaign.
Problem Description	In certain vehicles, a power supply component in the airbag control unit may corrode and cause the unit to fail. If the airbag control unit fails, the airbag warning light in the instrument panel will illuminate, and safety systems such as seat belt pretensioners and airbags may not deploy in the event of a crash, increasing the risk of occupant injury.

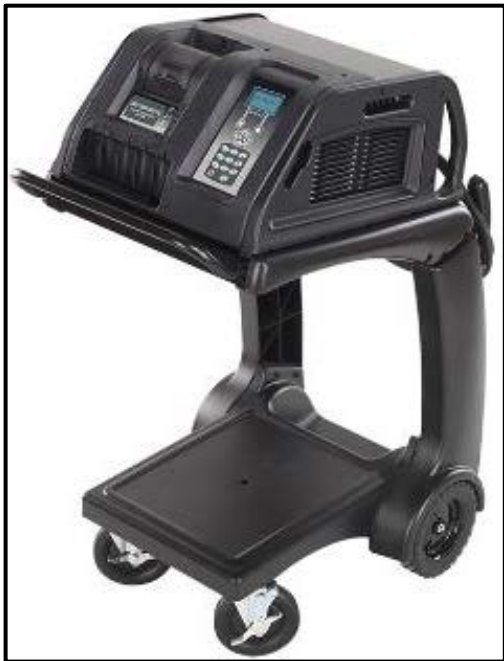
- GRX3000VAS – Battery Tester/Charger (or equivalent)
