Safety Recall Campaign

2006~2012MY  
Sedona (VQ)

SC133 (Rev 1 7/27/2106)

**SUBJECT:** FRONT LOWER CONTROL ARM INSPECTION, REPLACEMENT  
OR APPLICATION OF PREVENTATIVE ANTI-CORROSION MATERIAL (SC133)

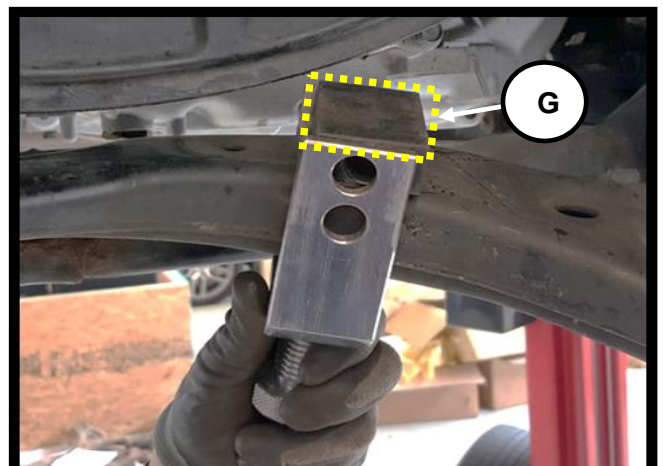
6. Set the Support Bar (G) on the top panel of the punch tool. Align the hole of the Support Bar to the hole in the Punch Tool.

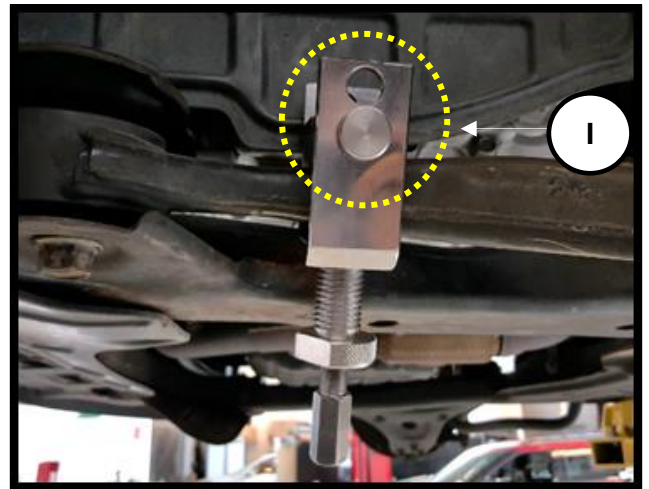
8. For (E-1) position, insert Support Pin to the lower hole of the Punching Tool.

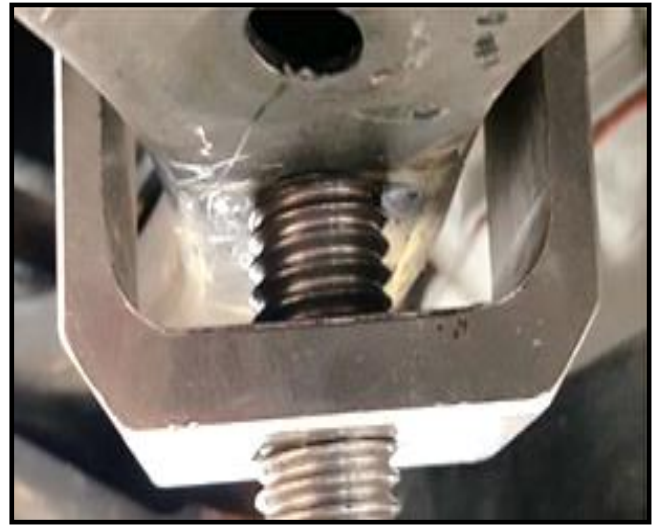
**NOTE:** Proper placement of the Punch Set Bolt with Center Punch Bolt retracted.

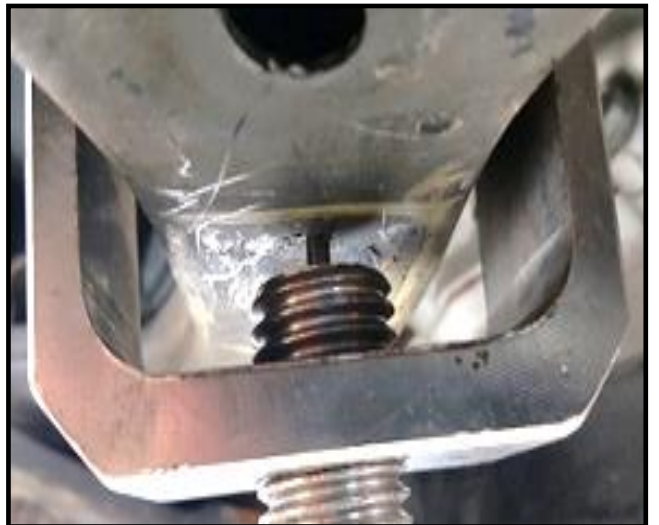
This is an incorrect installation of the Punch Set Bolt; the Center Punch Bolt is extended and the tool could be damaged.

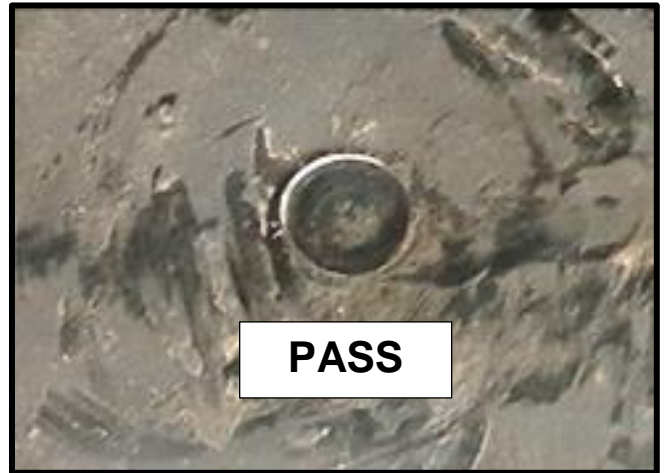
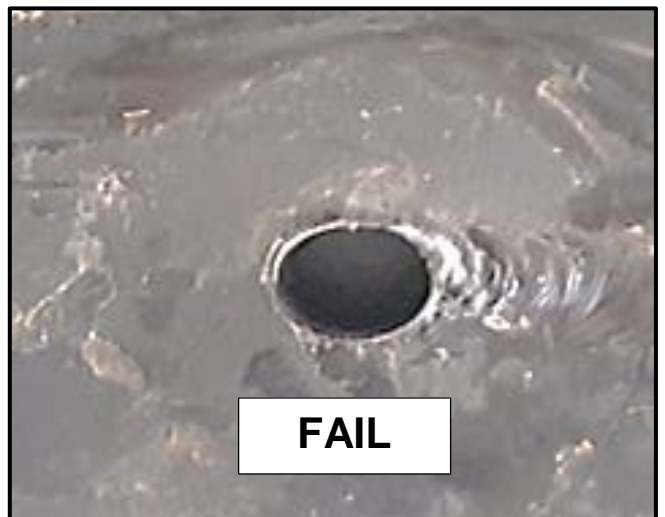
15. Inspect the punched area after punch test. If the punch test appears as shown in “FAIL” example at any test point, discontinue testing and replace both control arms per **Control Arm Replacement Procedure** on page 13. If the punch did not penetrate the control arm on both control arms, as shown in “PASS”, proceed to **Internal Inspection Procedure** on page 9.

If any test point appears as shown in “FAIL” replace both control arms per **Control Arm Replacement Procedure** on page 13.

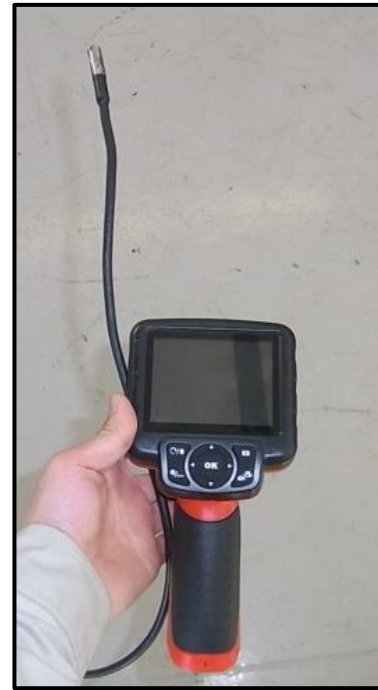
3. After removing all loose rust flakes from inside the lower control arm, use the borescope (supplied) to check remaining rust flakes and particles through hole in the lower control arm indicated in step 6 on the next page.

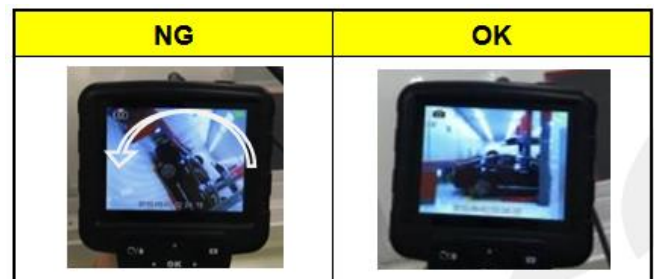
4. Power up and calibrate the display orientation direction by gripping the probe and turning as required. (Apply and align the 90 degree angle adaptor, as needed, for picture quality.)

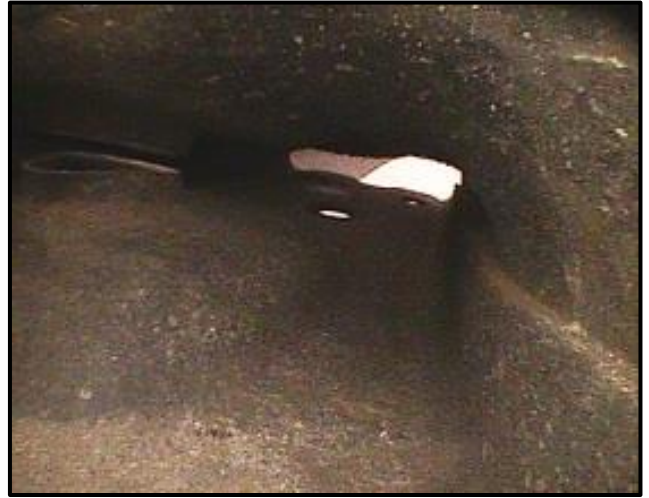
8. If the interior of the control arm is free of excessive rust particle build up, perform the **Reconditioning Procedure** on page 16 .

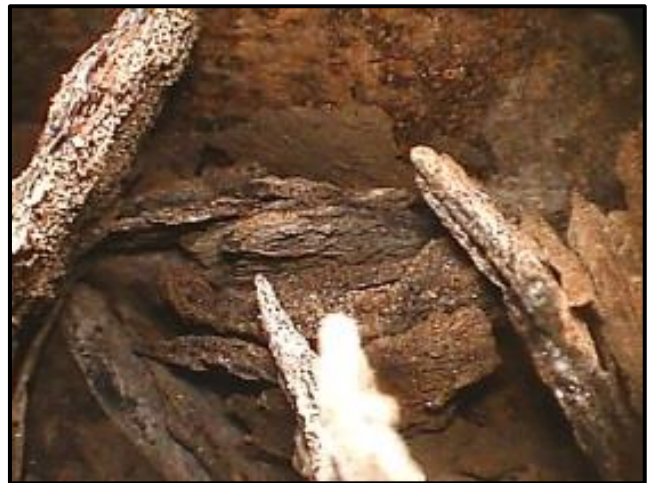
9. If the interior of the control arm has excessive rust scale which cannot be removed, replace both of the control arms. Refer to **Control Arm Replacement Procedure** on page 13.

If the control arm has to be replaced due to excessive internal rust, a picture must be attached to the warranty claim. Refer to the borescope manual for saving and attaching image files.

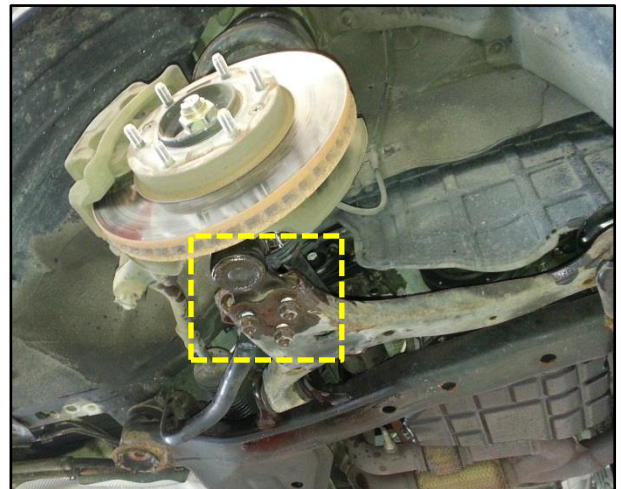
3. Loosen but do not remove the three (3) nuts securing the lower control arm to the ball joint.

**65.1 ~ 86.8 lb-ft (90 ~ 120 Nm)**

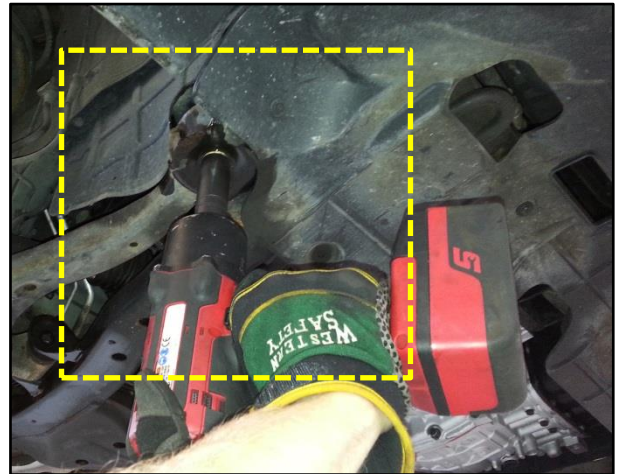
7. Remove the bolt securing the front mounting location for the lower control arm.

**115.7 ~ 130.2 lb-ft (156.9 ~ 176.5 Nm)**

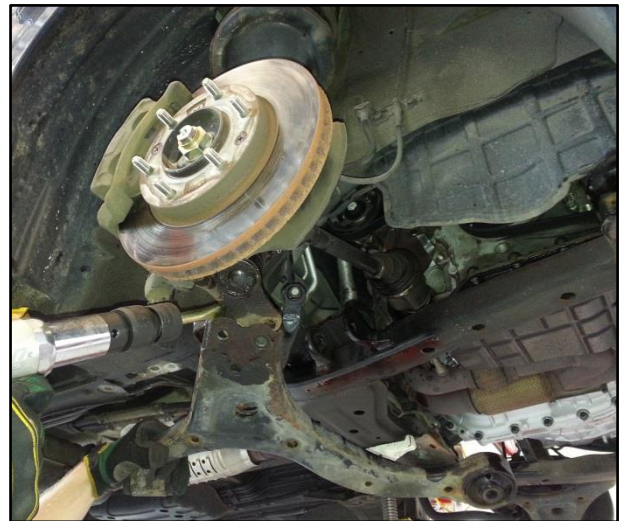
8. Use an air hammer with a chisel bit to remove the lower control arm from the ball joint.

To avoid possible injury, make sure to support the lower control arm prior to removing it from the ball joint.

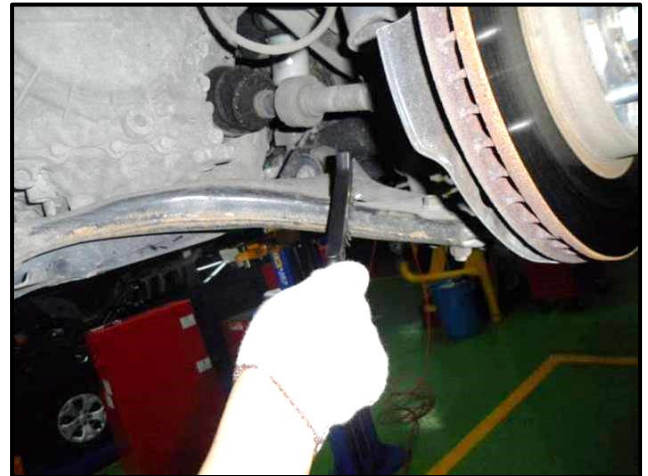
1. Use a metal bristle brush to remove any surface rust from the outside of the lower control arms. Then use shop air to remove any loose dust from the lower control arm surfaces.

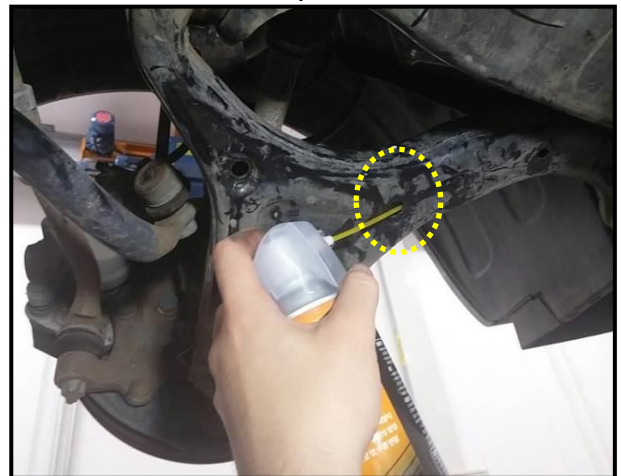
3. Use the spray can wax to apply cavity wax into the four (4) indicated holes.

These three holes require at least three (3) seconds of continuous spray for a thorough application.

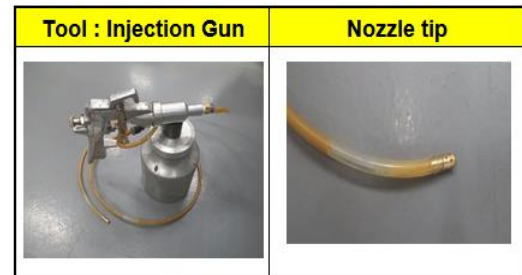
4. Prepare the Wax Injection Gun and supplied tip for application of cavity wax material. Remove hose with the ridged nozzle end and install the new (flexible over entire length) hose.

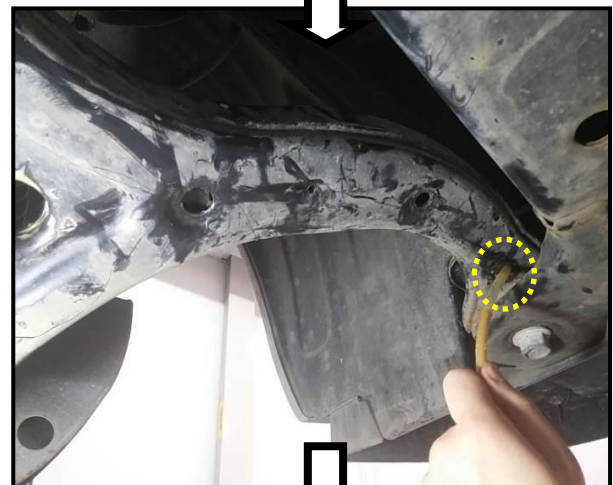
5. Use the Wax Injection Gun to apply cavity wax to the five (5) indicated holes on the lower control arm. Make sure to use ONLY one quarter (1/4) of the contents in each bottle per lower control arm.

These holes require at least three (3) seconds of continuous spray for a thorough application.

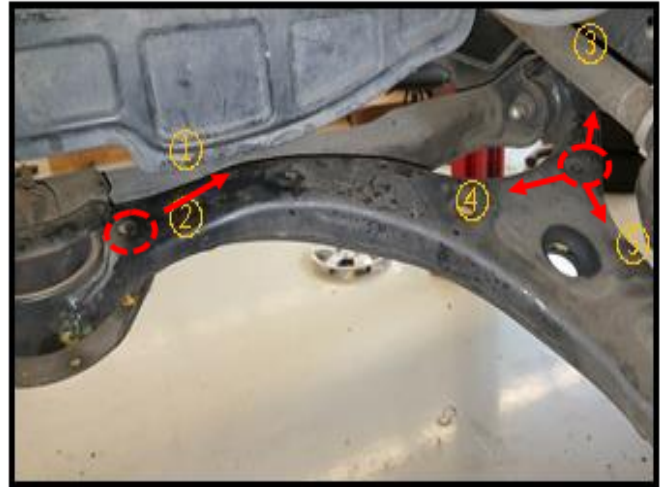
8. Insert the camera through the upper holes of the panel without bending the camera wand. (Use the 90 degree reflector.)

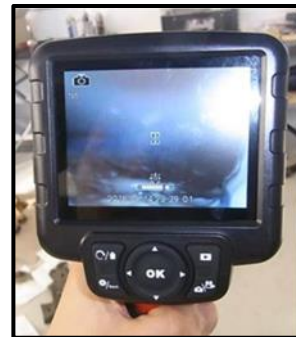
9. Check the wax application coverage inside the lower arm with the video camera. Take and save 5 photos, including the time and date stamp, of the locations, as identified in the pictures on this page.

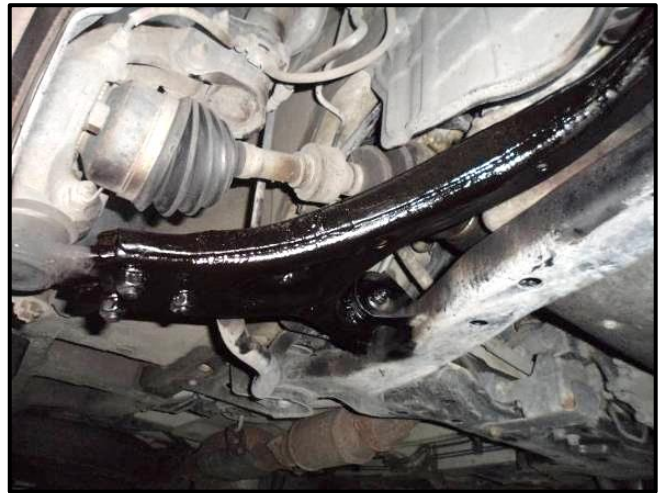
10. Spray underbody coating onto the upper and lower surfaces of the lower control arm. Avoid over-spraying other parts of the vehicle.
